## Item #13811313 - 2016 JLG 4069LE Electric Scissor Lift

# Inspection Report

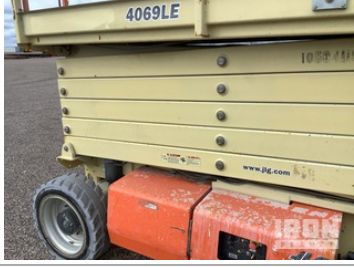
| Paint | No visible damage | |

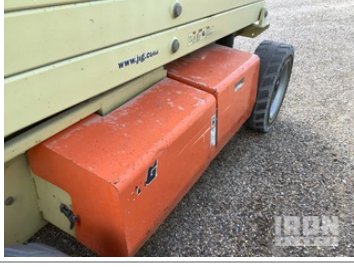
| Body Panels | No visible damage or missing components | |

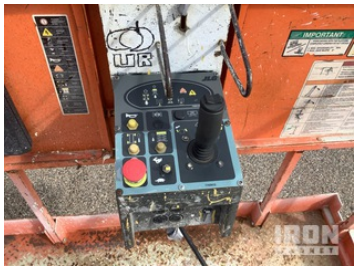
| Item | Assessment | Photo |
|---|---|---|
| Control Console | No visible damage or missing components | |

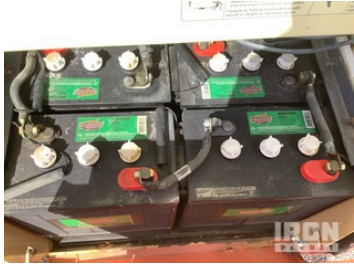
| Electrical Operating System | | |
|---|---|---|
| Cables and Connections | No visible damage or missing components | |

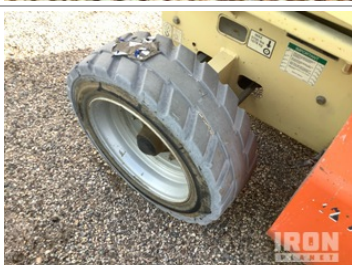
| Item | Assessment | Photo |
|---|---|---|
| Left Front Tire | Cracks, Chunks missing | |

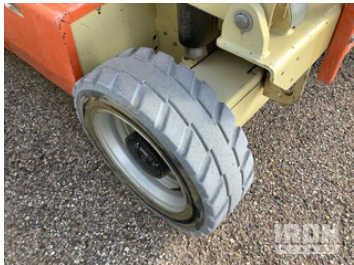
| Left Rear Tire | Cracks, Chunks missing | |

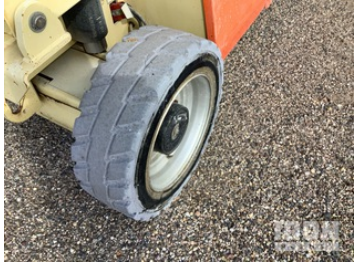
| Right Rear Tire | Cracks, Chunks missing | |

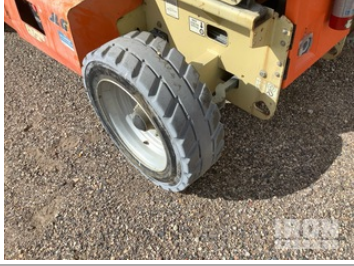
| Right Front Tire | Cracks, Chunks missing | |
