## Item #14339929 - 2017 Skyjack SJ4632 Electric Scissor Lift

# Inspection Report

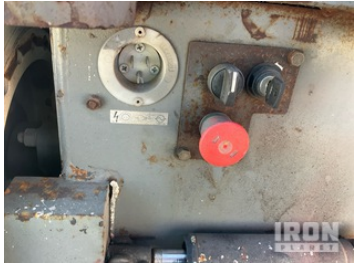
| Control Station Ground | | |
|---|---|---|
| Function Controls | ★ ★ ★ ☆ | |
| Limited Function Check | The main components are in place and operational as noted. | |

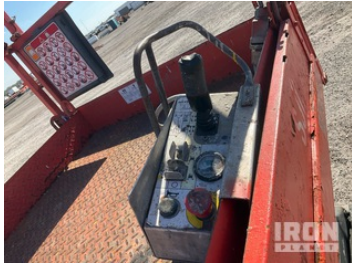
| Item | Assessment | Photo |
|---|---|---|
| Upper Function Controls | ★★★★☆ | |
| Limited Function Check | The main components are in place and operational as noted. | |

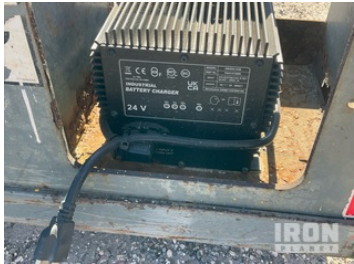
| Electrical Operating System | | |
|---|---|---|
| Battery Charger | Included Appears normal - Not operationally checked, 110V AC Volt, Single Phase | |

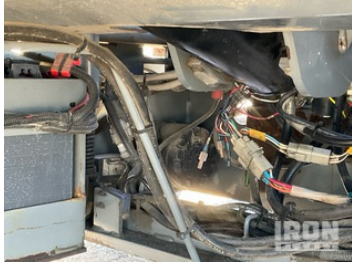
| Item | Assessment | Photo |
|---|---|---|
| Drive Motors | ★★★☆☆ | |
| Limited Function Check | The drivetrain was operational. | |

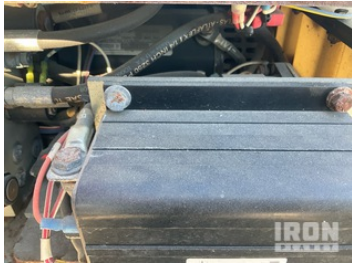
| Hydraulics | | |
|---|---|---|
| Pumps (Hydraulics) | ★★★★☆ | |

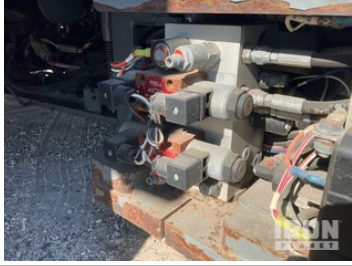
| Hydraulics | | |
|---|---|---|
| Valves | ★★★★☆ | |

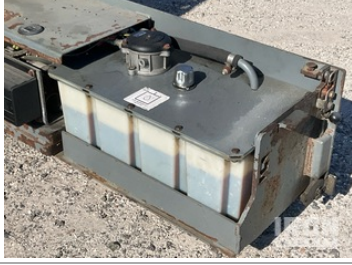
| Hydraulics | | |
|---|---|---|
| Hydraulic Tank | ★★★★☆ | |

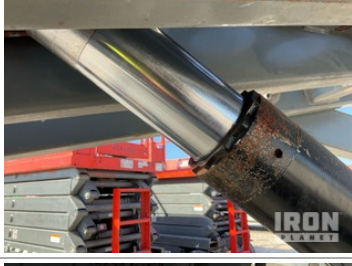
| Hydraulics | | |
|---|---|---|
| Lift Cylinders | ★★★★☆ | |

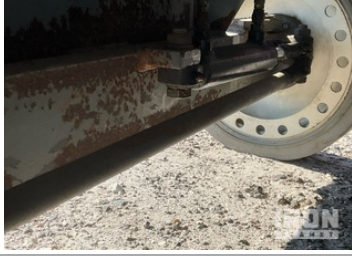
| Hydraulics | | |
|---|---|---|
| Steering Cylinder | ★★★★☆ | |

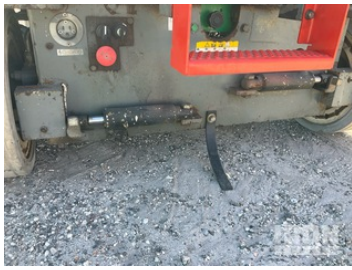
| Item | Assessment | Photo |
|---|---|---|
| Brake System | ★★☆☆<br>The brake system functioned, stopping and holding the machine. | |

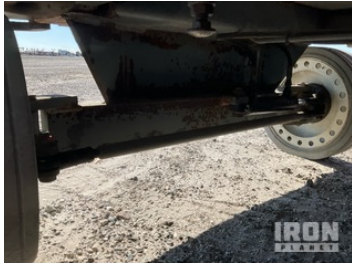
| Item | Assessment | Photo |
|---|---|---|
| Steering Linkage | ★★☆☆ | |

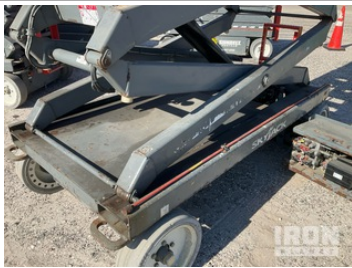
| Item | Assessment | Photo |
|---|---|---|
| Frame Condition | ★★☆☆ | |

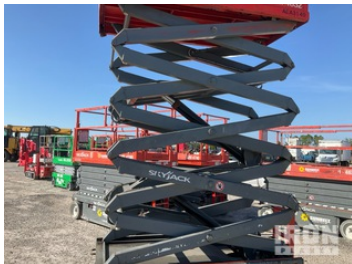
| Item | Assessment | Photo |
|---|---|---|
| Scissor Linkage | ★★☆☆ | |

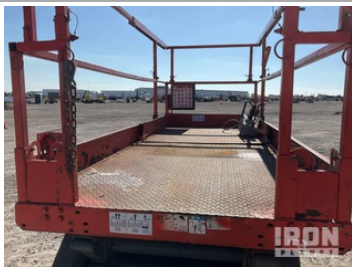
| Item | Assessment | Photo |
|---|---|---|
| Platform Condition | ★★☆☆ | |

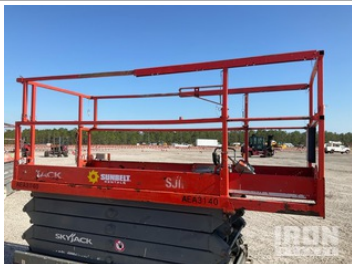
| Item | Assessment | Photo |
|---|---|---|
| Platform Extension | ★★☆☆ | |

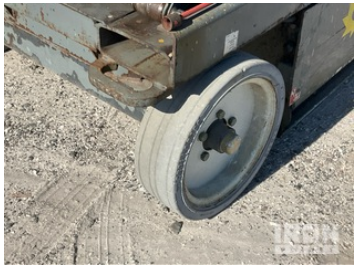
| Left Front Tire | Cracks | |

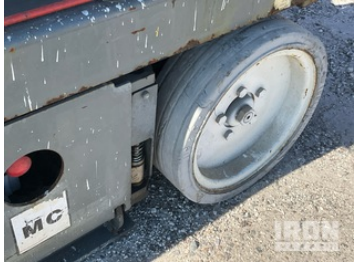
| Left Rear Tire | Cracks | |

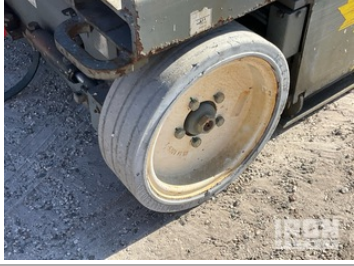
| Right Rear Tire | Cracks | |

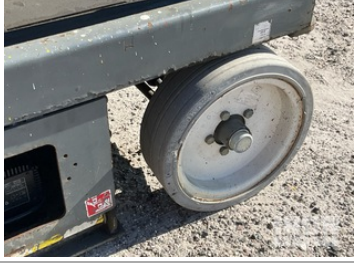
| Right Front Tire | Cracks | |

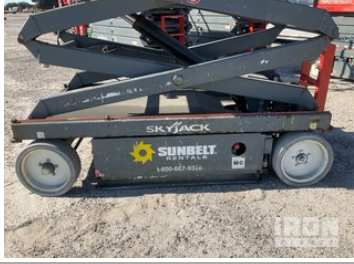
| Pothole Protection Bars | ★★★★☆<br>Functional | |
