## Item #13811480 - 2016 JLG 4069LE Electric Scissor Lift

# Inspection Report

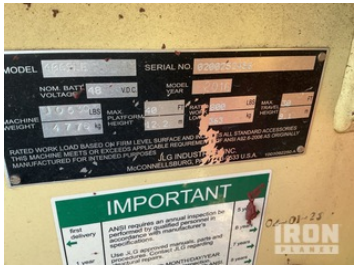
| Serial Number / VIN | 0200252456 | |

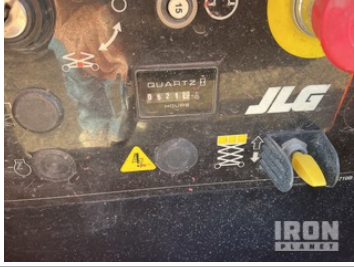
| Hour Meter / Odometer | 521 hrs | |

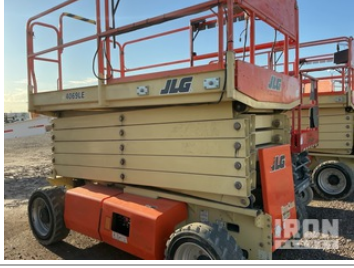
| Paint | No visible damage | |

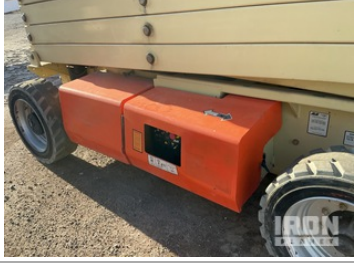
| Body Panels | No visible damage or missing components | |

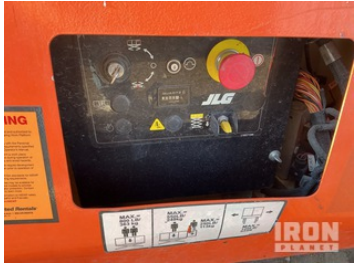
| Control Station Ground | | |
|---|---|---|
| Gauges | Operational | |

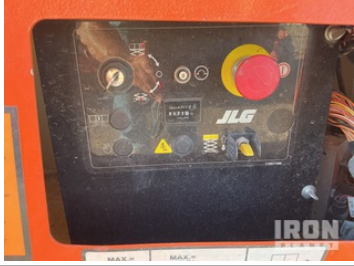
| Control Station Ground | | |
|---|---|---|
| Function Controls | ★★★★☆ | |

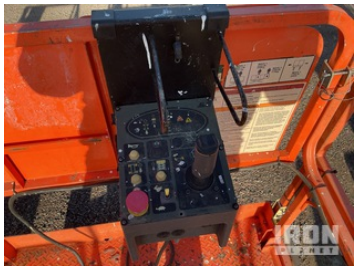
| Item | Assessment | Photo |
|---|---|---|
| Control Console | No visible damage or missing components | A close-up photograph of the control console, showing various buttons, switches, and a joystick. The console is mounted on an orange scissor lift platform. A watermark "IRON PLANET" is visible in the bottom right corner. |

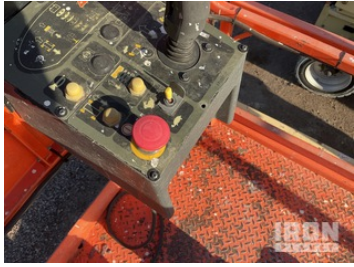
| Item | Assessment | Photo |
|---|---|---|
| Emergency Shut Off Switch | Operational | A close-up photograph of the emergency shut off switch, which is a red button. It is located on the control console. A watermark "IRON PLANET" is visible in the bottom right corner. |

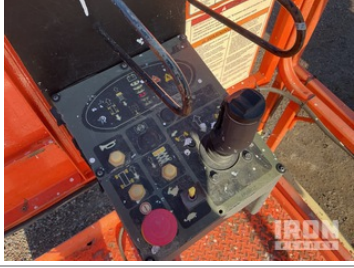
| Item | Assessment | Photo |
|---|---|---|
| Upper Function Controls | ★★★★☆ | A close-up photograph of the upper function controls, showing a joystick and several buttons. A watermark "IRON PLANET" is visible in the bottom right corner. |

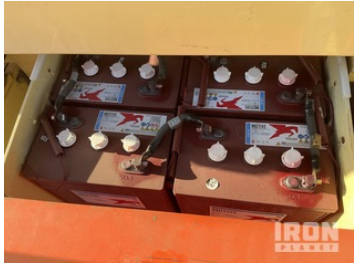
| Electrical Operating System | | |
|---|---|---|
| Cables and Connections | No visible damage or missing components | |

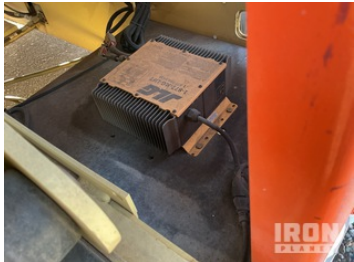
| Electrical Operating System | | |
|---|---|---|
| Battery Charger | Included 110 Volt, Single Phase | |

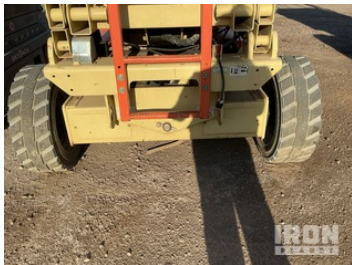
| Item | Assessment | Photo |
|---|---|---|
| Drive Motors | ★★★★☆ | |

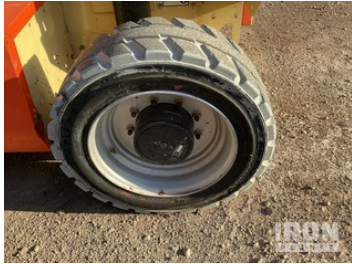
| Item | Assessment | Photo |
|---|---|---|
| Final Drives | ★★★★☆ | |

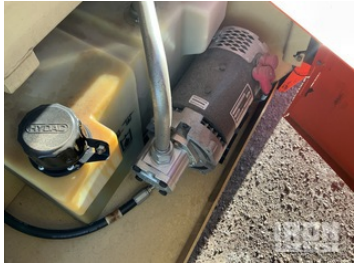
| Hydraulics | | |
|---|---|---|
| Pumps (Hydraulics) | ★★★★☆ | A close-up photograph of a hydraulic pump assembly mounted on a yellow metal frame. The pump is a black cylindrical unit with various hoses and electrical connections. An "IRON PLANET" watermark is visible in the bottom right corner. |

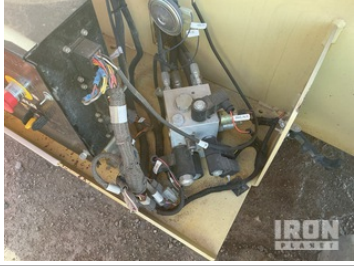
| Hydraulics | | |
|---|---|---|
| Valves | ★★★★☆ | A photograph showing a hydraulic valve assembly with multiple ports and hoses, mounted on a yellow metal frame. An "IRON PLANET" watermark is visible in the bottom right corner. |

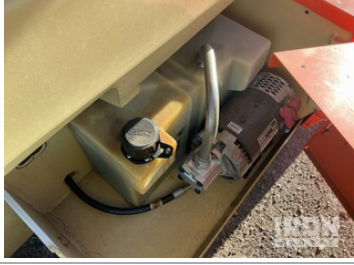
| Hydraulics | | |
|---|---|---|
| Hydraulic Tank | ★★★★☆ | A photograph of a hydraulic tank, which is a yellow metal container with a pump and valve assembly mounted on top. An "IRON PLANET" watermark is visible in the bottom right corner. |

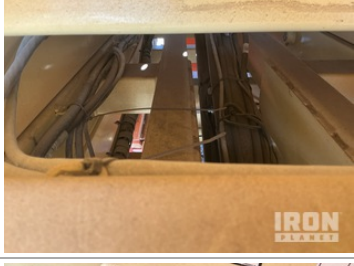
| Hydraulics | | |
|---|---|---|
| Lift Cylinders | ★★★★☆ | A photograph showing the internal components of a lift cylinder, including hydraulic hoses and structural metal beams. An "IRON PLANET" watermark is visible in the bottom right corner. |

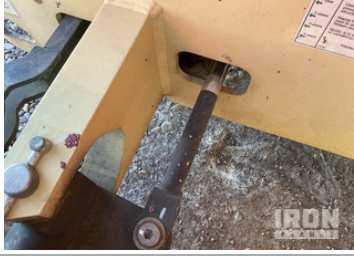
| Hydraulics | | |
|---|---|---|
| Steering Cylinder | ★★★★☆ | A photograph of a steering cylinder, showing the hydraulic ram and mounting brackets. An "IRON PLANET" watermark is visible in the bottom right corner. |

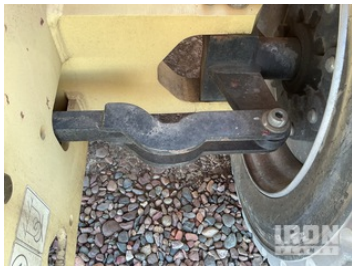
| Item | Assessment | Photo |
|---|---|---|
| Steering Linkage | ★★★★☆ | |

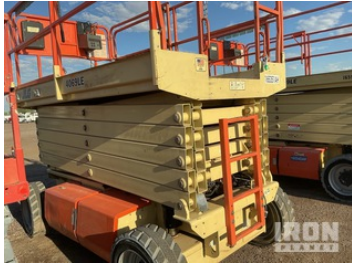
| Item | Assessment | Photo |
|---|---|---|
| Frame Condition | ★★★★☆ | |

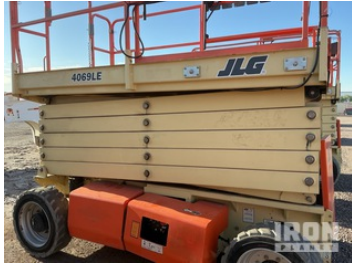
| Item | Assessment | Photo |
|---|---|---|
| Scissor Linkage | ★★★★☆ | |

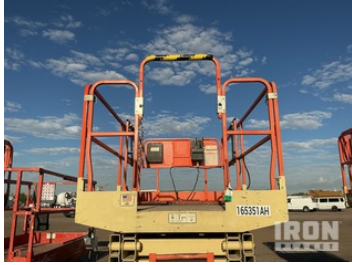
| Item | Assessment | Photo |
|---|---|---|
| Platform Condition | ★★★★☆ | |

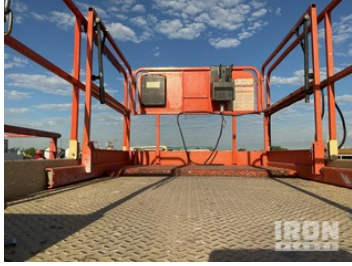
| Item | Assessment | Photo |
|---|---|---|
| Platform Extension | ★★★★☆ | |

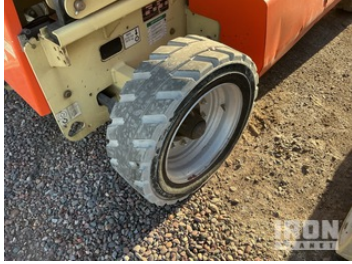
| Item | Assessment | Photo |
|---|---|---|
| Left Front Tire | No visible defects | |

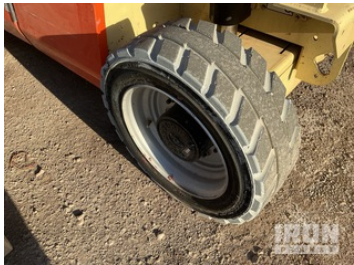
| Left Rear Tire | No visible defects | |

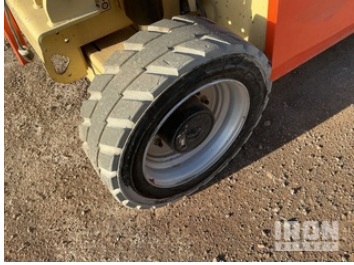
| Right Rear Tire | Cracks | |

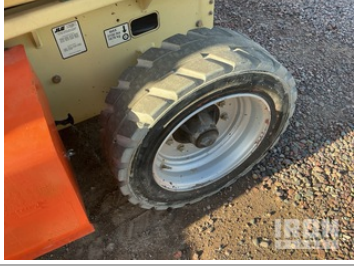
| Right Front Tire | No visible defects | |

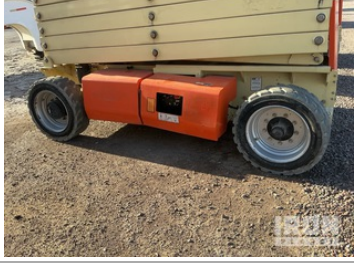
| Wheel Condition | No visible damage or missing components | |
