## Item #13811336 - 2017 JLG 4069LE Electric Scissor Lift

- Features: 40 ft Max Platform Height, 800 lb Max Weight Capacity, Platform Extension, Power to Platform, Solid Non-Marking Tires, Upper Control Box
- Meter Reading: 451 Miles
- Serial # : 0200263121
- Inspection Completed: 11/3/25

# Inspection Report

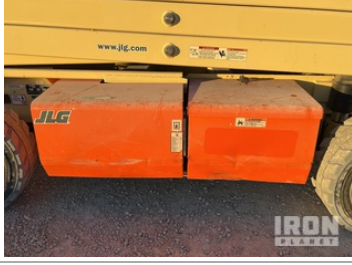
| Body Panels | Battery compartment door damaged,<br>Hydraulic compartment door damaged | |

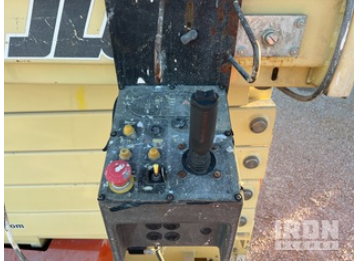
| Item | Assessment | Photo |
|---|---|---|
| Control Console | No visible damage or missing components | |

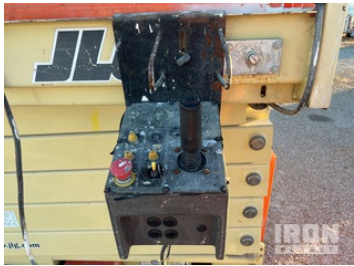
| Item | Assessment | Photo |
|---|---|---|
| Upper Function Controls | ★★★★☆ | |

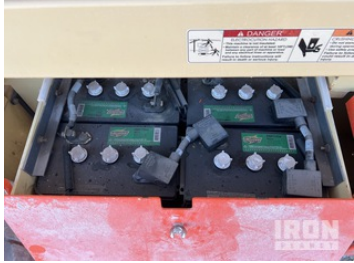
| Electrical Operating System | | |
|---|---|---|
| Cables and Connections | No visible damage or missing components | |

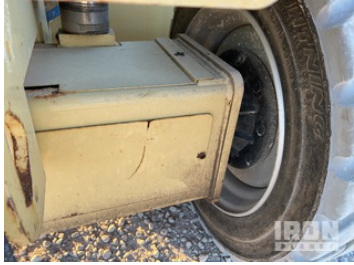
| Item | Assessment | Photo |
|---|---|---|
| Drive Motors | ★★★☆☆ | |

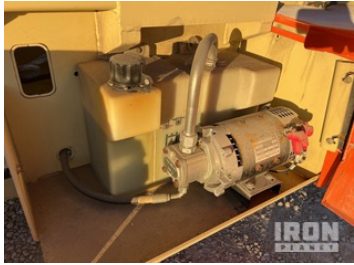
| Hydraulics | | |
|---|---|---|
| Pumps (Hydraulics) | ★★★★☆ | A close-up photograph of a hydraulic pump assembly mounted on a yellow metal frame. The pump is a cylindrical unit with various hoses and electrical connections. An "IRON PLANET" watermark is visible in the bottom right corner. |

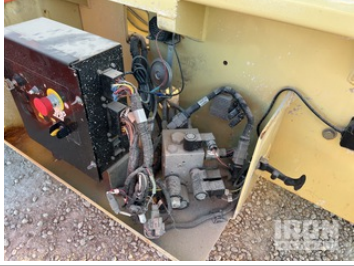
| Hydraulics | | |
|---|---|---|
| Valves | ★★★★☆ | A photograph showing a hydraulic valve assembly with multiple ports and hoses. The assembly is mounted on a yellow metal frame. An "IRON PLANET" watermark is visible in the bottom right corner. |

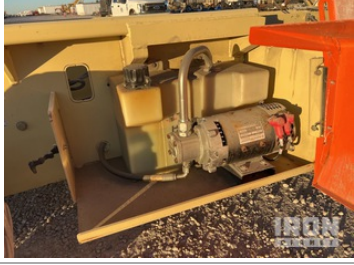
| Hydraulics | | |
|---|---|---|
| Hydraulic Tank | ★★★★☆ | A photograph of a hydraulic tank and pump assembly. The tank is a large, rectangular metal container, and the pump is mounted on top. The entire unit is painted yellow. An "IRON PLANET" watermark is visible in the bottom right corner. |

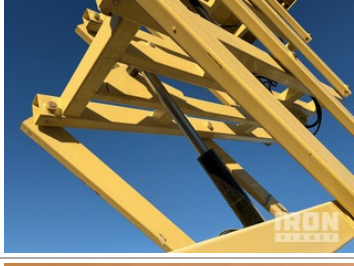
| Hydraulics | | |
|---|---|---|
| Lift Cylinders | ★★★★☆ | A photograph of a hydraulic lift cylinder. The cylinder is a long, black metal tube with a piston rod extending from one end. It is mounted on a yellow metal frame. An "IRON PLANET" watermark is visible in the bottom right corner. |

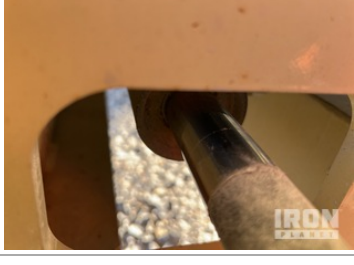
| Hydraulics | | |
|---|---|---|
| Steering Cylinder | ★★★★☆ | A photograph of a steering cylinder. The cylinder is a black metal tube with a piston rod extending from one end. It is mounted on a yellow metal frame. An "IRON PLANET" watermark is visible in the bottom right corner. |

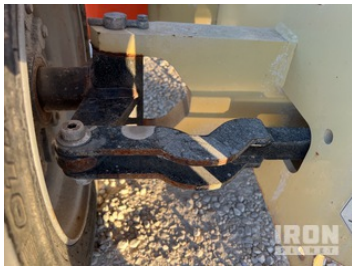
| Item | Assessment | Photo |
|---|---|---|
| Steering Linkage | ★★★★☆ | |

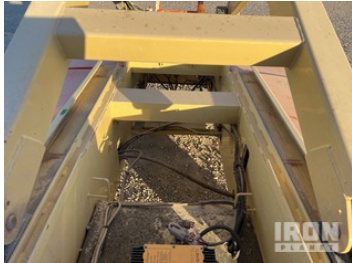
| Item | Assessment | Photo |
|---|---|---|
| Frame Condition | ★★★★☆ | |

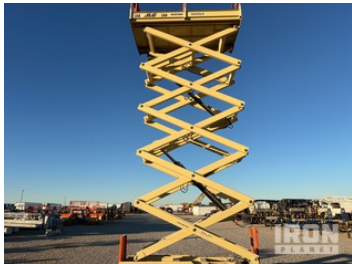
| Item | Assessment | Photo |
|---|---|---|
| Scissor Linkage | ★★★★☆ | |

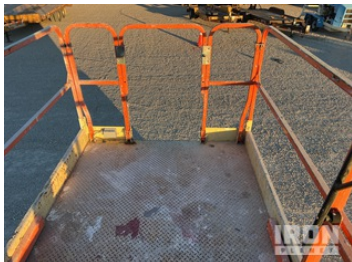
| Item | Assessment | Photo |
|---|---|---|
| Platform Condition | ★★★★☆ | |

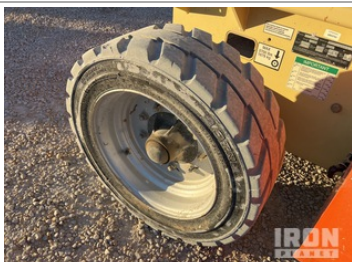
| Item | Assessment | Photo |
|---|---|---|
| Left Front Tire | Cracks, Chunks missing, Tears | |

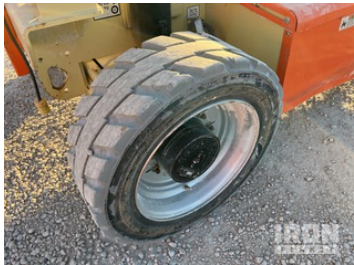
| Left Rear Tire | Cracks, Chunks missing, Tears | |

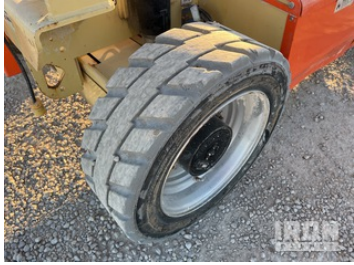
| Right Rear Tire | Cracks, Chunks missing, Tears | |

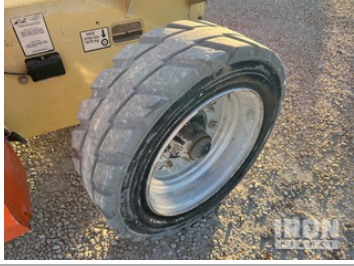
| Right Front Tire | Cracks, Chunks missing, Tears | |
