## Item #14339902 - 2016 Skyjack SJ4632 Electric Scissor Lift

# Inspection Report

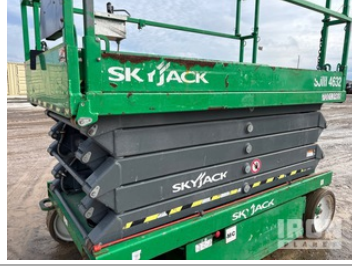
| Paint | No visible damage | |

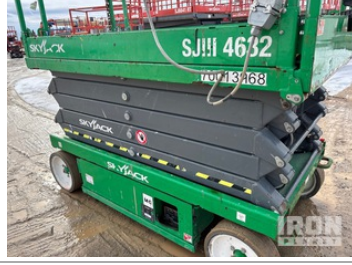
| Body Panels | No visible damage or missing components | |

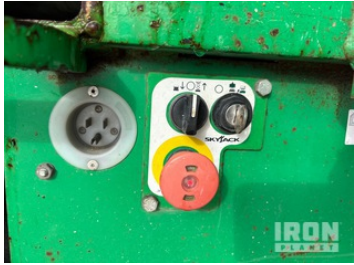
| Control Station Ground | | |
|---|---|---|
| Function Controls | ☆☆☆☆ | |

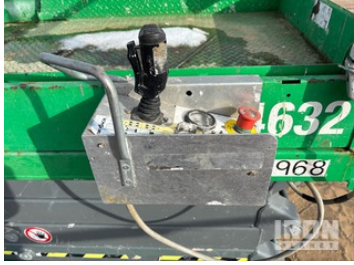
| Item | Assessment | Photo |
|---|---|---|
| Control Console | No visible damage or missing components | |

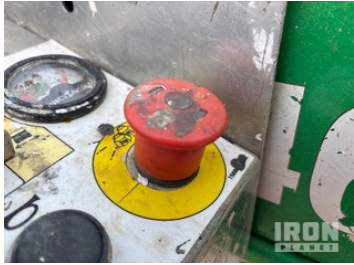
| Item | Assessment | Photo |
|---|---|---|
| Emergency Shut Off Switch | Operational | |

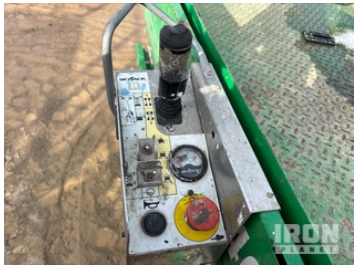
| Item | Assessment | Photo |
|---|---|---|
| Upper Function Controls | ☆☆☆☆ | |

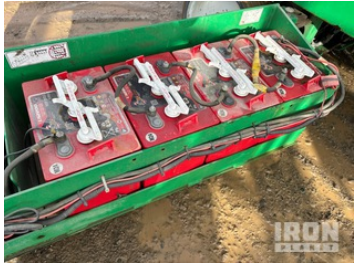
| Electrical Operating System | | |
|---|---|---|
| Cables and Connections | No visible damage or missing components | |

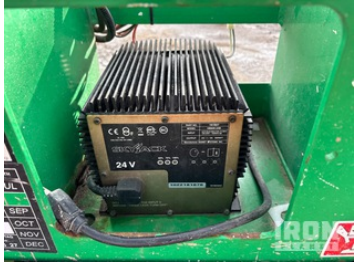
| Electrical Operating System | | |
|---|---|---|
| Battery Charger | Included Appears normal - Not operationally checked, 100-240 Volt, Single Phase | |

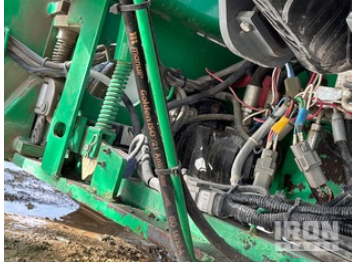
| Item | Assessment | Photo |
|---|---|---|
| Drive Motors | ★★★★☆ | |

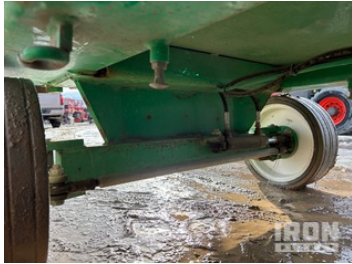
| Item | Assessment | Photo |
|---|---|---|
| Front Drive Axle | ★★★★☆ | |

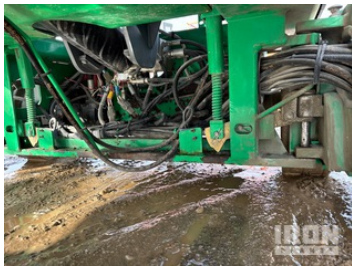
| Item | Assessment | Photo |
|---|---|---|
| Rear Drive Axle | ★★★★☆ | |

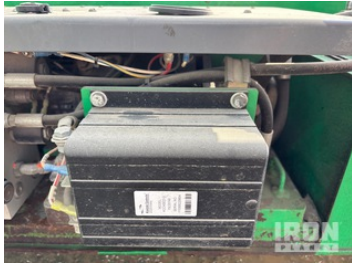
| Hydraulics | | |
|---|---|---|
| Pumps (Hydraulics) | ★★★★☆ | |

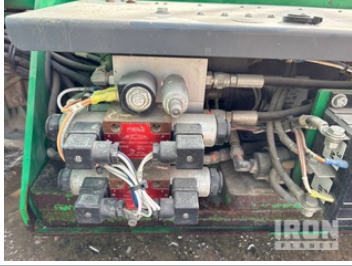
| Hydraulics | | |
|---|---|---|
| Valves | ★★★★☆ | |

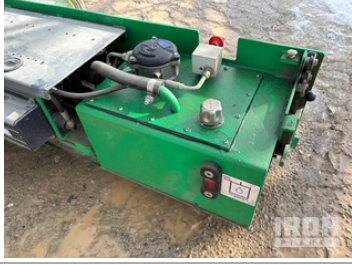
| Hydraulics | | |
|---|---|---|
| Hydraulic Tank | ★★★☆☆<br>Seepage | |

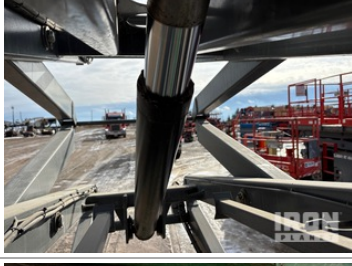
| Hydraulics | | |
|---|---|---|
| Lift Cylinders | ★★★★☆ | |

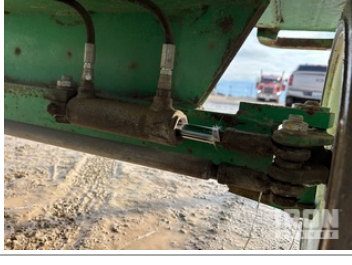
| Hydraulics | | |
|---|---|---|
| Steering Cylinder | ★★★★☆ | |

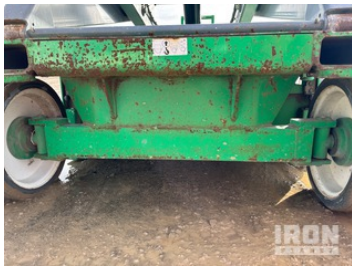
| Item | Assessment | Photo |
|---|---|---|
| Steering Linkage | ★★★★☆ | |

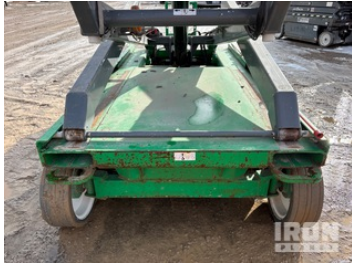
| Item | Assessment | Photo |
|---|---|---|
| Frame Condition | ★★★★☆ | |

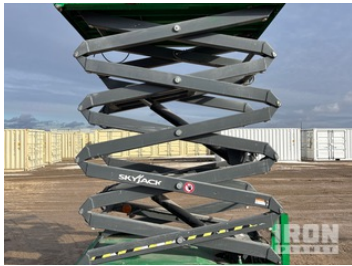
| Item | Assessment | Photo |
|---|---|---|
| Scissor Linkage | ★★★★☆ | |

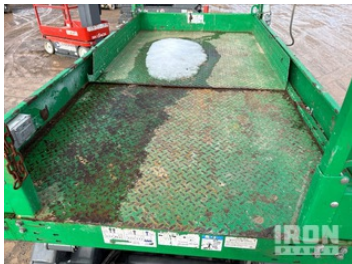
| Item | Assessment | Photo |
|---|---|---|
| Platform Condition | ★★★★☆ | |

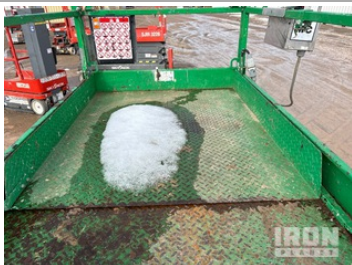
| Item | Assessment | Photo |
|---|---|---|
| Platform Extension | ★★★★☆ | |

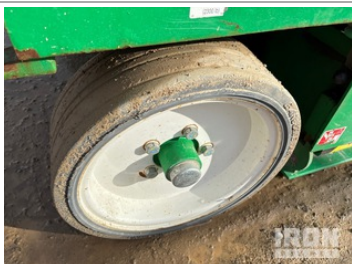
| Item | Assessment | Photo |
|---|---|---|
| Left Front Tire | No visible defects | |

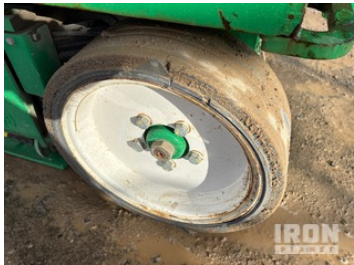
| Left Rear Tire | Chunks missing | |

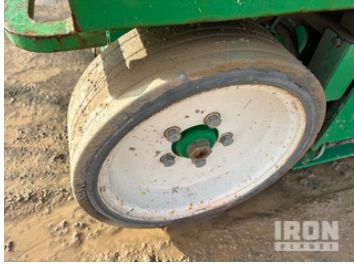
| Right Rear Tire | No visible defects | |

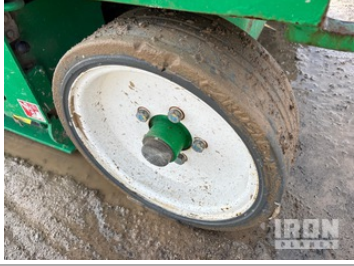
| Right Front Tire | Chunks missing | |

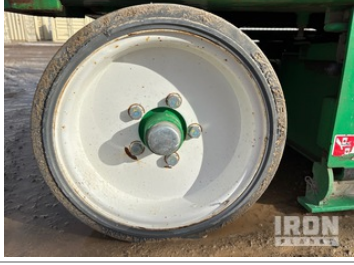
| Wheel Condition | No visible damage or missing components | |

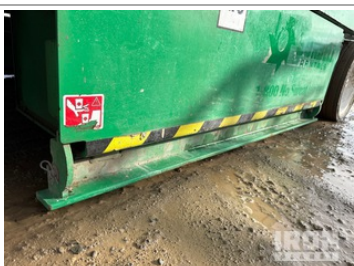
| Pothole Protection Bars | ★★★★☆<br>Functional | |
