## Item #13811302 - 2017 JLG 4069LE Electric Scissor Lift

- Features: 40 ft Max Platform Height, 300 lb Max Weight Capacity, Platform Extension, Power to Platform, Solid Non-Marking Tires, Upper Control Box
- Meter Reading: 322 Hours
- Serial # : 0200264009
- Inspection Completed: 10/9/25

# Inspection Report

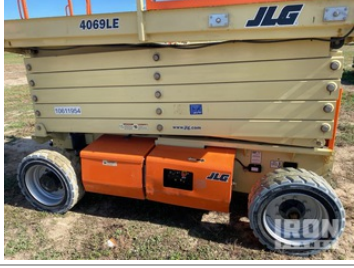
| Paint | No visible damage | |

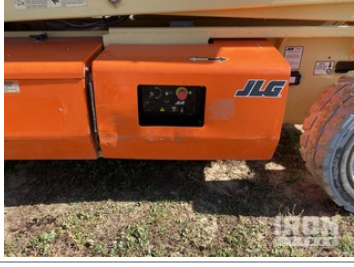
| Body Panels | Battery compartment door damaged,<br>Hydraulic compartment door damaged | |

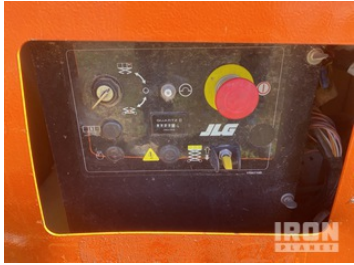
| Control Station Ground | | |
|---|---|---|
| Function Controls | ★ ★ ★ ☆ | |

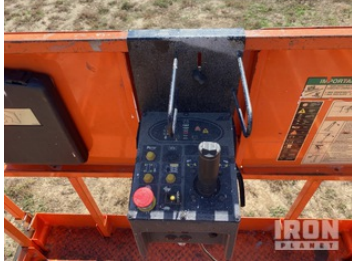
| Item | Assessment | Photo |
|---|---|---|
| Control Console | No visible damage or missing components | |

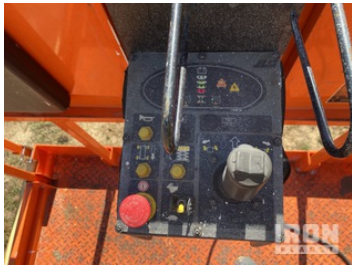
| Item | Assessment | Photo |
|---|---|---|
| Upper Function Controls | ★★★★☆ | |

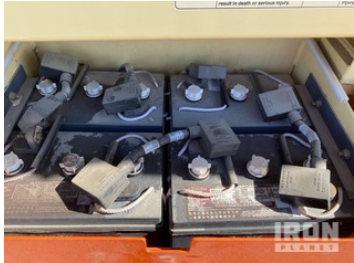
| Electrical Operating System | | |
|---|---|---|
| Cables and Connections | No visible damage or missing components | |

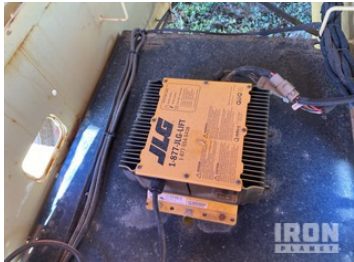
| Electrical Operating System | | |
|---|---|---|
| Battery Charger | Appears normal - Not operationally checked, 120 Volt, Single Phase | |

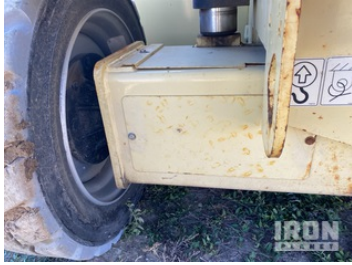
| Item | Assessment | Photo |
|---|---|---|
| Drive Motors | ★★★★☆ | |

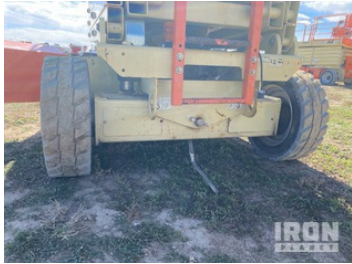
| Item | Assessment | Photo |
|---|---|---|
| Rear Drive Axle | ★★★★☆ | |

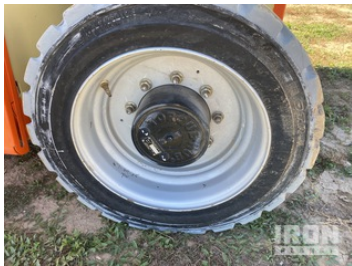
| Item | Assessment | Photo |
|---|---|---|
| Final Drives | ★★★★☆ | |

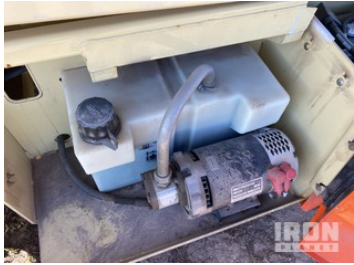
| Hydraulics | | |
|---|---|---|
| Pumps (Hydraulics) | ★★★★☆ | |

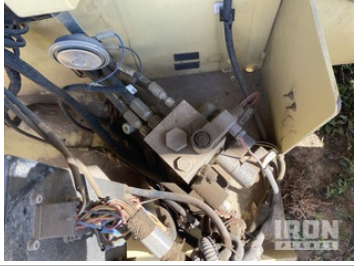
| Hydraulics | | |
|---|---|---|
| Valves | ★★★★☆ | |

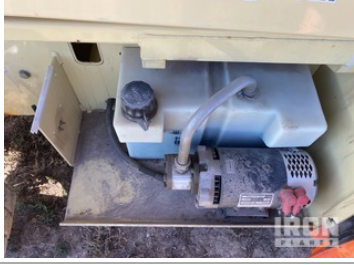
| Hydraulics | | |
|---|---|---|
| Hydraulic Tank | ★★★★☆ | |

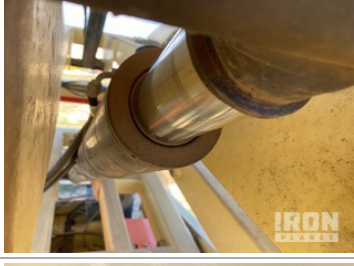
| Hydraulics | | |
|---|---|---|
| Lift Cylinders | ★★★★☆ | |

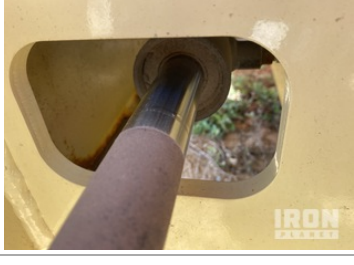
| Hydraulics | | |
|---|---|---|
| Steering Cylinder | ★★★★☆ | |

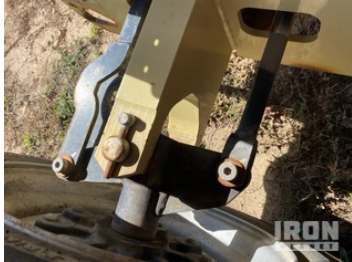
| Item | Assessment | Photo |
|---|---|---|
| Steering Linkage | ★★★★☆ | |

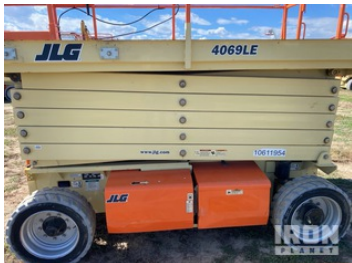
| Item | Assessment | Photo |
|---|---|---|
| Frame Condition | ★★★★☆ | |

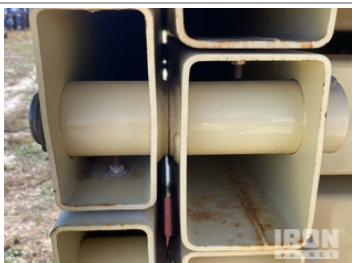
| Item | Assessment | Photo |
|---|---|---|
| Scissor Linkage | ★★★★☆ | |

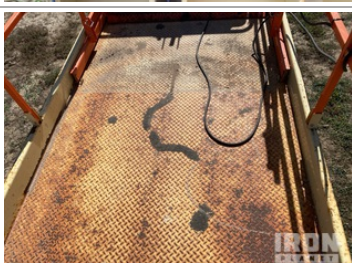
| Item | Assessment | Photo |
|---|---|---|
| Platform Condition | ★★★★☆ | |

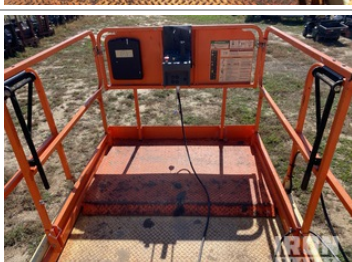
| Item | Assessment | Photo |
|---|---|---|
| Platform Extension | ★★★★☆ | |

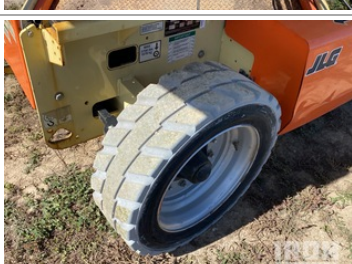
| Item | Assessment | Photo |
|---|---|---|
| Left Front Tire | No visible defects | |

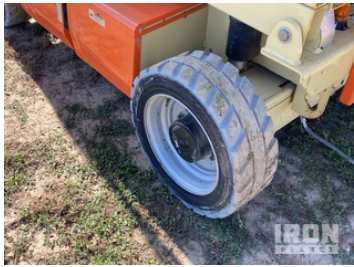
| Left Rear Tire | No visible defects | |

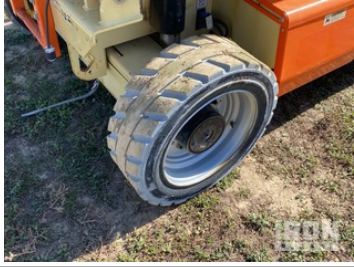
| Right Rear Tire | No visible defects | |

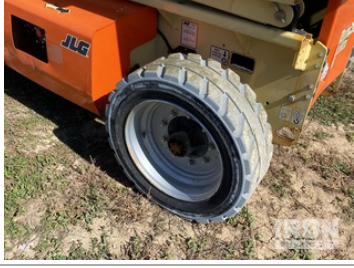
| Right Front Tire | No visible defects | |

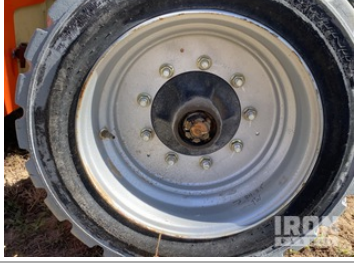
| Wheel Condition | Missing bearing dust cover. | |
