## Item #13811307 - 2018 JLG 4069LE Electric Scissor Lift

# Inspection Report

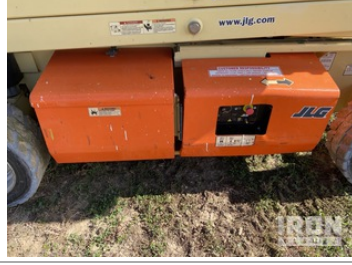
| Body Panels | Hydraulic compartment door damaged | |

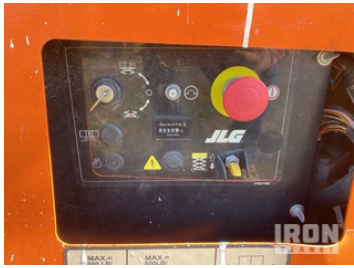
| Control Station Ground | | |
|---|---|---|
| Function Controls | ★★★★☆ | |

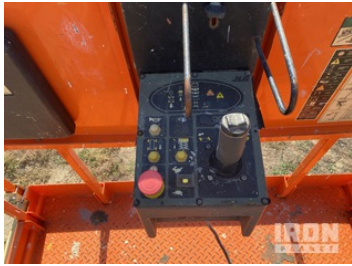
| Item | Assessment | Photo |
|---|---|---|
| Control Console | No visible damage or missing components | |

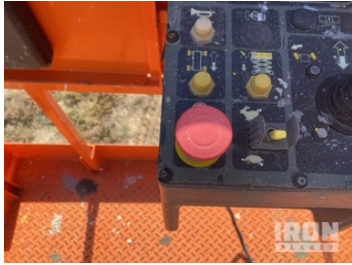
| Item | Assessment | Photo |
|---|---|---|
| Emergency Shut Off Switch | Operational | |

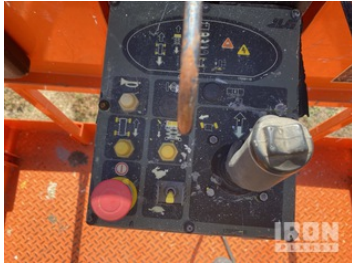
| Item | Assessment | Photo |
|---|---|---|
| Upper Function Controls | ★★★★☆ | |

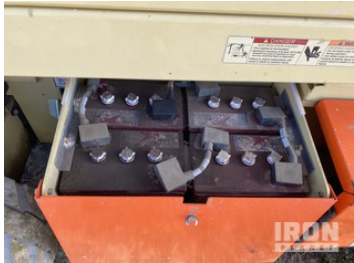
| Electrical Operating System | | |
|---|---|---|
| Cables and Connections | No visible damage or missing components | |

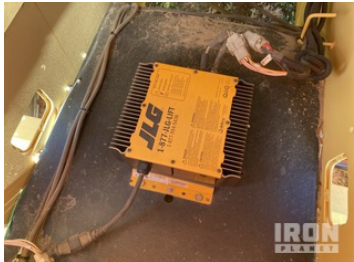
| Electrical Operating System | | |
|---|---|---|
| Battery Charger | Included Appears normal - Not operationally checked | |

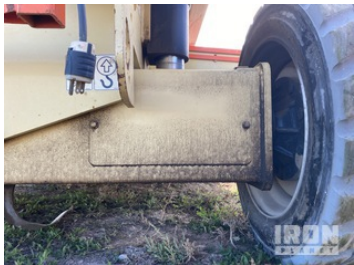
| Item | Assessment | Photo |
|---|---|---|
| Drive Motors | ★★★★☆ | |

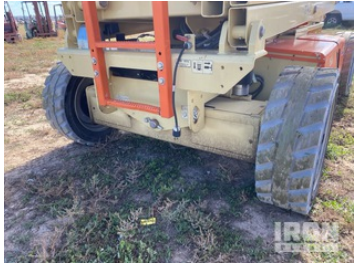
| Item | Assessment | Photo |
|---|---|---|
| Final Drives | ★★★★☆ | |

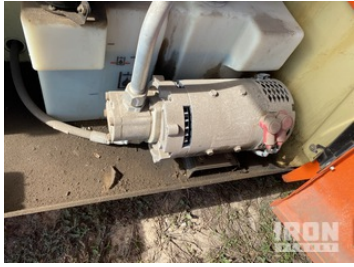
| Hydraulics | | |
|---|---|---|
| Pumps (Hydraulics) | ★★★★☆ | |

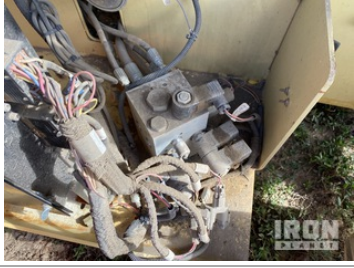
| Hydraulics | | |
|---|---|---|
| Valves | ★★★★☆ | |

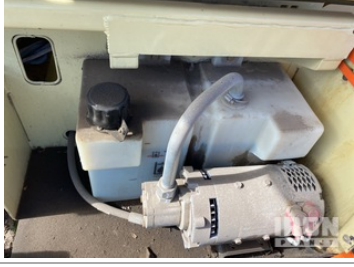
| Hydraulics | | |
|---|---|---|
| Hydraulic Tank | ★★★★☆ | |

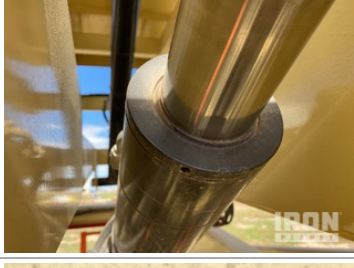
| Hydraulics | | |
|---|---|---|
| Lift Cylinders | ★★★★☆ | |

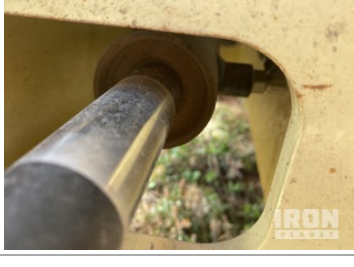
| Hydraulics | | |
|---|---|---|
| Steering Cylinder | ★★★★☆ | |

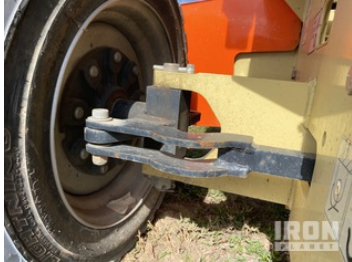
| Item | Assessment | Photo |
|---|---|---|
| Steering Linkage | ★★★★☆ | |

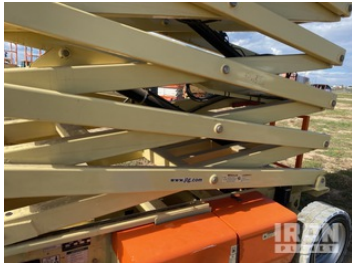
| Item | Assessment | Photo |
|---|---|---|
| Frame Condition | ★★★★☆ | |

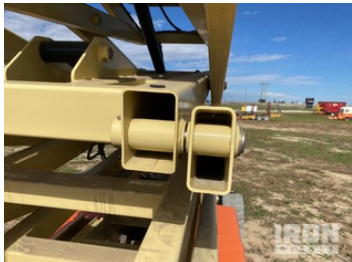
| Item | Assessment | Photo |
|---|---|---|
| Scissor Linkage | ★★★★☆ | |

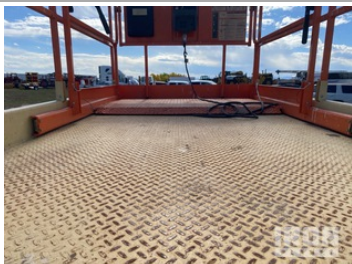
| Item | Assessment | Photo |
|---|---|---|
| Platform Condition | ★★★★☆ | |

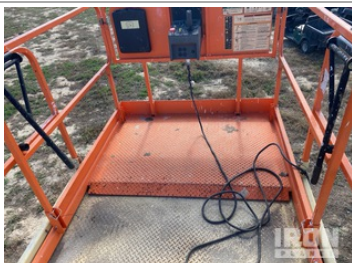
| Item | Assessment | Photo |
|---|---|---|
| Platform Extension | ★★★★☆ | |

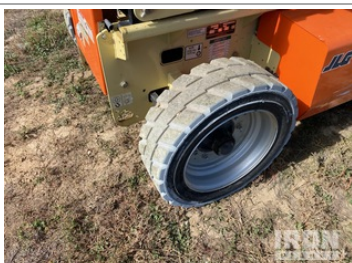
| Item | Assessment | Photo |
|---|---|---|
| Left Front Tire | No visible defects | |

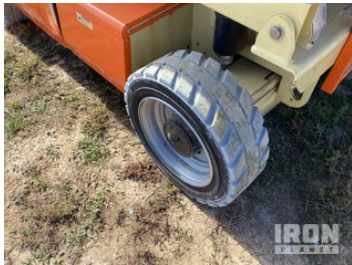
| Left Rear Tire | No visible defects | |

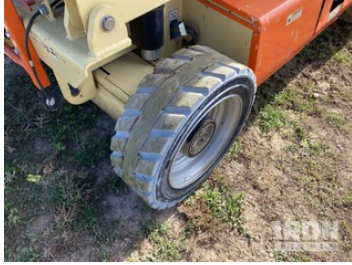
| Right Rear Tire | No visible defects | |

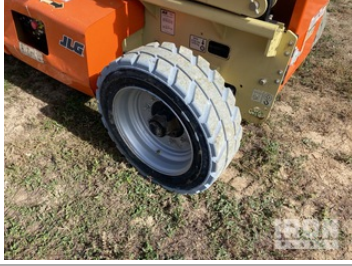
| Right Front Tire | No visible defects | |

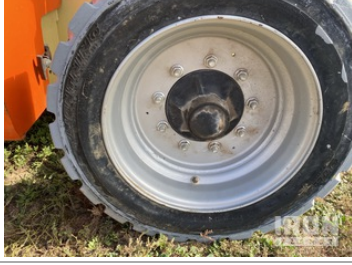
| Wheel Condition | No visible damage or missing components | |
