## Item #14097133 - 2018 Skyjack SJIII 4740 Electric Scissor Lift

# Inspection Report

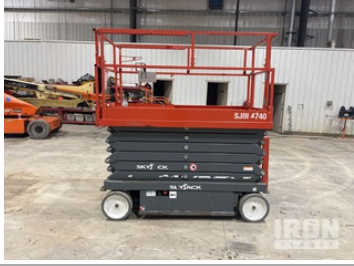
| Paint | No visible damage | |

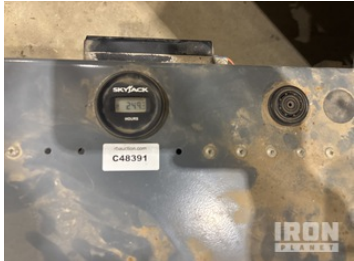
| Control Station Ground | | |
|---|---|---|
| Gauges | Operational | |

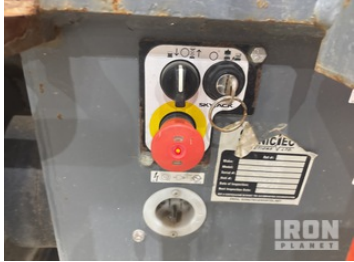
| Control Station Ground | | |
|---|---|---|
| Function Controls | ☆☆☆☆ | |

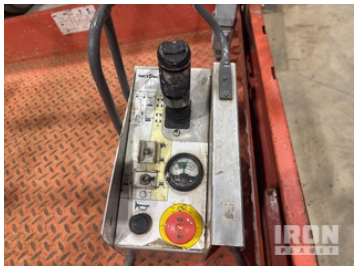
| Item | Assessment | Photo |
|---|---|---|
| Control Console | No visible damage or missing components | |

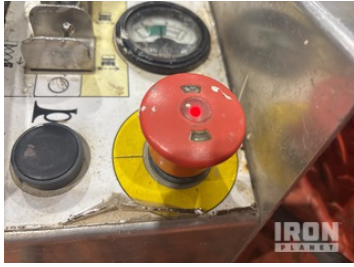
| Item | Assessment | Photo |
|---|---|---|
| Emergency Shut Off Switch | Operational | |

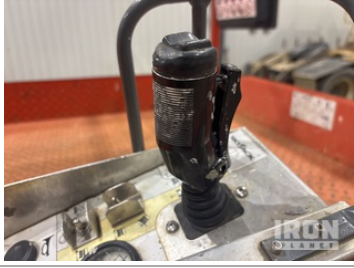
| Item | Assessment | Photo |
|---|---|---|
| Safety Control Hand/Foot Switch | ★★★★☆<br>Operational | |

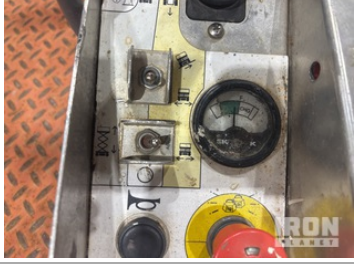
| Item | Assessment | Photo |
|---|---|---|
| Upper Function Controls | ★★★★☆ | |

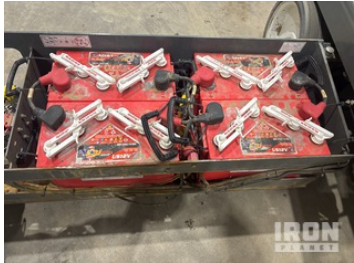
| Electrical Operating System | | |
|---|---|---|
| Cables and Connections | No visible damage or missing components | |

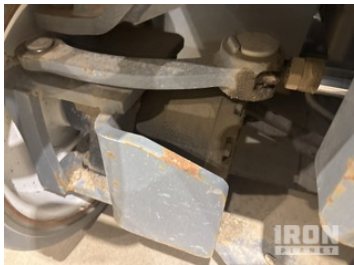
| Item | Assessment | Photo |
|---|---|---|
| Drive Motors | ★★★★☆ | |

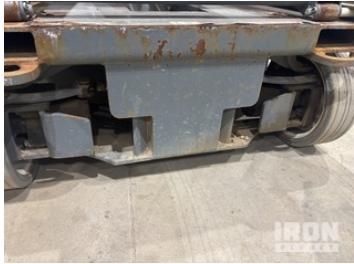
| Item | Assessment | Photo |
|---|---|---|
| Front Drive Axle | ★★★★☆ | |

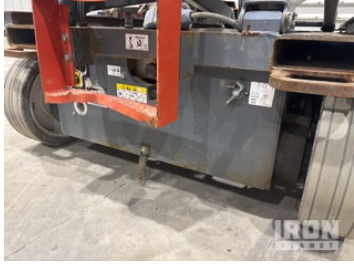
| Item | Assessment | Photo |
|---|---|---|
| Rear Drive Axle | ★★★★☆ | |

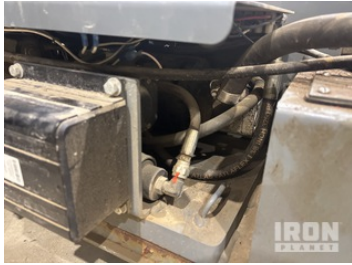
| Hydraulics | | |
|---|---|---|
| Pumps (Hydraulics) | ★★★★☆ | |

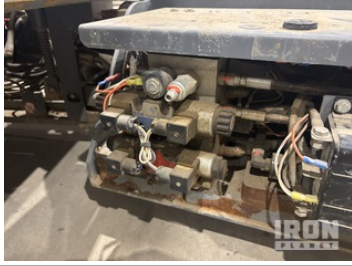
| Hydraulics | | |
|---|---|---|
| Valves | ★★★★☆ | |

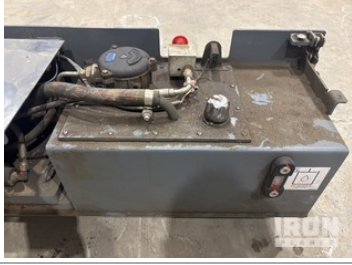
| Hydraulics | | |
|---|---|---|
| Hydraulic Tank | ★★★★☆ | |

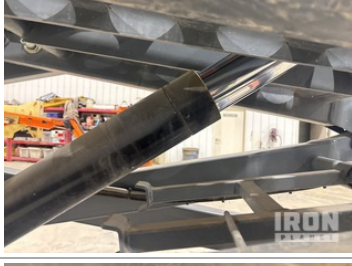
| Hydraulics | | |
|---|---|---|
| Lift Cylinders | ★★★★☆ | |

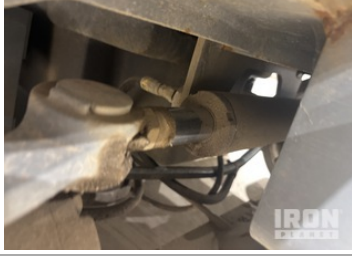
| Hydraulics | | |
|---|---|---|
| Steering Cylinder | ★★★★☆ | |

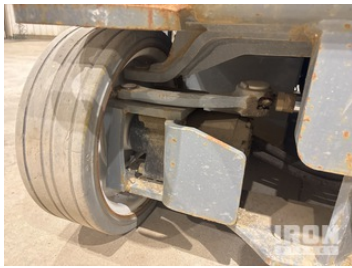
| Item | Assessment | Photo |
|---|---|---|
| Steering Linkage | ★★★★☆ | |

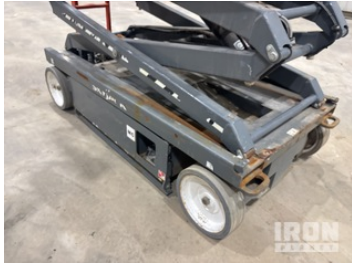
| Item | Assessment | Photo |
|---|---|---|
| Frame Condition | ★★★★☆ | |

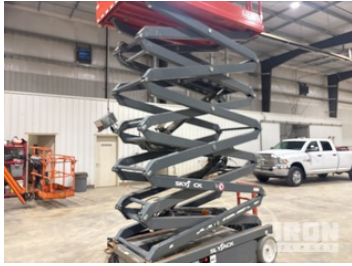
| Item | Assessment | Photo |
|---|---|---|
| Scissor Linkage | ★★★★☆ | |

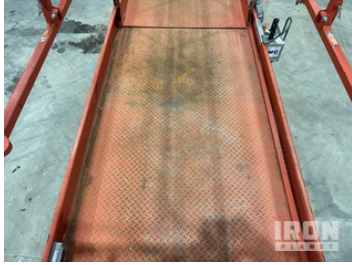
| Item | Assessment | Photo |
|---|---|---|
| Platform Condition | ★★★★☆ | |

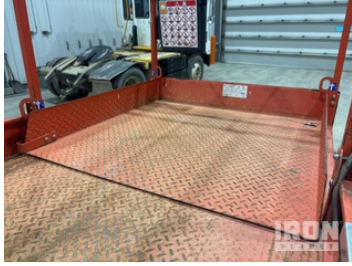
| Item | Assessment | Photo |
|---|---|---|
| Platform Extension | ★★★★☆ | |

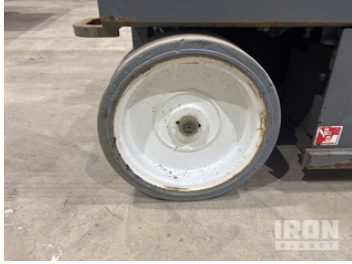
| Item | Assessment | Photo |
|---|---|---|
| Left Front Tire | No visible defects | |

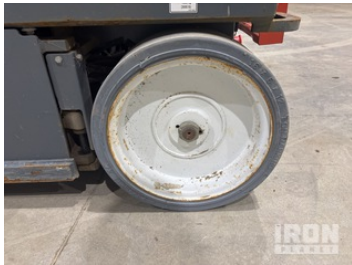
| Left Rear Tire | No visible defects | |

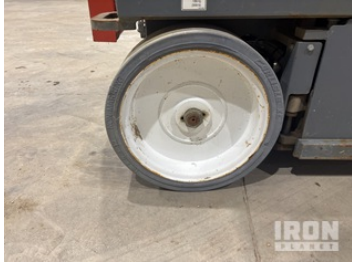
| Right Rear Tire | No visible defects | |

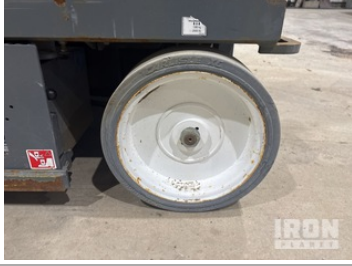
| Right Front Tire | No visible defects | |

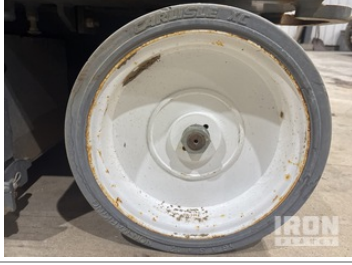
| Wheel Condition | No visible damage or missing components | |
