Item #14301288 - 2018 JLG 4069LE Electric Scissor Lift

Inspection Report

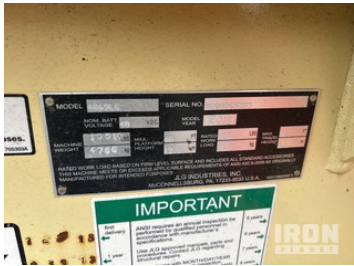
<p>Serial Number / VIN</p>	<p>200265353</p>

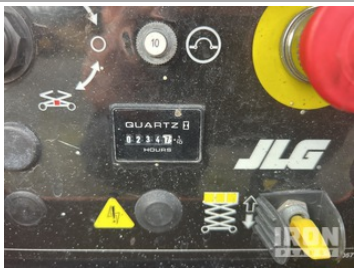
<p>Hour Meter / Odometer</p>	<p>234 hrs</p>

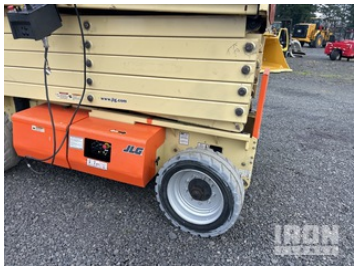
<p>Paint</p>	<p>No visible damage</p>

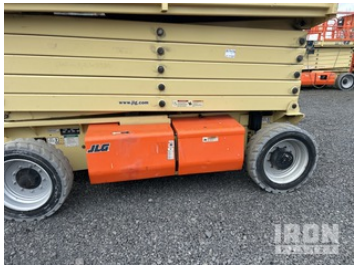
<p>Body Panels</p>	<p>No visible damage or missing components</p>

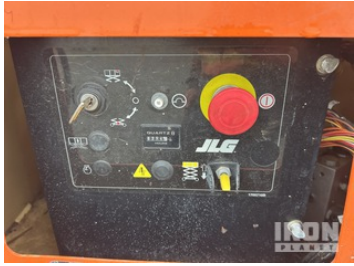
Control Station Ground		
Item	Assessment	Photo
Function Controls	★ ★ ★ ☆

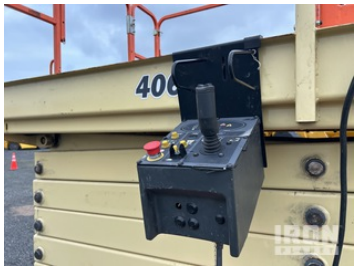
Control Station Upper		
Pin connection pivot point wear inspections are limited to sound, sight and feel observations. Dial indicator testing is not performed.		
Item	Assessment	Photo
Control Console	No visible damage or missing components

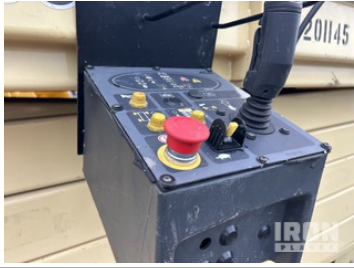
Emergency Shut Off Switch	Operational

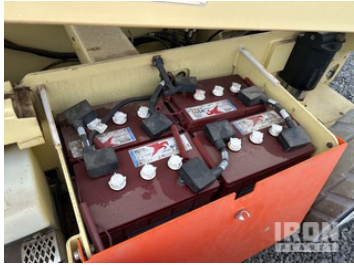
Electrical Operating System		
Item	Assessment	Photo
Operating Voltage	40 Volts	
Battery Condition	Functioned during the inspection	
Cables and Connections	No visible damage or missing components

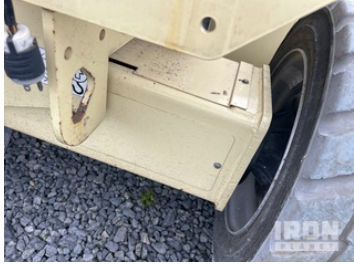
Drivetrain		
Operational test is limited to low speed in a confined flat area without load. Differential interlocks, full transmission shifting and functionality of all drive axles cannot be fully verified. Inspector listens for abnormal noises, observes leaks and notes physical damage.		
Item	Assessment	Photo
Drive Motors	★ ★ ★ ☆

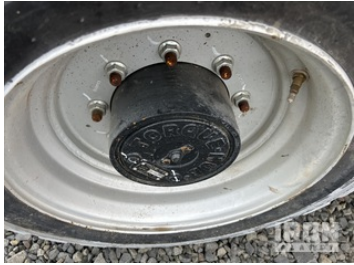
Final Drives	★ ★ ★ ☆

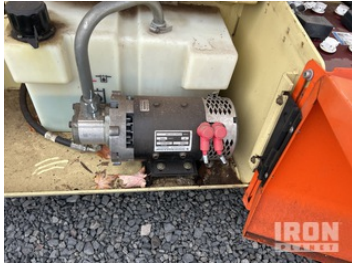
Hydraulics		
Item	Assessment	Photo
Pumps (Hydraulics)	★★★★☆

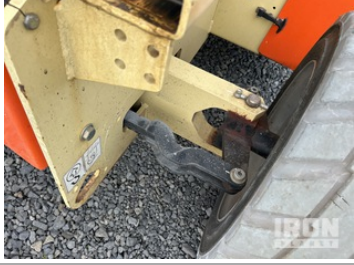
Chassis		
IronPlanet pin connection pivot point wear inspections are limited to sound, sight and feel observations. Dial indicator testing is not performed.		
Item	Assessment	Photo
Steering Linkage	★★★☆☆

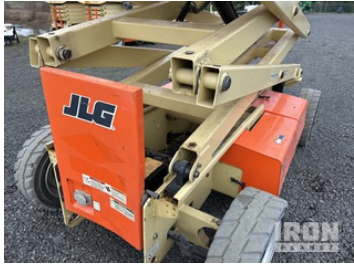
Frame Condition	★★★☆☆

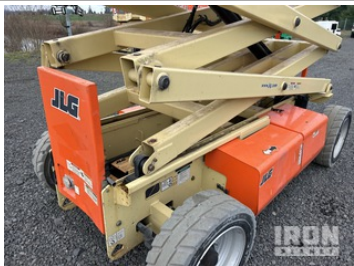
Scissor Linkage	★★★☆☆

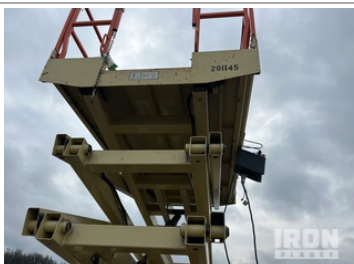
Platform Condition	★★★☆☆

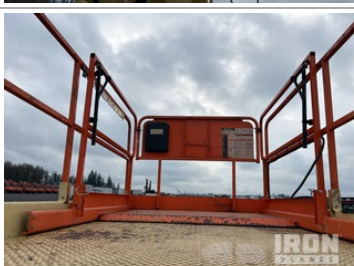
Platform Extension	★★★☆☆

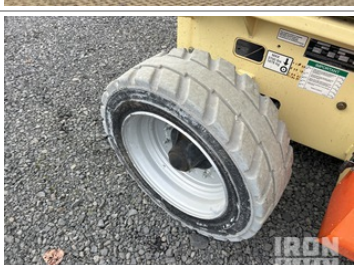
Left Front Tire	No visible defects

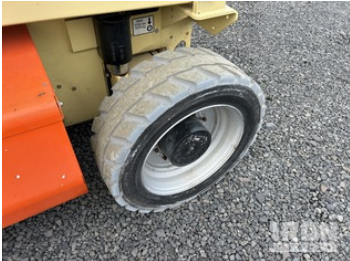
Left Rear Tire	No visible defects

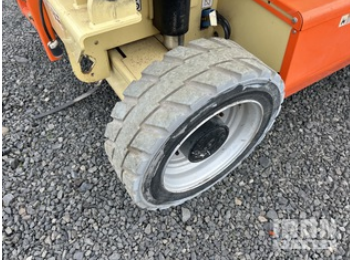
Right Rear Tire	No visible defects

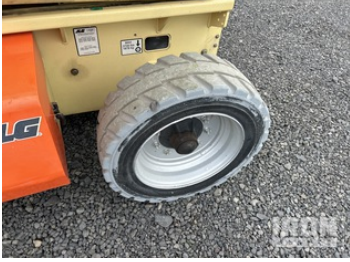
Right Front Tire	No visible defects

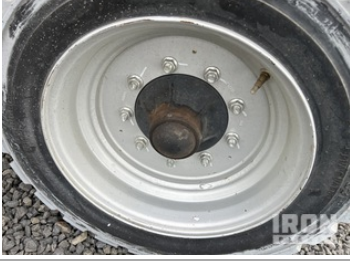
Wheel Condition	No visible damage or missing components
