## Item #13811484 - 2016 JLG 4069LE Electric Vertical Mast Lift

- Features: 40 ft Max Platform Height, 800 lb Max Weight Capacity, Platform Extension, Power to Platform, Solid Non-Marking Tires, Upper Control Box
- Meter Reading: 503 Hours
- Serial # : 0200253862
- Inspection Completed: 9/3/25

## Inspection Report

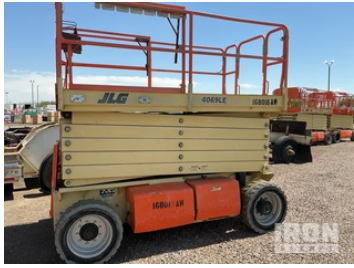
| Paint | No visible damage | |

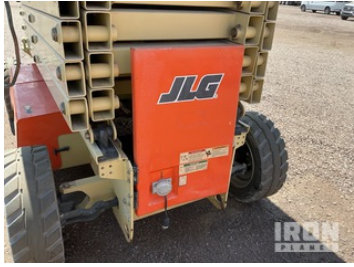
| Body Panels | Hydraulic compartment door damaged | |

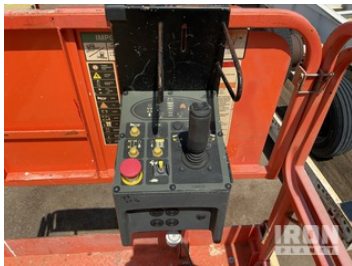
| Item | Assessment | Photo |
|---|---|---|
| Control Console | No visible damage or missing components | |

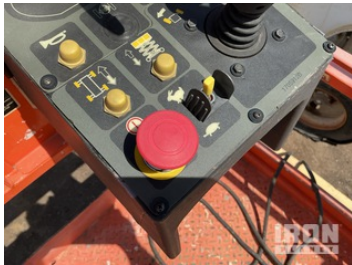
| Item | Assessment | Photo |
|---|---|---|
| Emergency Shut Off Switch | Operational | |

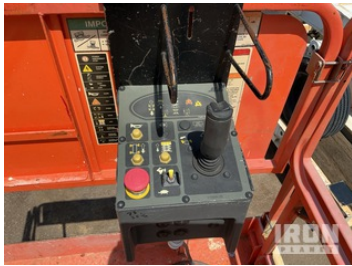
| Item | Assessment | Photo |
|---|---|---|
| Upper Function Controls | ★★★★☆ | |

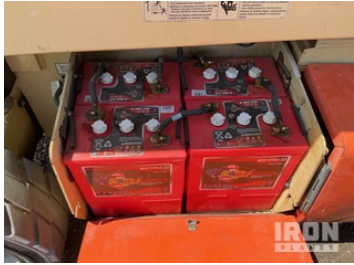
| Electrical Operating System | | |
|---|---|---|
| Cables and Connections | No visible damage or missing components | |

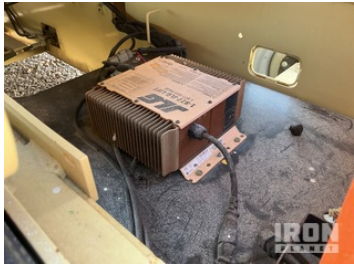
| Electrical Operating System | | |
|---|---|---|
| Battery Charger | Included Appears normal - Not operationally checked, 110 Volt, Single Phase | |

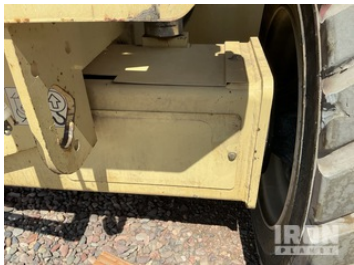
| Item | Assessment | Photo |
|---|---|---|
| Drive Motors | ★★★★☆ | |

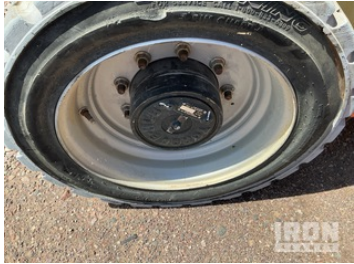
| Item | Assessment | Photo |
|---|---|---|
| Final Drives | ★★★★☆ | |

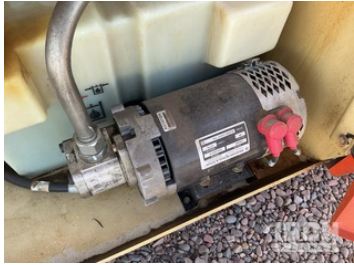
| Hydraulics | | |
|---|---|---|
| Pumps (Hydraulics) | ★★★★☆ | |

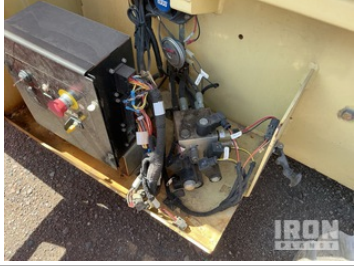
| Hydraulics | | |
|---|---|---|
| Valves | ★★★★☆ | |

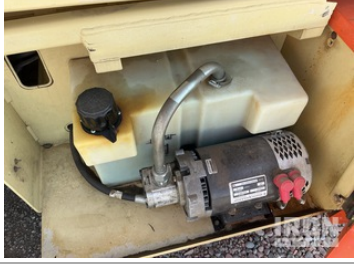
| Hydraulics | | |
|---|---|---|
| Hydraulic Tank | ★★★★☆ | |

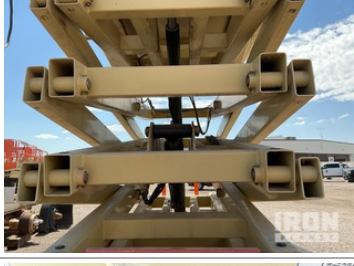
| Hydraulics | | |
|---|---|---|
| Lift Cylinders | ★★★★☆ | |

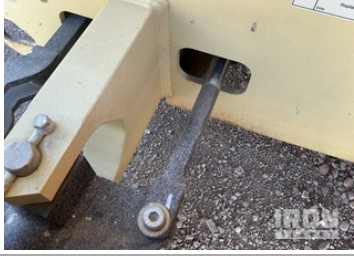
| Hydraulics | | |
|---|---|---|
| Steering Cylinder | ★★★★☆ | |

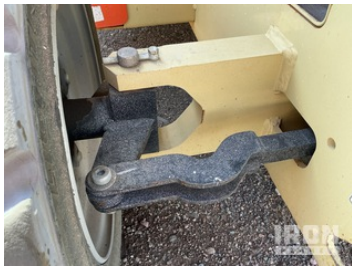
| Item | Assessment | Photo |
|---|---|---|
| Steering Linkage | ★★★★☆ | |

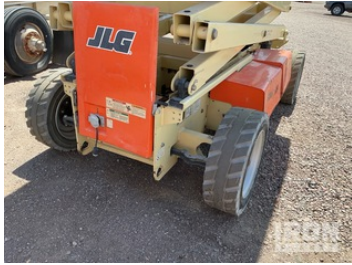
| Item | Assessment | Photo |
|---|---|---|
| Frame Condition | ★★★★☆ | |

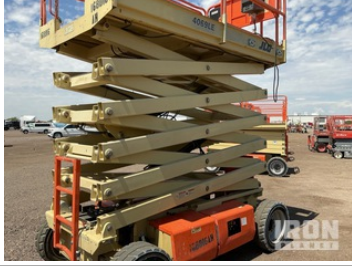
| Item | Assessment | Photo |
|---|---|---|
| Scissor Linkage | ★★★★☆ | |

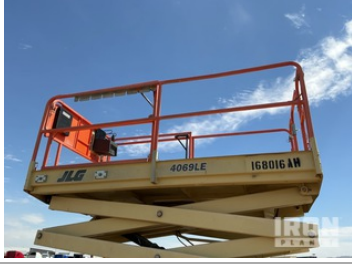
| Item | Assessment | Photo |
|---|---|---|
| Platform Condition | ★★★★☆ | |

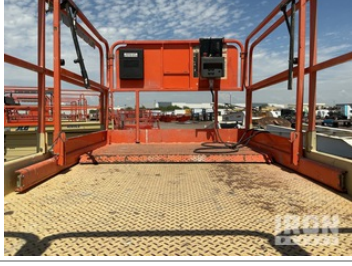
| Item | Assessment | Photo |
|---|---|---|
| Platform Extension | ★★★★☆ | |

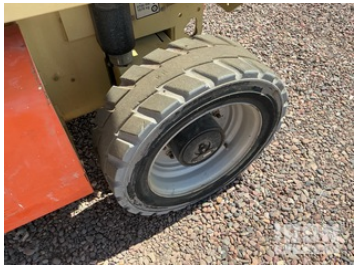
| Left Rear Tire | No visible defects | |

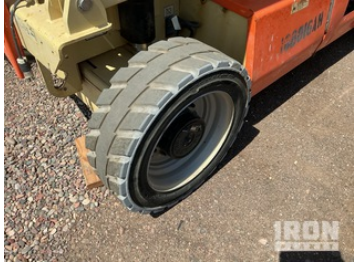
| Right Rear Tire | No visible defects | |

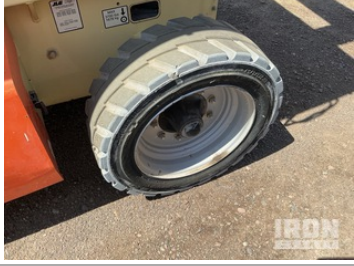
| Right Front Tire | No visible defects | |

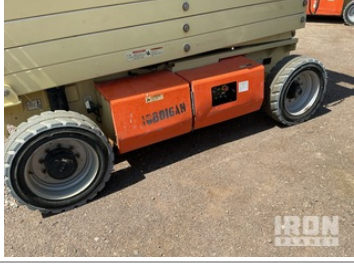
| Wheel Condition | No visible damage or missing components | |
