## Item #13810956 - 2016 JLG 4069LE Electric Scissor Lift

- Features: 40 ft Max Platform Height, 800 lb Max Weight Capacity, Power to Platform
- Meter Reading: 555 Hours
- Serial # : 0200253063
- Inspection Completed: 8/26/25

# Inspection Report

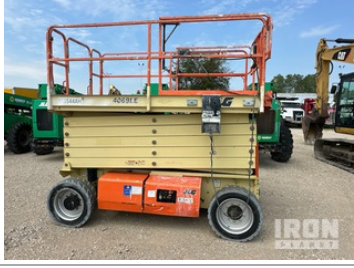
| Paint | No visible damage | |

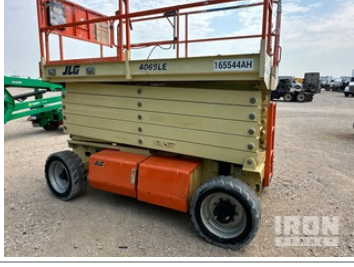
| Body Panels | Battery compartment door damaged | |

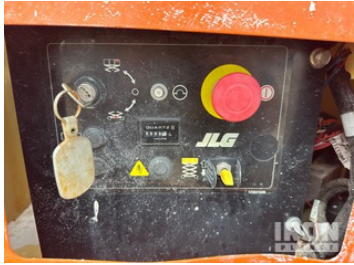
| Control Station Ground | | |
|---|---|---|
| Function Controls | ★ ★ ★ ☆ | |

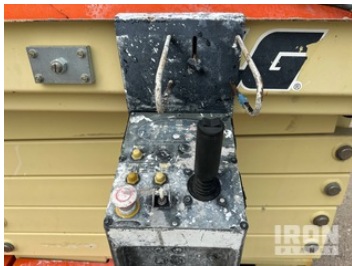
| Item | Assessment | Photo |
|---|---|---|
| Control Console | No visible damage or missing components | |

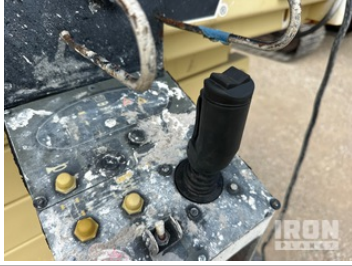
| Item | Assessment | Photo |
|---|---|---|
| Upper Function Controls | ★★★★☆ | |

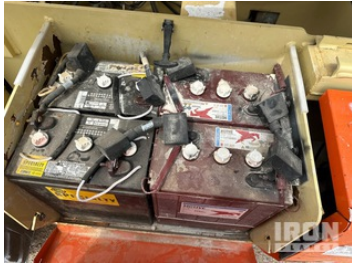
| Item | Assessment | Photo |
|---|---|---|
| Cables and Connections | No visible damage or missing components | |

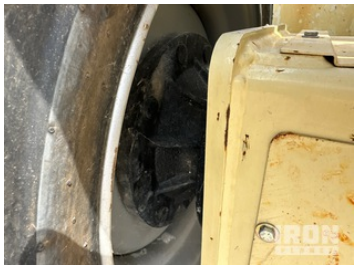
| Item | Assessment | Photo |
|---|---|---|
| Drive Motors | ★★★★☆ | |

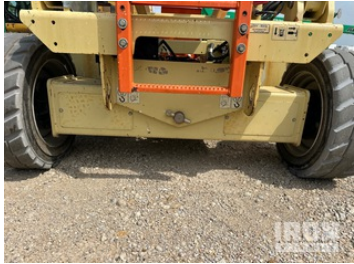
| Item | Assessment | Photo |
|---|---|---|
| Front Drive Axle | ★★★★☆ | |

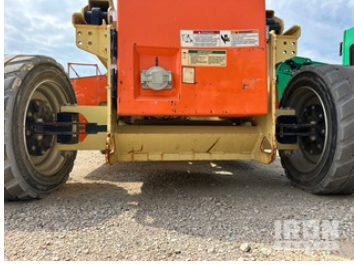
| Item | Assessment | Photo |
|---|---|---|
| Rear Drive Axle | ★★★★☆ | |

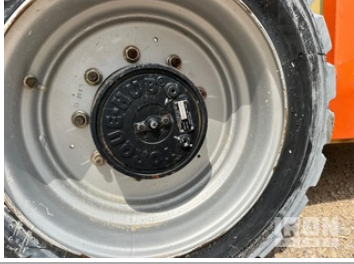
| Item | Assessment | Photo |
|---|---|---|
| Final Drives | ★★★★☆ | |

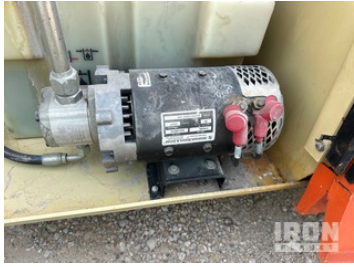
| Hydraulics | | |
|---|---|---|
| Pumps (Hydraulics) | ★★★★☆ | A close-up photograph of a hydraulic pump assembly mounted on a yellow metal frame. The pump is a compact, cylindrical unit with various hoses and electrical connections. An "IRON PLANET" watermark is visible in the bottom right corner. |

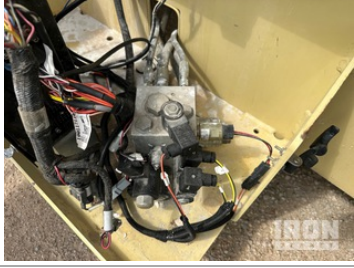
| Hydraulics | | |
|---|---|---|
| Valves | ★★★★☆ | A photograph showing a hydraulic valve assembly with multiple ports and hoses, mounted on a yellow metal structure. The assembly is complex, with various wires and hydraulic lines connected. An "IRON PLANET" watermark is visible in the bottom right corner. |

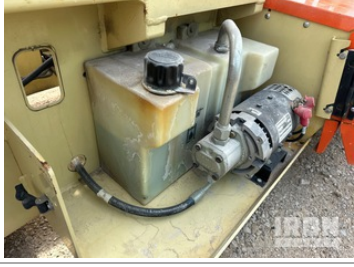
| Hydraulics | | |
|---|---|---|
| Hydraulic Tank | ★★★★☆ | A photograph of a hydraulic tank and pump assembly. The tank is a large, rectangular metal container with a pump mounted on top. Various hoses and electrical connections are visible. An "IRON PLANET" watermark is visible in the bottom right corner. |

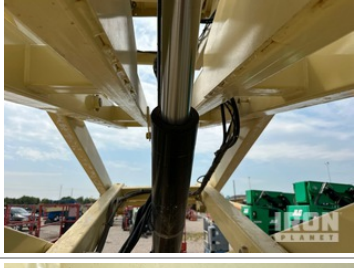
| Hydraulics | | |
|---|---|---|
| Lift Cylinders | ★★★★☆ | A photograph looking up at a large hydraulic cylinder, which is part of the lift mechanism. The cylinder is a thick, black metal rod extending upwards. The background shows a construction site with various equipment. An "IRON PLANET" watermark is visible in the bottom right corner. |

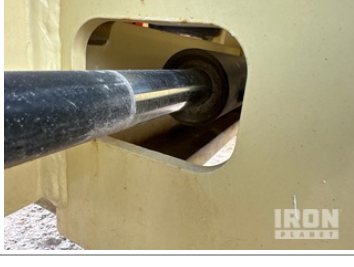
| Hydraulics | | |
|---|---|---|
| Steering Cylinder | ★★★★☆ | A close-up photograph of a steering cylinder, showing the hydraulic rod and the mounting bracket. The cylinder is a thick, black metal rod. An "IRON PLANET" watermark is visible in the bottom right corner. |

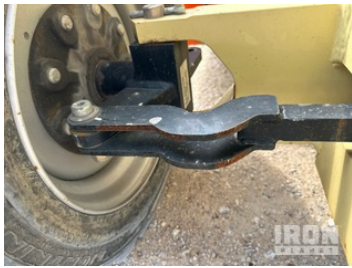
| Item | Assessment | Photo |
|---|---|---|
| Steering Linkage | ★★★★☆ | |

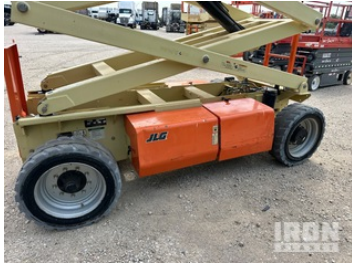
| Item | Assessment | Photo |
|---|---|---|
| Frame Condition | ★★★★☆ | |

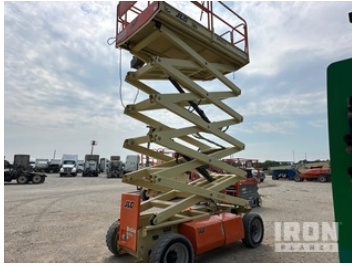
| Item | Assessment | Photo |
|---|---|---|
| Scissor Linkage | ★★★★☆ | |

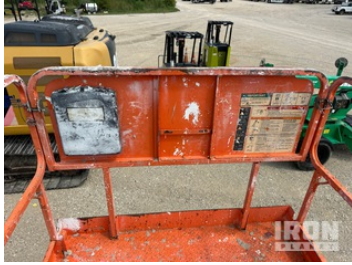
| Item | Assessment | Photo |
|---|---|---|
| Platform Condition | ★★★★☆ | |

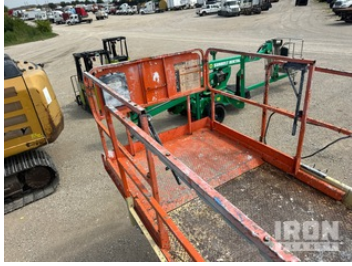
| Item | Assessment | Photo |
|---|---|---|
| Platform Extension | ★★★★☆ | |

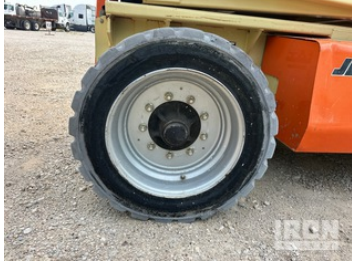
| Item | Assessment | Photo |
|---|---|---|
| Left Front Tire | No visible defects | |

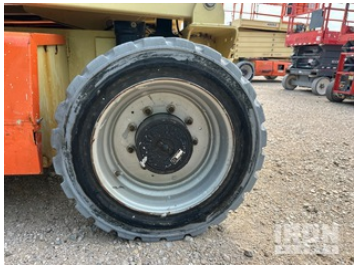
| Left Rear Tire | No visible defects | |

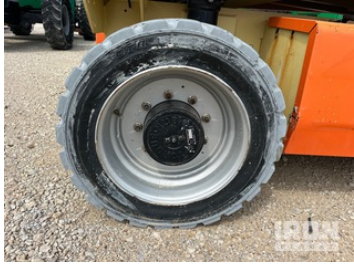
| Right Rear Tire | No visible defects | |

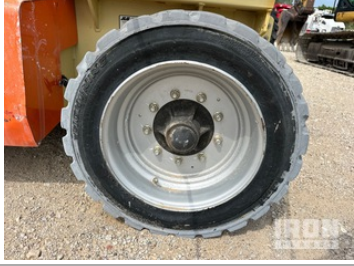
| Right Front Tire | No visible defects | |

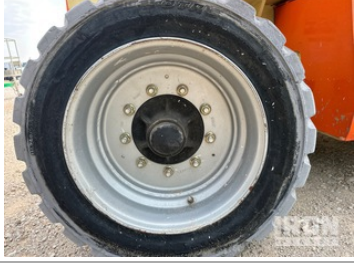
| Wheel Condition | No visible damage or missing components | |
