## Item #14097074 - 2018 Genie GS-4047 Electric Scissor Lift

# Inspection Report

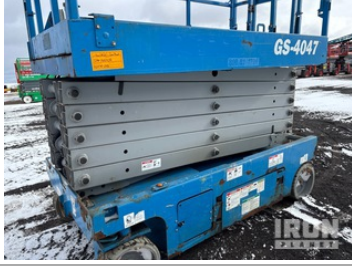
| Paint | No visible damage | |

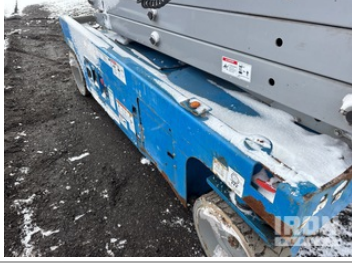
| Body Panels | Battery compartment door heavy rust / corrosion, Hydraulic compartment door damaged | |

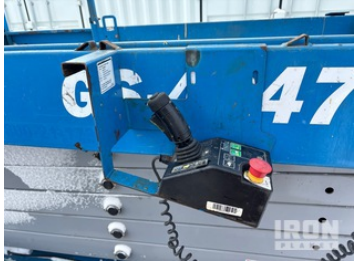
| Item | Assessment | Photo |
|---|---|---|
| Control Console | No visible damage or missing components | |

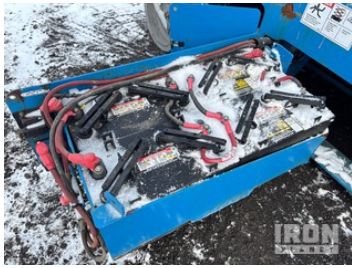
| Electrical Operating System | | |
|---|---|---|
| Cables and Connections | No visible damage or missing components Corrosion starting on one battery | |

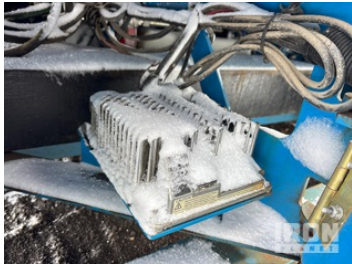
| Electrical Operating System | | |
|---|---|---|
| Battery Charger | Included Appears normal - Not operationally checked, Single Phase | |

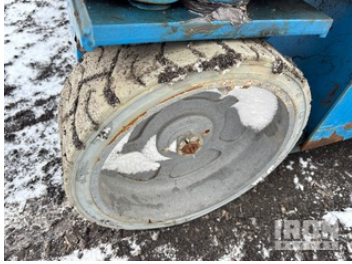
| Item | Assessment | Photo |
|---|---|---|
| Left Front Tire | Cracks | |

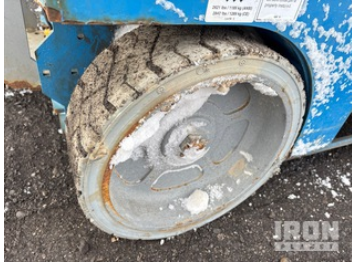
| Right Rear Tire | Tears | |

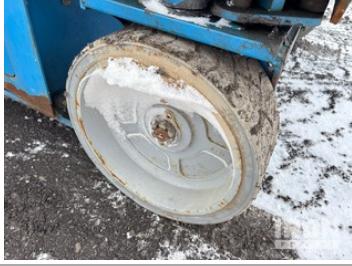
| Right Front Tire | Cracks | |

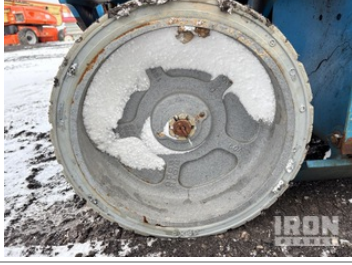
| Wheel Condition | No visible damage or missing components | |

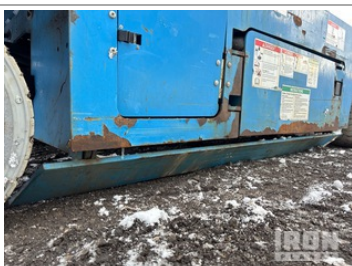
| Pothole Protection Bars | ★★★★☆<br>Functional | |
