## Item #14339931 - 2017 Skyjack SJ 4740 Electric Scissor Lift

# Inspection Report

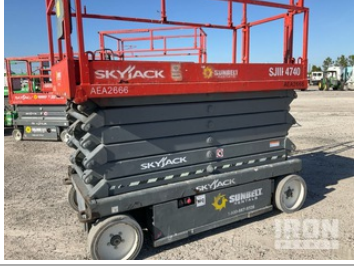
| Paint | No visible damage | |

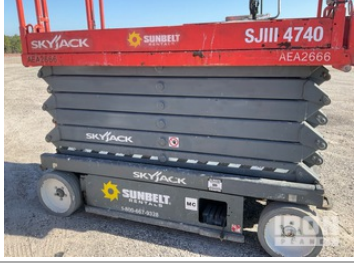
| Body Panels | No visible damage or missing components | |

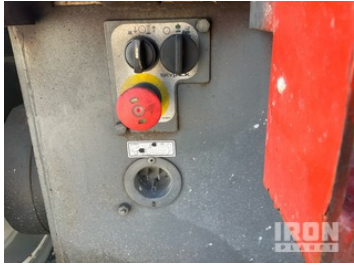
| Control Station Ground | | |
|---|---|---|
| Function Controls | ☆☆☆☆ | |

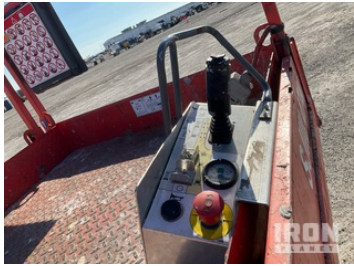
| Item | Assessment | Photo |
|---|---|---|
| Control Console | No visible damage or missing components | |

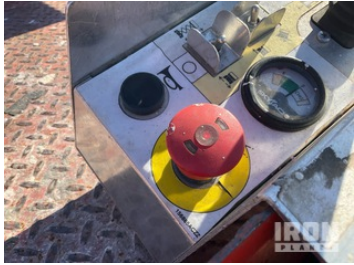
| Item | Assessment | Photo |
|---|---|---|
| Emergency Shut Off Switch | Operational | |

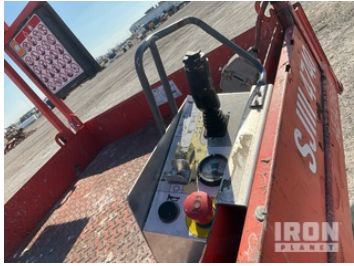
| Item | Assessment | Photo |
|---|---|---|
| Upper Function Controls | ★★★★☆ | |

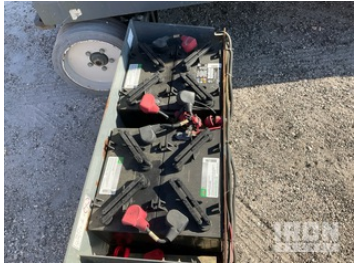
| Electrical Operating System | | |
|---|---|---|
| Cables and Connections | No visible damage or missing components | |

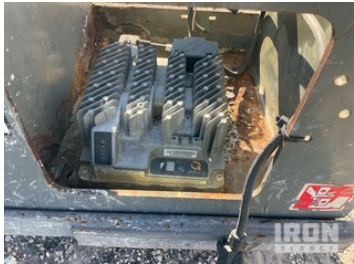
| Electrical Operating System | | |
|---|---|---|
| Battery Charger | Included Appears normal - Not operationally checked, 110V AC Volt, Single Phase | |

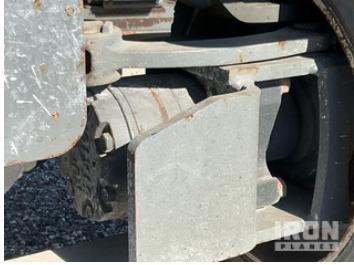
| Item | Assessment | Photo |
|---|---|---|
| Drive Motors | ★★★☆☆ | |

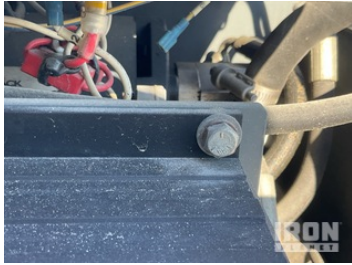
| Hydraulics | | |
|---|---|---|
| Pumps (Hydraulics) | ★★★★☆ | |

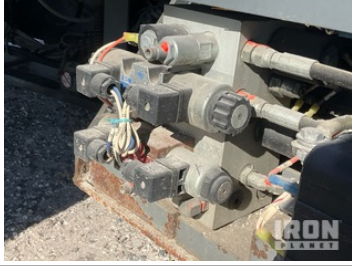
| Hydraulics | | |
|---|---|---|
| Valves | ★★★★☆ | |

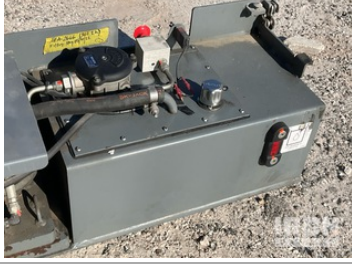
| Hydraulics | | |
|---|---|---|
| Hydraulic Tank | ★★★★☆ | |

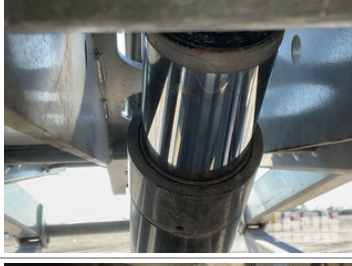
| Hydraulics | | |
|---|---|---|
| Lift Cylinders | ★★★★☆ | |

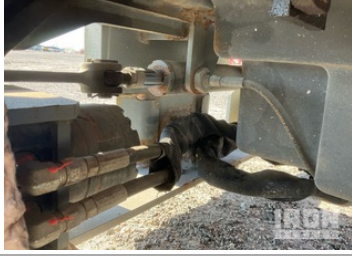
| Hydraulics | | |
|---|---|---|
| Steering Cylinder | ★★★★☆ | |

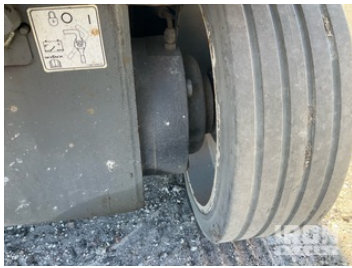
| Item | Assessment | Photo |
|---|---|---|
| Brake System | ★★☆☆<br>The brake system functioned, stopping and holding the machine. | |

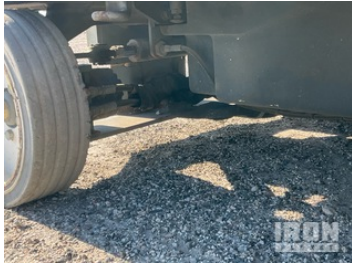
| Item | Assessment | Photo |
|---|---|---|
| Steering Linkage | ★★☆☆ | |

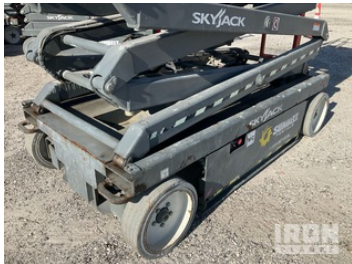
| Item | Assessment | Photo |
|---|---|---|
| Frame Condition | ★★☆☆ | |

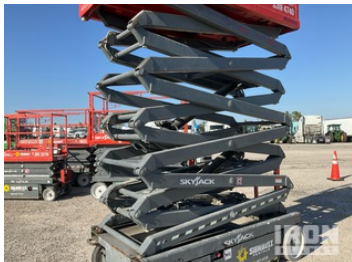
| Item | Assessment | Photo |
|---|---|---|
| Scissor Linkage | ★★☆☆ | |

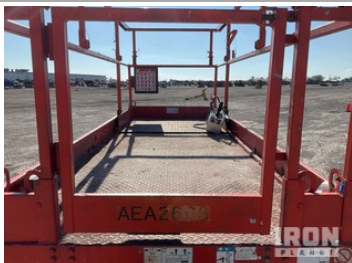
| Item | Assessment | Photo |
|---|---|---|
| Platform Condition | ★★☆☆ | |

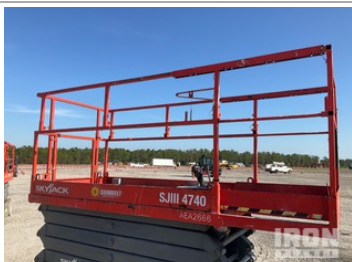
| Item | Assessment | Photo |
|---|---|---|
| Platform Extension | ★★☆☆ | |

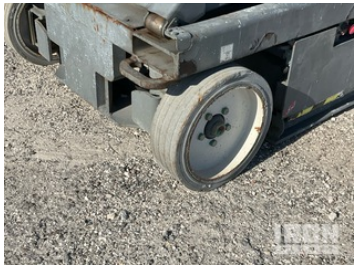
| Left Front Tire | Cracks | |

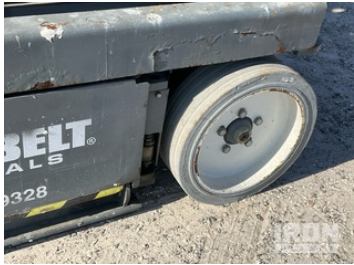
| Left Rear Tire | Cracks | |

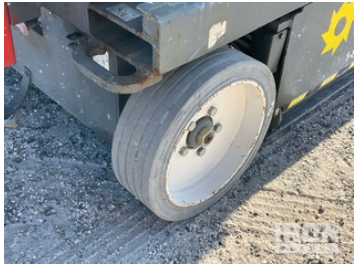
| Right Rear Tire | Cracks | |

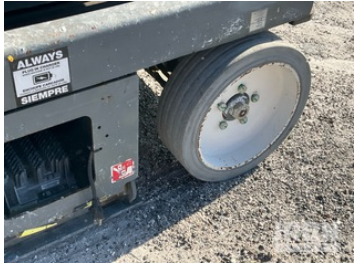
| Right Front Tire | Cracks | |

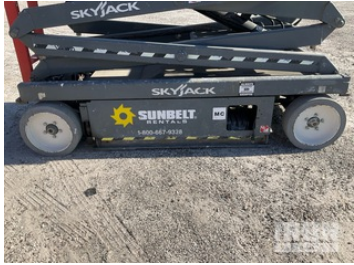
| Wheel Condition | No visible damage or missing components | |

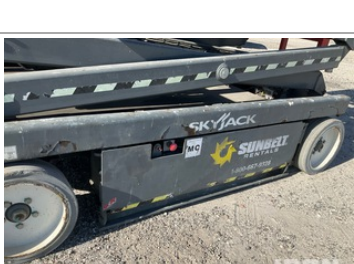
| Pothole Protection Bars | ★★★★☆<br>Functional | |
