## Item #13811486 - 2016 JLG 4069LE Electric Scissor Lift

# Inspection Report

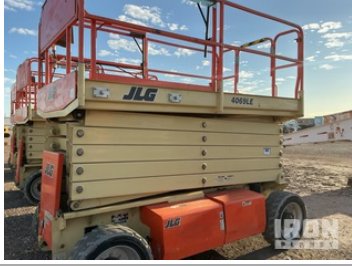
| Paint | No visible damage | |

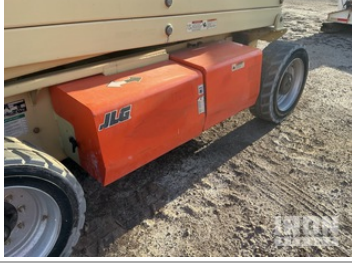
| Body Panels | No visible damage or missing components | |

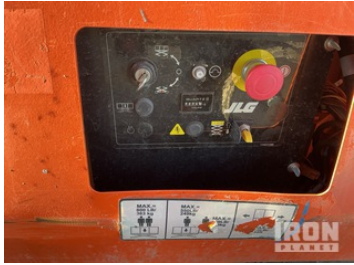
| Control Station Ground | | |
|---|---|---|
| Function Controls | ★ ★ ☆ ☆ | |
| Limited Function Check | The main components are in place and operational as noted. | |

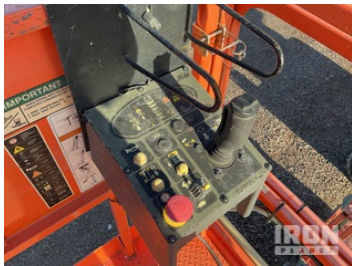
| Item | Assessment | Photo |
|---|---|---|
| Control Console | No visible damage or missing components | |

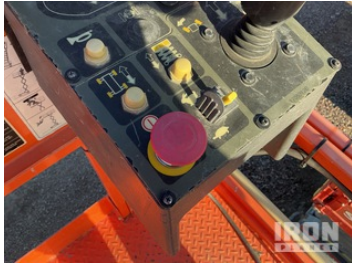
| Item | Assessment | Photo |
|---|---|---|
| Emergency Shut Off Switch | Operational | |

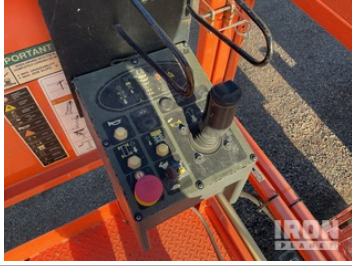
| Item | Assessment | Photo |
|---|---|---|
| Upper Function Controls | ★★★★☆ | |

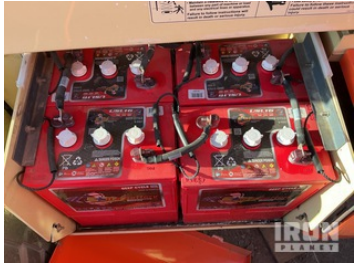
| Electrical Operating System | | |
|---|---|---|
| Cables and Connections | No visible damage or missing components | |

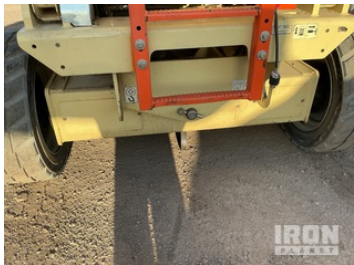
| Item | Assessment | Photo |
|---|---|---|
| Drive Motors | ★★★★☆ | |

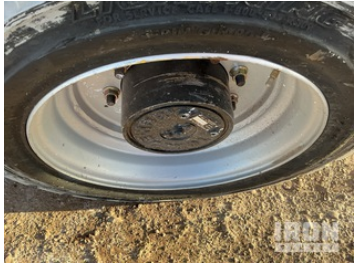
| Item | Assessment | Photo |
|---|---|---|
| Final Drives | ★★★★☆ | |

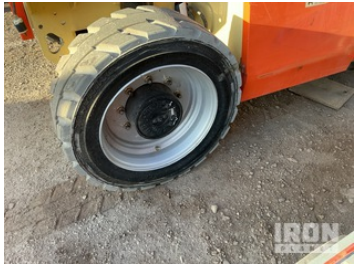
| Item | Assessment | Photo |
|---|---|---|
| Drivetrain #1 | | |

| Item | Assessment | Photo |
|---|---|---|
| Limited Function Check | The drivetrain was operational except as noted. Unit has system fault intermittent operation | |

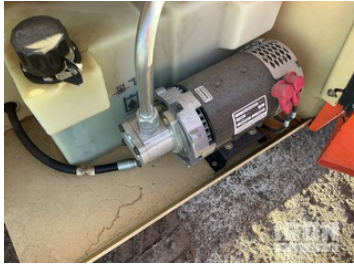
| Hydraulics | | |
|---|---|---|
| Pumps (Hydraulics) | ★★★★☆ | |

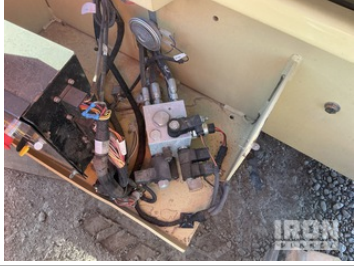
| Hydraulics | | |
|---|---|---|
| Valves | ★★★★☆ | |

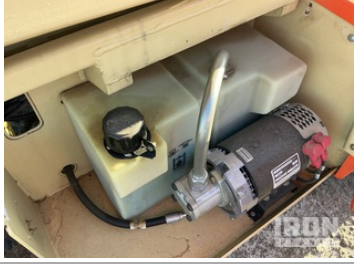
| Hydraulics | | |
|---|---|---|
| Hydraulic Tank | ★★★★☆ | |

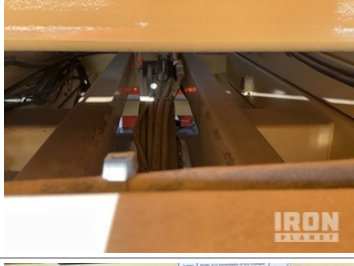
| Hydraulics | | |
|---|---|---|
| Lift Cylinders | ★★★★☆ | |
| Limited Function Check | some components could not be operationally, checked, do to system fault unit could not be raised or lowered | |

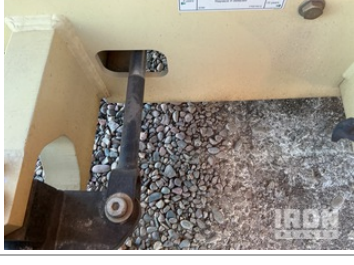
| Hydraulics | | |
|---|---|---|
| Steering Cylinder | ★★★★☆ | |

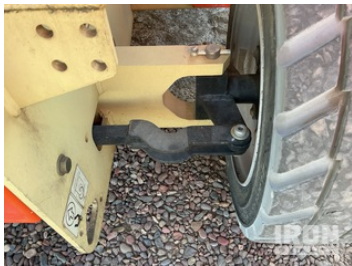
| Item | Assessment | Photo |
|---|---|---|
| Steering Linkage | ★★★★☆ | |

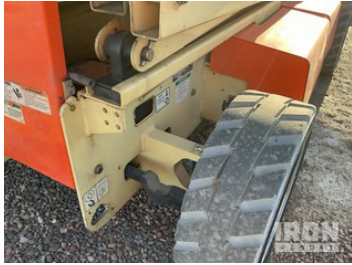
| Item | Assessment | Photo |
|---|---|---|
| Frame Condition | ★★★★☆ | |

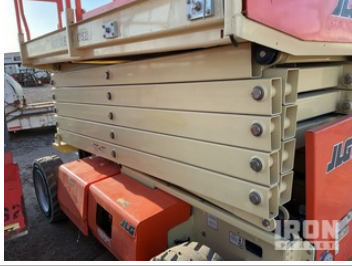
| Item | Assessment | Photo |
|---|---|---|
| Scissor Linkage | ★★★★☆ | |

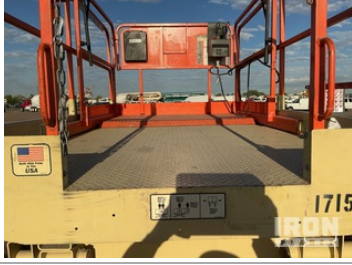
| Item | Assessment | Photo |
|---|---|---|
| Platform Condition | ★★★★☆ | |

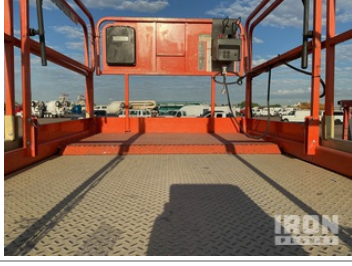
| Item | Assessment | Photo |
|---|---|---|
| Platform Extension | ★★★★☆ | |

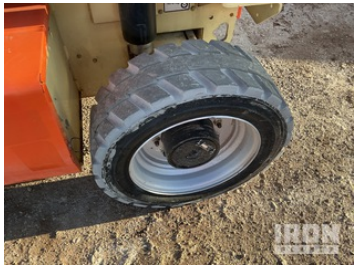
| Left Rear Tire | No visible defects | |

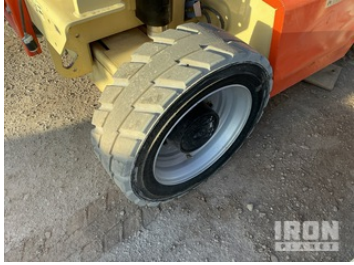
| Right Rear Tire | No visible defects | |

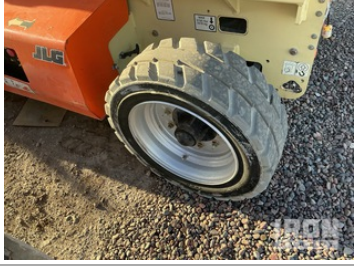
| Right Front Tire | No visible defects | |

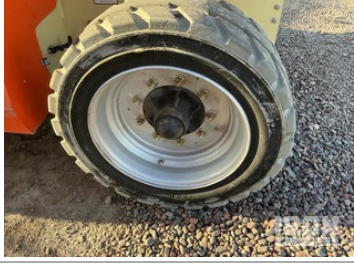
| Wheel Condition | No visible damage or missing components | |
