## Item #14301271 - 2018 JLG 4069LE Electric Scissor Lift

# Inspection Report

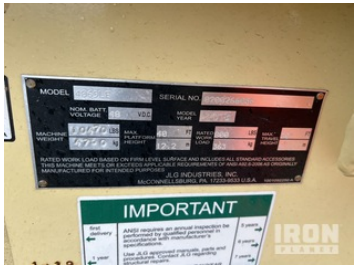
Serial Number / VIN	0200266056

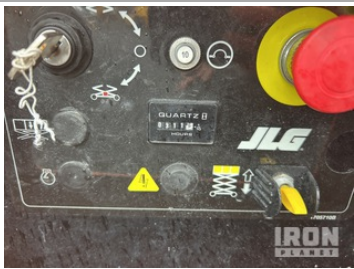
Hour Meter / Odometer	311 hrs

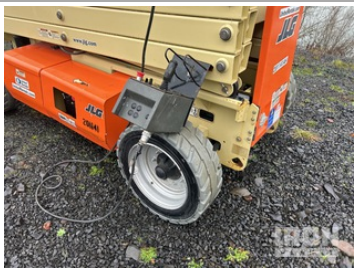
Paint	No visible damage

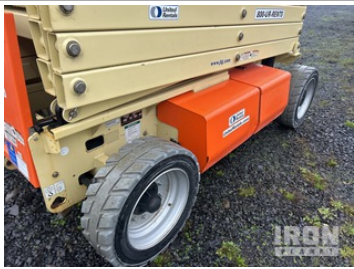
Body Panels	No visible damage or missing components

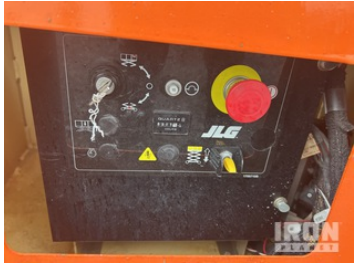
<b>Control Station Ground</b>		
<b>Item</b>	<b>Assessment</b>	<b>Photo</b>
Function Controls	★ ★ ★ ☆

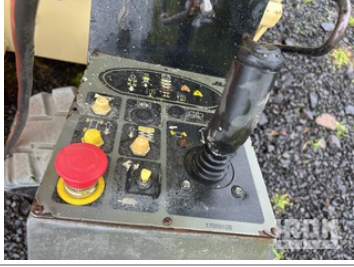
Upper Function Controls	★★★★☆

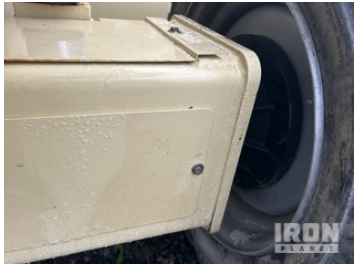
<b>Drivetrain</b>		
Operational test is limited to low speed in a confined flat area without load. Differential interlocks, full transmission shifting and functionality of all drive axles cannot be fully verified. Inspector listens for abnormal noises, observes leaks and notes physical damage.		
<b>Item</b>	<b>Assessment</b>	<b>Photo</b>
Drive Motors	★ ★ ★ ☆

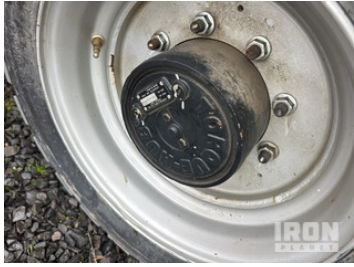
Final Drives	★ ★ ★ ☆

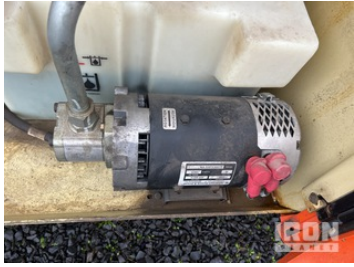
Hydraulics		
Item	Assessment	Photo
Pumps (Hydraulics)	★★★★☆

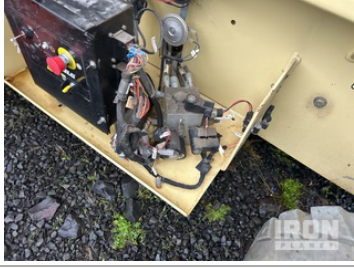
Valves	★★★★☆

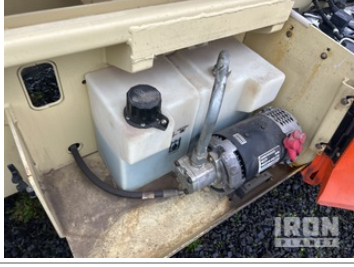
Hydraulic Tank	★★★★☆

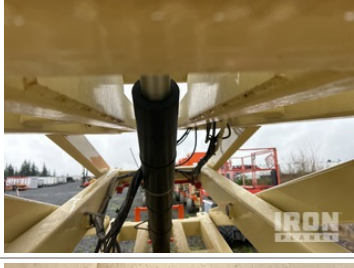
Lift Cylinders	★★★★☆

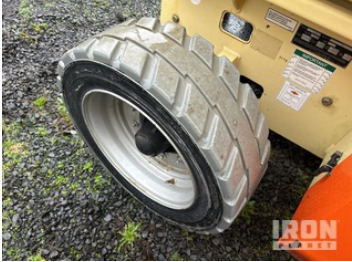
Left Front Tire	No visible defects

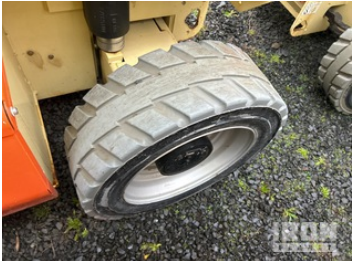
Left Rear Tire	No visible defects

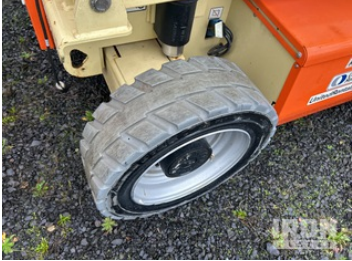
Right Rear Tire	No visible defects

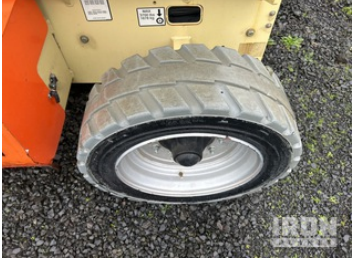
Right Front Tire	No visible defects

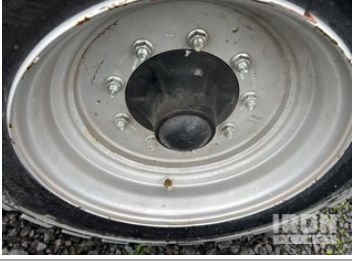
Wheel Condition	No visible damage or missing components
