## Item #14095007 - 2016 Genie GS-4390 Diesel 4x4 Scissor Lift

- Features: 1500 lb Max Weight Capacity, Platform Extension, Power to Platform, Onboard Generator, Foam Filled Tires, Upper Control Box, 2015 US EPA Label, Deutz D2.9 L4 4 Cylinder 49 hp Diesel Engine
- Meter Reading: 2,759 Hours
- Serial #: GS9016F-51456
- Inspection Completed: 10/9/25

# Inspection Report

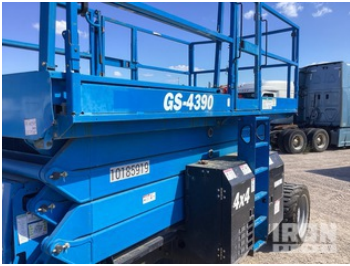
| Paint | No visible damage | |

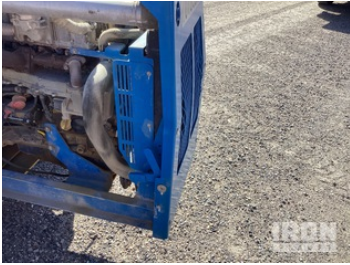
| Body Panels | Engine compartment door damaged | |

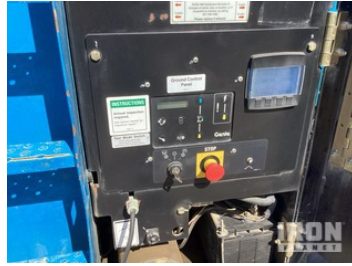
| Control Station Ground | | |
|---|---|---|
| Function Controls | ★★★★☆ | |

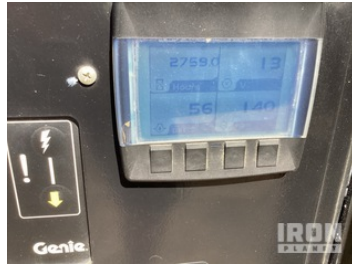
| Control Station Ground | | |
|---|---|---|
| Engine Oil Pressure | The gauge registers in the operating range. | |

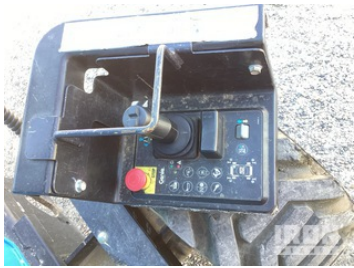
| Item | Assessment | Photo |
|---|---|---|
| Control Console | No visible damage or missing components | |

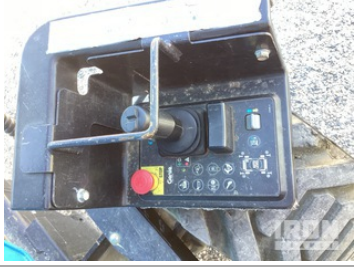
| Item | Assessment | Photo |
|---|---|---|
| Upper Function Controls | ★★★★☆ | |

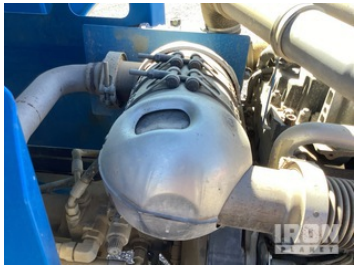
| Engine | | |
|---|---|---|
| Exhaust System | No visible damage or missing components | |

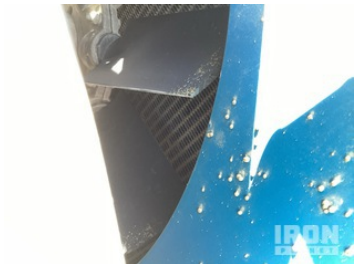
| Engine | | |
|---|---|---|
| Radiator | ★★★☆☆ | |

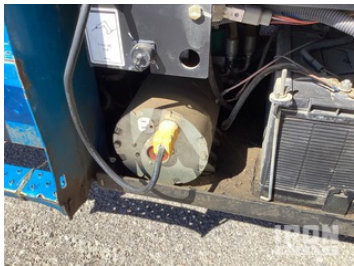
| Engine | | |
|---|---|---|
| Onboard Generator | Not operationally checked | |

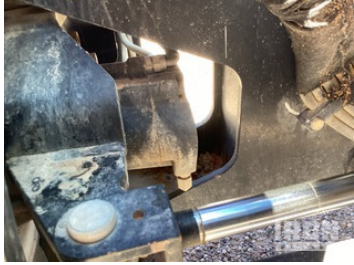
| Item | Assessment | Photo |
|---|---|---|
| Drive Motors | ☆☆☆☆<br>Can not get rear motors | |

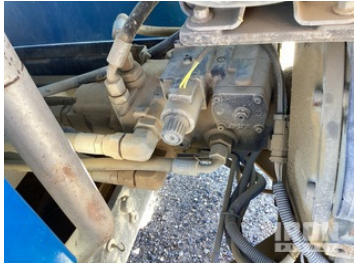
| Hydraulics | | |
|---|---|---|
| Pumps (Hydraulics) | ★★★★☆ | |

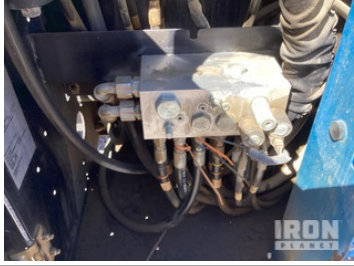
| Hydraulics | | |
|---|---|---|
| Valves | ★★★★☆ | |

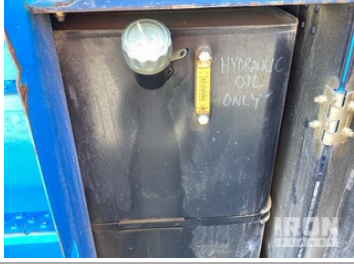
| Hydraulics | | |
|---|---|---|
| Hydraulic Tank | ★★★★☆ | |

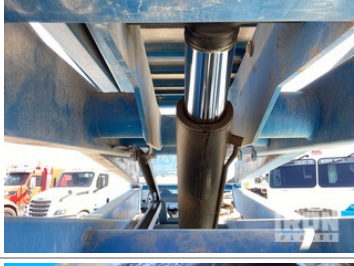
| Hydraulics | | |
|---|---|---|
| Lift Cylinders | ★★★☆☆<br>Seepage | |

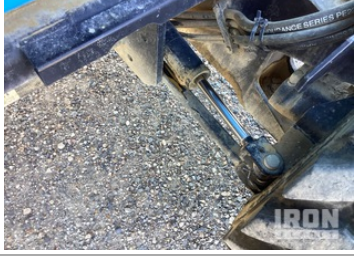
| Hydraulics | | |
|---|---|---|
| Steering Cylinder | ★★★★☆ | |

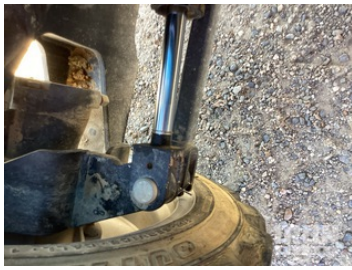
| Item | Assessment | Photo |
|---|---|---|
| Steering Linkage | ★★★★☆ | |

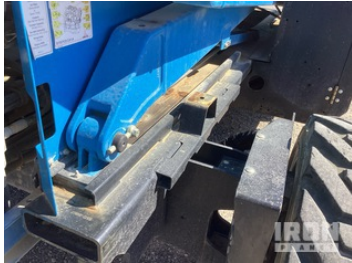
| Item | Assessment | Photo |
|---|---|---|
| Frame Condition | ★★★★☆ | |

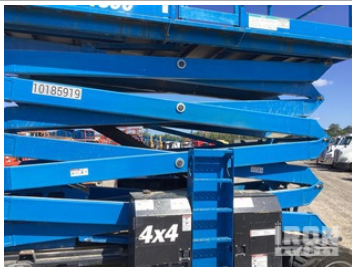
| Item | Assessment | Photo |
|---|---|---|
| Scissor Linkage | ★★★☆☆<br>Cracked weld | |

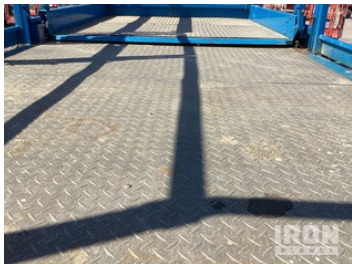
| Item | Assessment | Photo |
|---|---|---|
| Platform Condition | ★★★★☆ | |

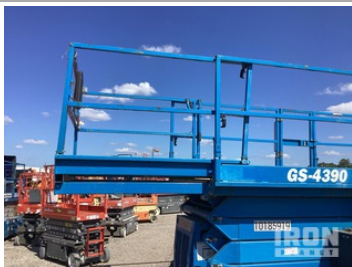
| Item | Assessment | Photo |
|---|---|---|
| Platform Extension | ★★★★☆ | |

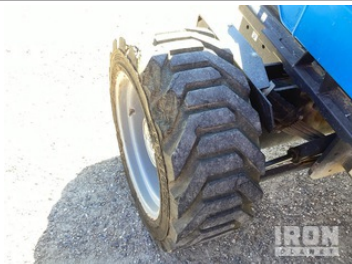
| Item | Assessment | Photo |
|---|---|---|
| Left Front Tire | Chunks missing | |

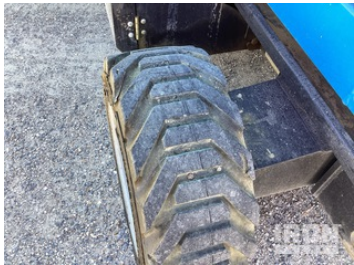
| Left Rear Tire | Chunks missing | |

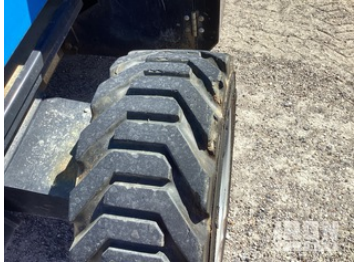
| Right Rear Tire | Chunks missing | |

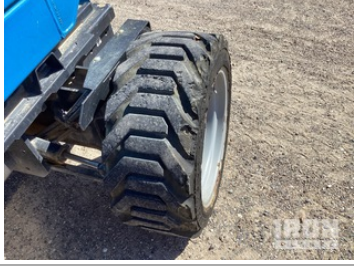
| Right Front Tire | Chunks missing | |

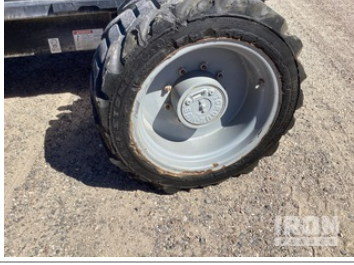
| Wheel Condition | No visible damage or missing components | |
