## Item #14095018 - 2016 Skyjack SJ8841RT Dual Fuel 4x4 Scissor Lift

- Features: 41 ft Max Platform Height, 1500 lb Max Weight Capacity, Platform Extension, Power to Platform, Upper Control Box, 2015 US EPA Label, Kubota WG972-GL-ET 3 Cylinder 962 cc Dual Fuel Engine
- Meter Reading: 1,793 Hours
- Serial # : 40001982
- Inspection Completed: 9/30/25

# Inspection Report

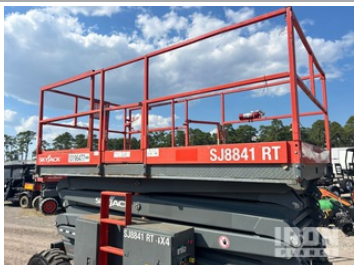
| Paint | No visible damage | |

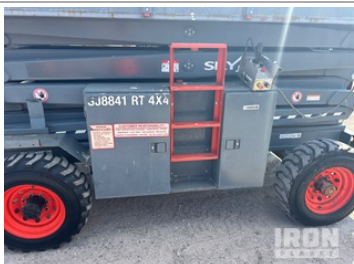
| Body Panels | No visible damage or missing components | |

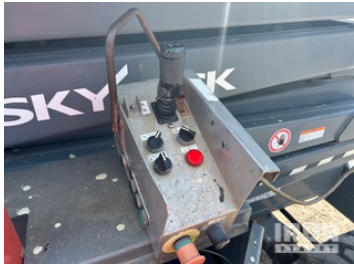
| Item | Assessment | Photo |
|---|---|---|
| Control Console | Boot torn on joystick | |

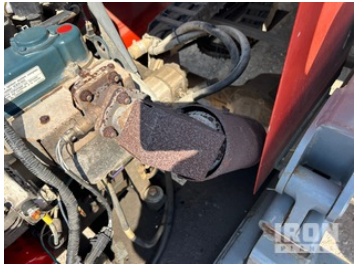
| Engine | | |
|---|---|---|
| Exhaust System | No visible damage or missing components | |

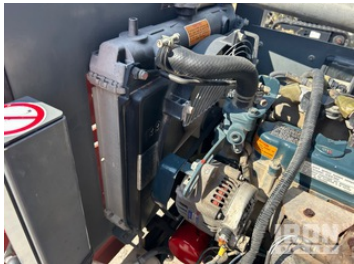
| Engine | | |
|---|---|---|
| Radiator | ★★★★☆ | |

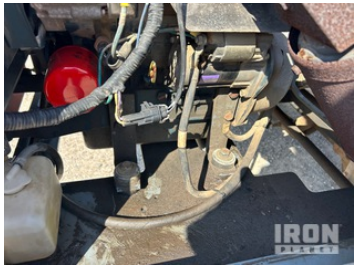
| Engine | | |
|---|---|---|
| Oil Leaks | No dripping leaks | |

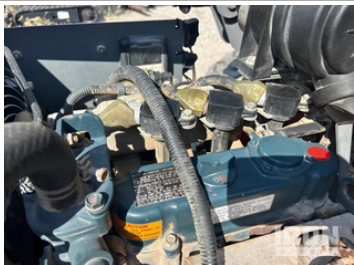
| Engine | | |
|---|---|---|
| Fuel Leaks | No dripping leaks | |

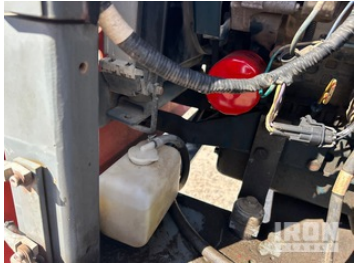
| Cooling System Leaks | No dripping leaks | |

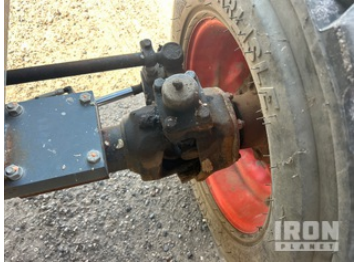
| Item | Assessment | Photo |
|---|---|---|
| Drive Motors | ★★★★☆ | |

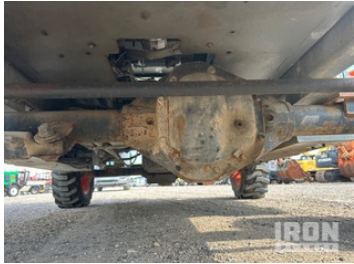
| Item | Assessment | Photo |
|---|---|---|
| Front Drive Axle | ★★★★☆ | |

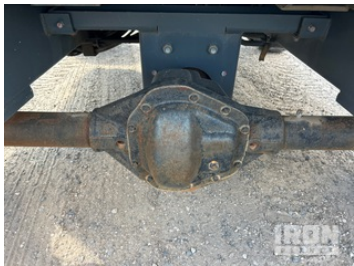
| Item | Assessment | Photo |
|---|---|---|
| Rear Drive Axle | ★★★★☆ | |

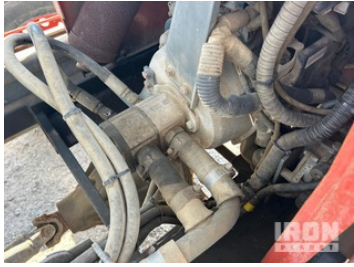
| Hydraulics | | |
|---|---|---|
| Pumps (Hydraulics) | ★★★★☆ | |

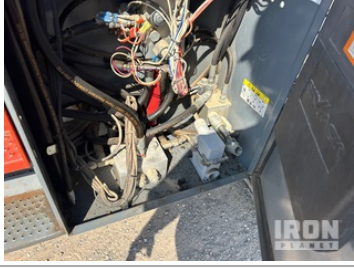
| Hydraulics | | |
|---|---|---|
| Valves | ★★★★☆ | |

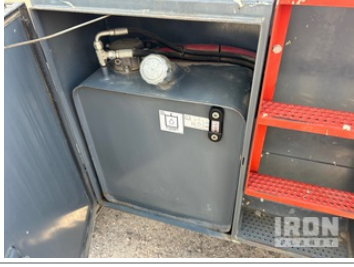
| Hydraulics | | |
|---|---|---|
| Hydraulic Tank | ★★★★☆ | |

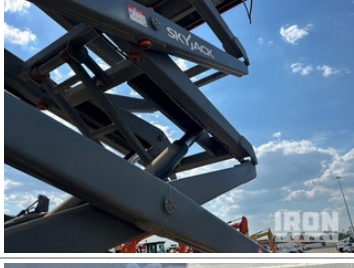
| Hydraulics | | |
|---|---|---|
| Lift Cylinders | ★★★★☆ | |

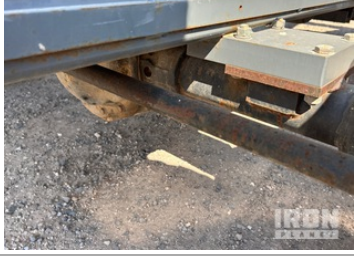
| Hydraulics | | |
|---|---|---|
| Steering Cylinder | ★★★★☆ | |

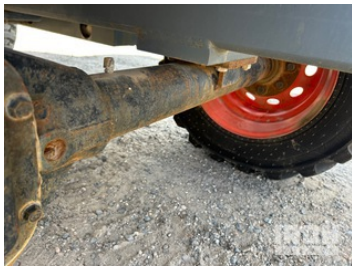
| Item | Assessment | Photo |
|---|---|---|
| Brake System | ★★☆☆<br>The brake system functioned, stopping and holding the machine. | |

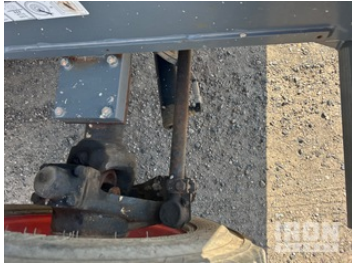
| Item | Assessment | Photo |
|---|---|---|
| Steering Linkage | ★★☆☆ | |

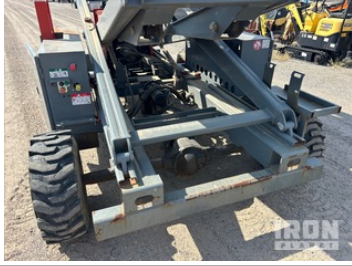
| Item | Assessment | Photo |
|---|---|---|
| Frame Condition | ★★☆☆ | |

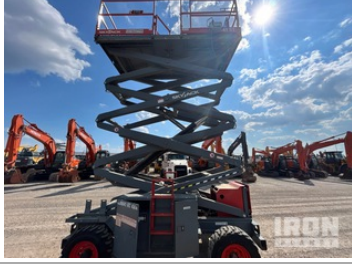
| Item | Assessment | Photo |
|---|---|---|
| Scissor Linkage | ★★☆☆ | |

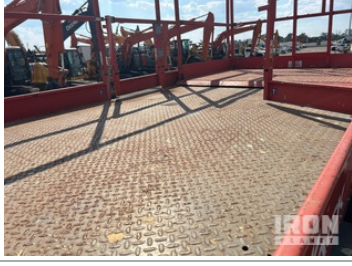
| Item | Assessment | Photo |
|---|---|---|
| Platform Condition | ★★☆☆ | |

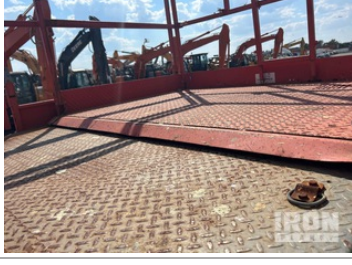
| Item | Assessment | Photo |
|---|---|---|
| Platform Extension | ★★☆☆ | |

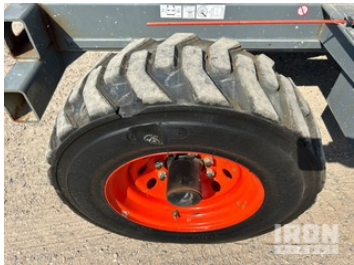
| Left Front Tire | Chunks missing | |

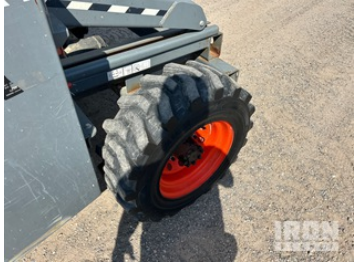
| Left Rear Tire | No visible defects | |

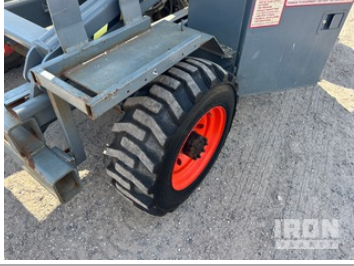
| Right Rear Tire | No visible defects | |

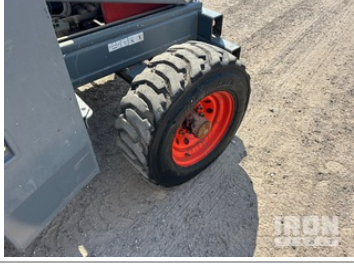
| Right Front Tire | Cracks, Chunks missing | |

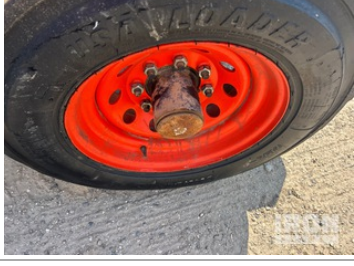
| Wheel Condition | No visible damage or missing components | |
