## Item #14340518 - 2016 Skyjack SJ9250 RT Dual Fuel 4x4 Scissor Lift

## Inspection Report

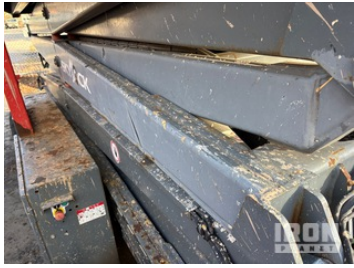
| Paint | Concrete residue Other unknown material | |

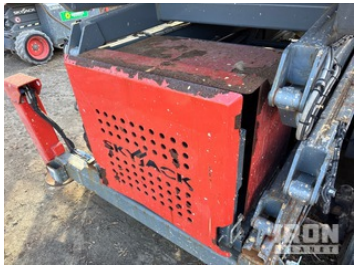
| Body Panels | Engine compartment door damaged | |

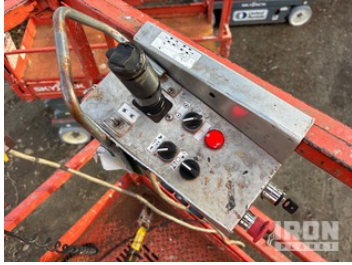
| Item | Assessment | Photo |
|---|---|---|
| Upper Function Controls | ★★★☆☆<br>Drive controls Inoperable | |

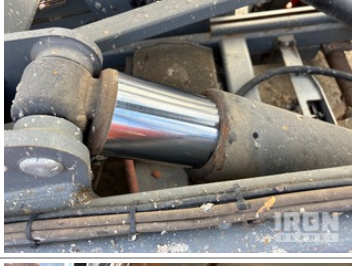
| Hydraulics | | |
|---|---|---|
| Lift Cylinders | ★★★★☆<br>Right upper lift cylinder has seepage. | |

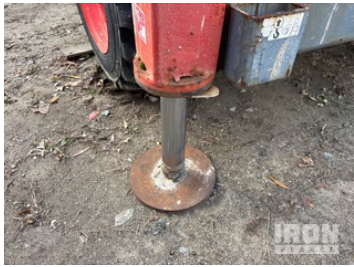
| Outrigger Cylinders | ★★★☆☆ | |

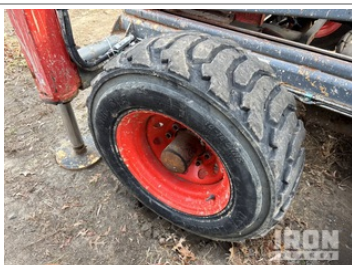
| Item | Assessment | Photo |
|---|---|---|
| Left Front Tire | Chunks missing, Tears | |

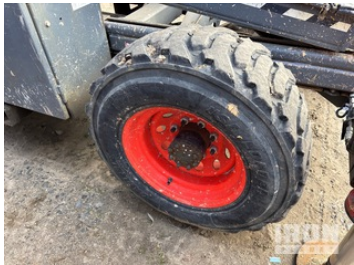
| Left Rear Tire | Chunks missing, Tears | |

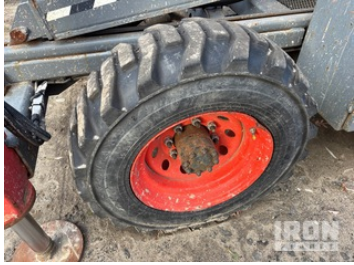
| Right Rear Tire | Chunks missing, Tears | |

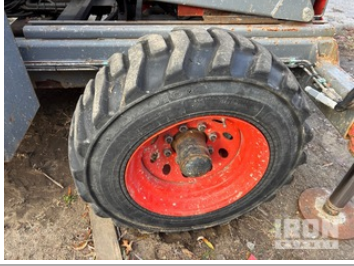
| Right Front Tire | Chunks missing, Tears | |

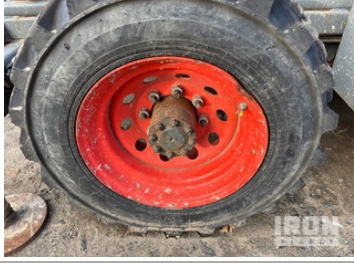
| Wheel Condition | Right rear bent | |
