## Item #14095014 - 2017 Skyjack SJ6832 RT Dual Fuel 4x4 Scissor Lift

## Inspection Report

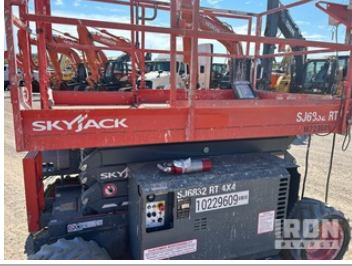
| Paint | No visible damage | |

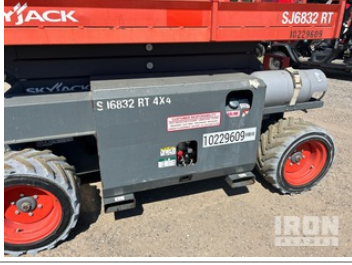
| Body Panels | No visible damage or missing components | |

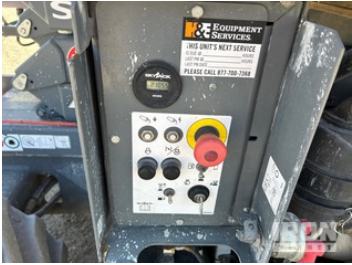
| Control Station Ground | | |
|---|---|---|
| Function Controls | ☆☆☆☆ | |

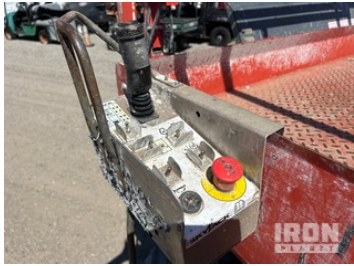
| Item | Assessment | Photo |
|---|---|---|
| Control Console | No visible damage or missing components | |

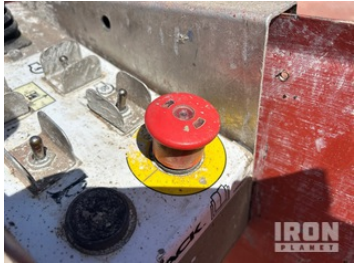
| Item | Assessment | Photo |
|---|---|---|
| Emergency Shut Off Switch | Operational | |

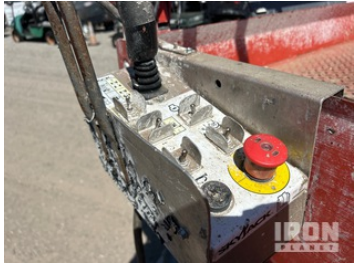
| Item | Assessment | Photo |
|---|---|---|
| Upper Function Controls | ★★★★☆ | |

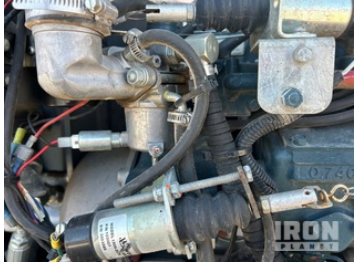
| Engine | | |
|---|---|---|
| Fuel System | Operational | |

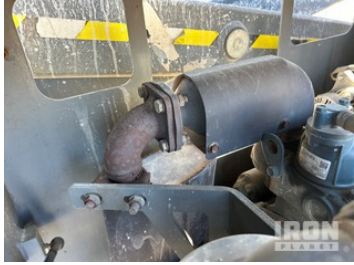
| Engine | | |
|---|---|---|
| Exhaust System | No visible damage or missing components | |

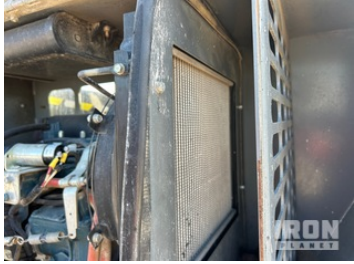
| Engine | | |
|---|---|---|
| Radiator | ★★★★☆ | |

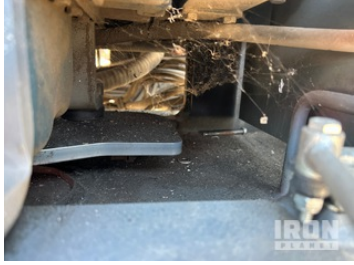
| Engine | | |
|---|---|---|
| Oil Leaks | No dripping leaks | |

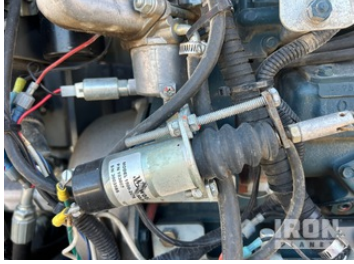
| Engine | | |
|---|---|---|
| Fuel Leaks | No dripping leaks | |

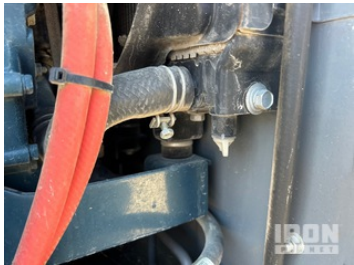
| Cooling System Leaks | No dripping leaks | |

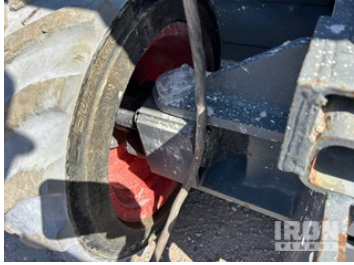
| Item | Assessment | Photo |
|---|---|---|
| Drive Motors | ☆☆☆☆ | |

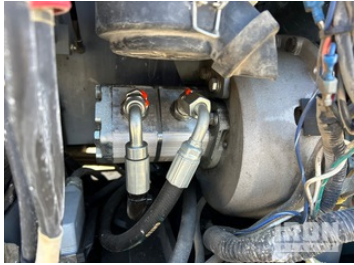
| Hydraulics | | |
|---|---|---|
| Pumps (Hydraulics) | ★★★★☆ | |

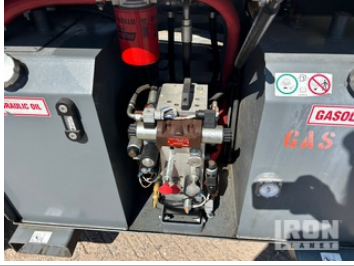
| Hydraulics | | |
|---|---|---|
| Valves | ★★★★☆ | |

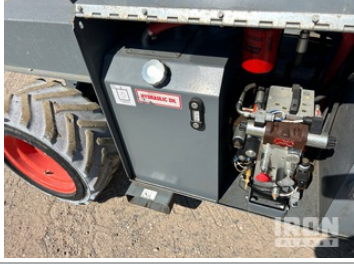
| Hydraulics | | |
|---|---|---|
| Hydraulic Tank | ★★★★☆ | |

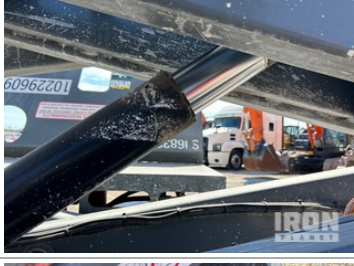
| Hydraulics | | |
|---|---|---|
| Lift Cylinders | ★★★★☆ | |

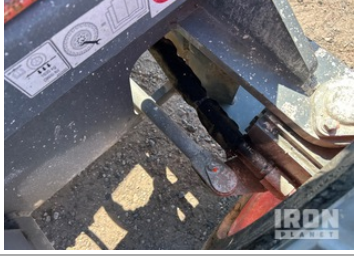
| Hydraulics | | |
|---|---|---|
| Steering Cylinder | ★★★★☆ | |

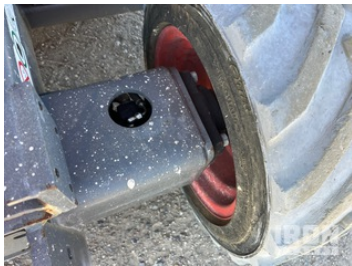
| Item | Assessment | Photo |
|---|---|---|
| Brake System | ★★☆☆<br>The brake system functioned, stopping and holding the machine. | |

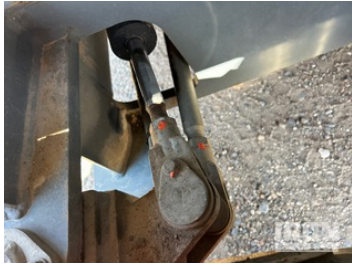
| Item | Assessment | Photo |
|---|---|---|
| Steering Linkage | ★★☆☆ | |

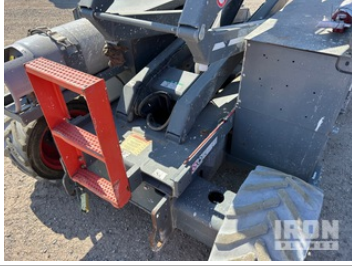
| Item | Assessment | Photo |
|---|---|---|
| Frame Condition | ★★☆☆ | |

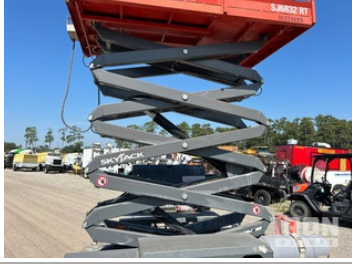
| Item | Assessment | Photo |
|---|---|---|
| Scissor Linkage | ★★☆☆ | |

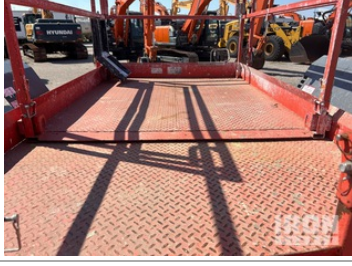
| Item | Assessment | Photo |
|---|---|---|
| Platform Condition | ★★☆☆ | |

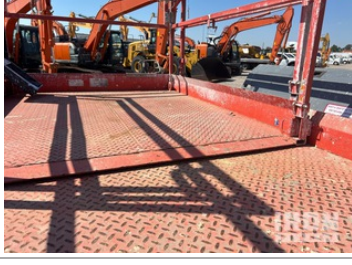
| Item | Assessment | Photo |
|---|---|---|
| Platform Extension | ★★☆☆ | |

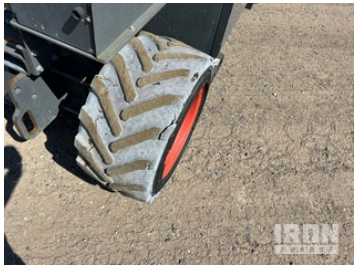
| Left Front Tire | Cracks, Chunks missing | |

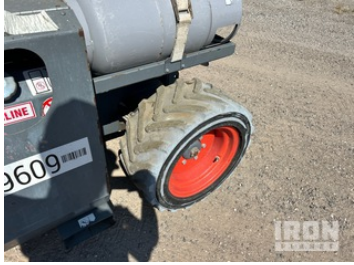
| Left Rear Tire | Cracks, Chunks missing | |

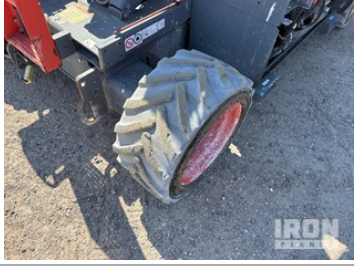
| Right Rear Tire | Cracks, Chunks missing | |

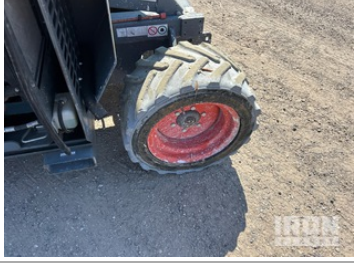
| Right Front Tire | Cracks, Chunks missing | |

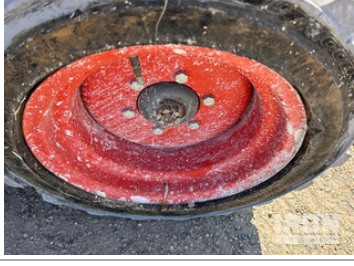
| Wheel Condition | No visible damage or missing components | |
