## Item #14339934 - 2016 Skyjack SJ6826 RT Dual Fuel 4x4 Scissor Lift

# Inspection Report

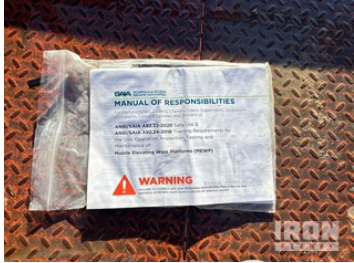
| Safety | | |
|---|---|---|
| ANSI Guidelines | All books present but water damaged | |

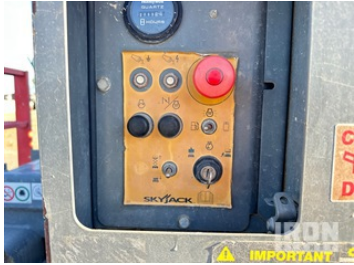
| Control Station Ground | | |
|---|---|---|
| Function Controls | ☆☆☆☆ | |

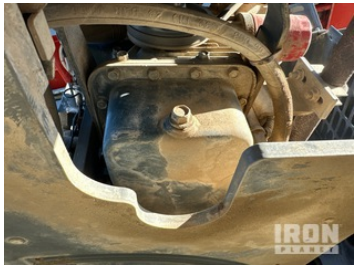
| Oil Leaks | Rear of engine | |

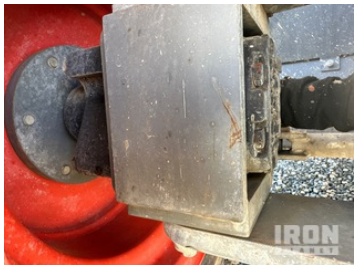
| Item | Assessment | Photo |
|---|---|---|
| Drive Motors | ★★★☆☆ | |

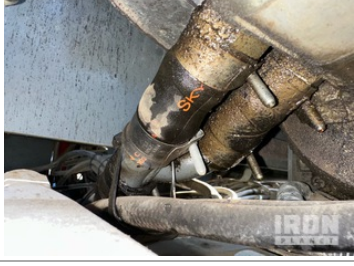
| Hydraulics | | |
|---|---|---|
| Hoses | Some lines/fittings have a dripping leak. | |

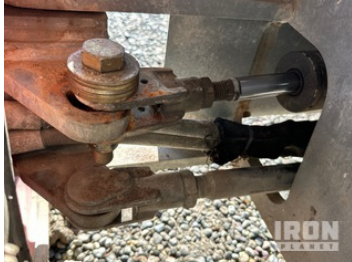
| Item | Assessment | Photo |
|---|---|---|
| Steering Linkage | ★★☆☆ | |

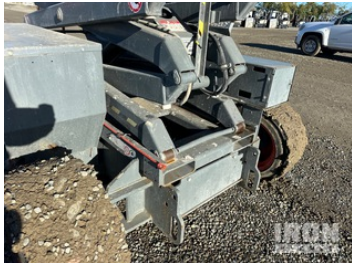
| Item | Assessment | Photo |
|---|---|---|
| Frame Condition | ★★☆☆ | |

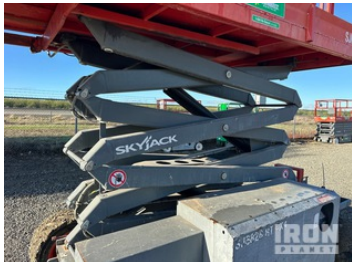
| Item | Assessment | Photo |
|---|---|---|
| Scissor Linkage | ★★☆☆ | |

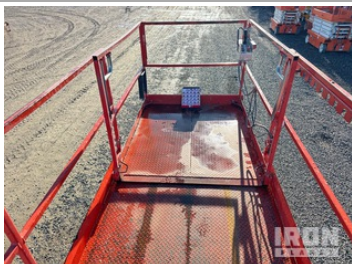
| Item | Assessment | Photo |
|---|---|---|
| Platform Condition | ★★☆☆ | |

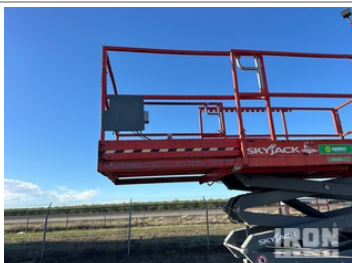
| Item | Assessment | Photo |
|---|---|---|
| Platform Extension | ★★☆☆ | |

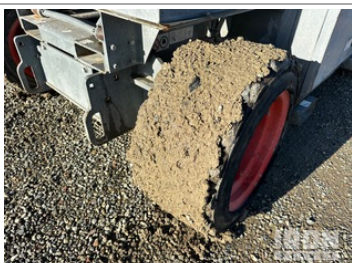
| Item | Assessment | Photo |
|---|---|---|
| Left Front Tire | Cracks, Chunks missing, Tears | |

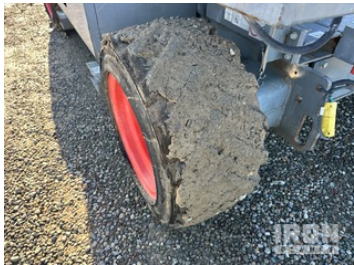
| Left Rear Tire | Cracks, Chunks missing | |

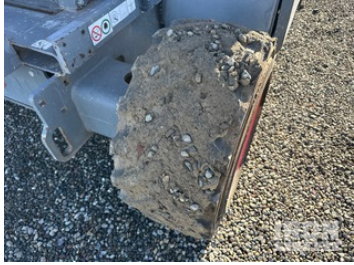
| Right Rear Tire | Cracks, Chunks missing | |

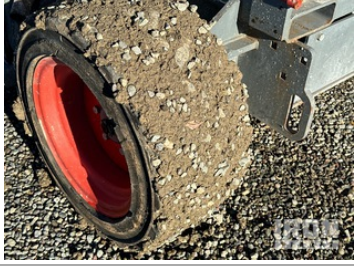
| Right Front Tire | Cracks, Chunks missing | |
