## Item #14095051 - 2017 Genie Z45/25 4WD Diesel Articulating Boom Lift

- Features: 46 ft 1 in Max Platform Height, 500 lb Max Weight Capacity, Jib, Power to Platform, Onboard Generator, Tier 4, 2017 US EPA Label, CARB Compliant, Deutz 4 Cylinder Diesel Engine, 315/55D 20 Tires
- Meter Reading: 2,625 Miles
- Serial # : Z4525N-58458
- Inspection Completed: 10/8/25

# Inspection Report

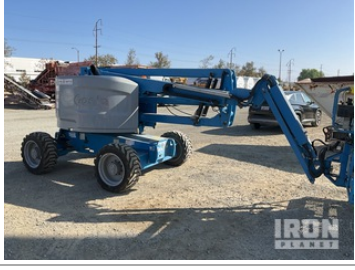
| Paint | No visible damage | |

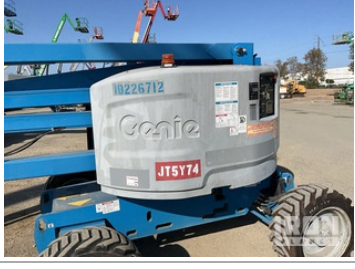
| Body Panels | No visible damage or missing components | |

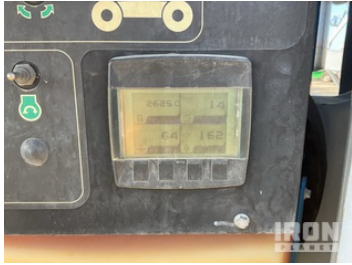
| Control Station Ground | | |
|---|---|---|
| Gauges | Operational | |

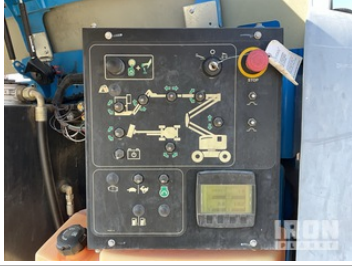
| Control Station Ground | | |
|---|---|---|
| Function Controls | ★★★★☆ | |

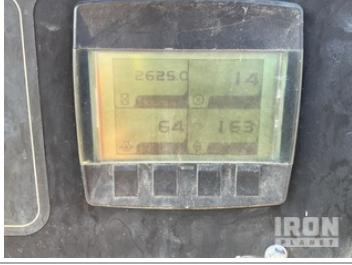
| Control Station Ground | | |
|---|---|---|
| Oil Pressure | The gauge registers in the operating range. 64 PSI | |

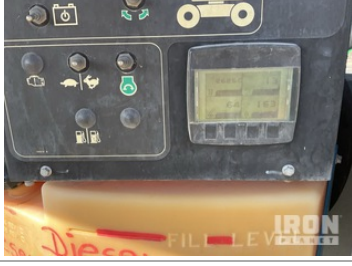
| Control Station Ground | | |
|---|---|---|
| Warning Lights | Operational | |

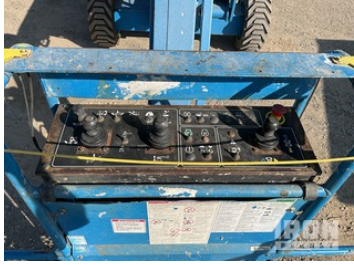
| Item | Assessment | Photo |
|---|---|---|
| Control Console | No visible damage or missing components | |

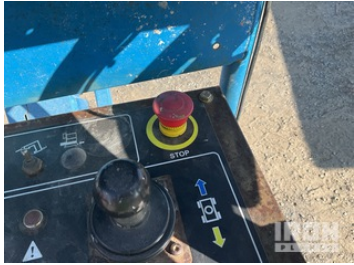
| Item | Assessment | Photo |
|---|---|---|
| Emergency Shut Off Switch | Operational | |

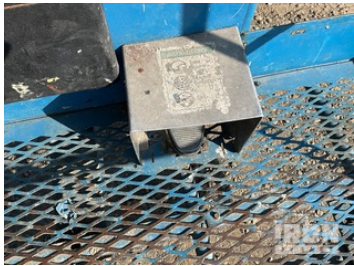
| Item | Assessment | Photo |
|---|---|---|
| Safety Control Hand/Foot Switch | ☆☆☆☆<br>Operational | |

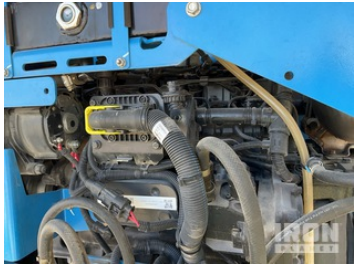
| Engine | | |
|---|---|---|
| Fuel System | Operational | |

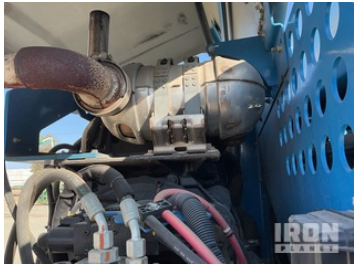
| Engine | | |
|---|---|---|
| Exhaust System | No visible damage or missing components | |

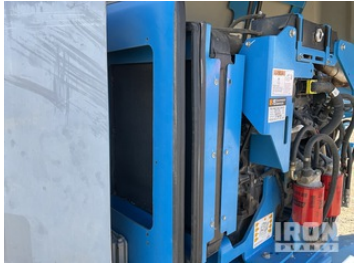
| Engine | | |
|---|---|---|
| Radiator | ★★★★☆ | |

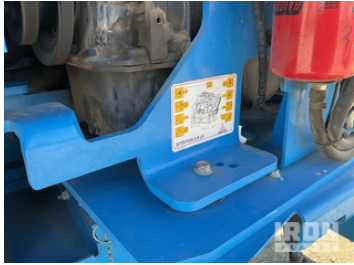
| Engine | | |
|---|---|---|
| Oil Leaks | No dripping leaks | |

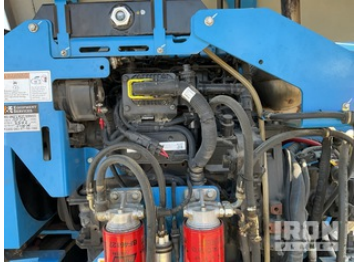
| Engine | | |
|---|---|---|
| Fuel Leaks | No dripping leaks | |

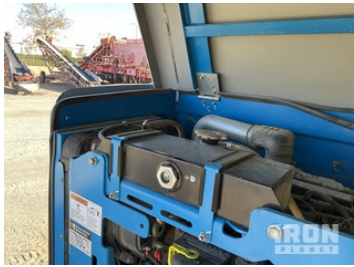
| Cooling System Leaks | No dripping leaks | |

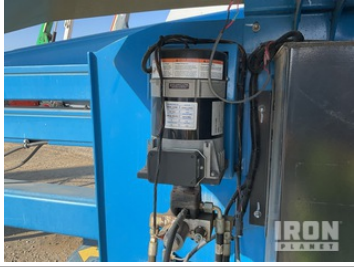
| Onboard Generator | Not operationally checked | |

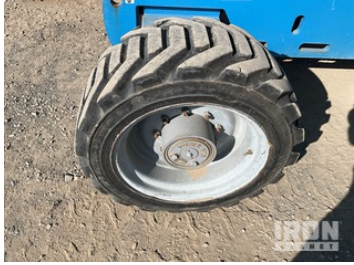
| Item | Assessment | Photo |
|---|---|---|
| Left Front Final Drive | ★★★★☆ | A close-up photograph of the left front final drive assembly, showing a large, treaded tire mounted on a white metal rim. The assembly is part of a blue lift chassis. |

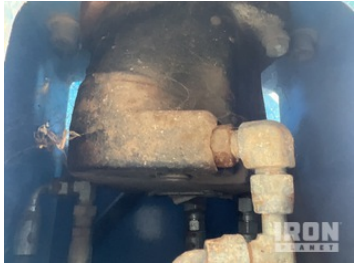
| Item | Assessment | Photo |
|---|---|---|
| Left Front Drive Motor | ★★★★☆ | A close-up photograph of the left front drive motor, a cylindrical component with a yellow protective cap, mounted on a blue metal frame. |

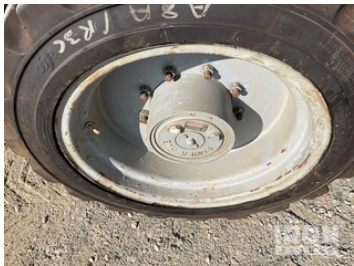
| Item | Assessment | Photo |
|---|---|---|
| Left Rear Final Drive | ★★★★☆ | A close-up photograph of the left rear final drive assembly, showing a large, treaded tire mounted on a white metal rim. The assembly is part of a blue lift chassis. |

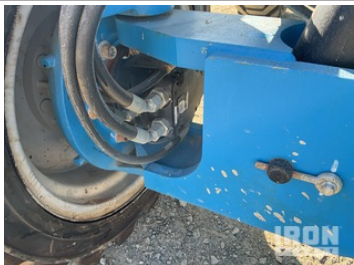
| Item | Assessment | Photo |
|---|---|---|
| Left Rear Drive Motor | ★★★★☆ | A close-up photograph of the left rear drive motor, a cylindrical component with a yellow protective cap, mounted on a blue metal frame. |

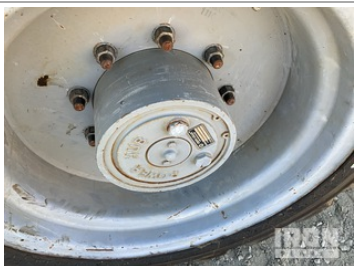
| Item | Assessment | Photo |
|---|---|---|
| Right Rear Final Drive | ★★★★☆ | A close-up photograph of the right rear final drive assembly, showing a large, treaded tire mounted on a white metal rim. The assembly is part of a blue lift chassis. |

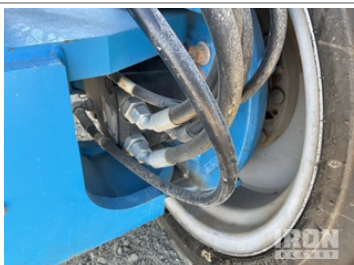
| Item | Assessment | Photo |
|---|---|---|
| Right Rear Drive Motor | ★★★★☆ | A close-up photograph of the right rear drive motor, a cylindrical component with a yellow protective cap, mounted on a blue metal frame. |

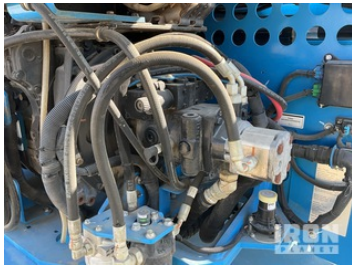
| Hydraulics | | |
|---|---|---|
| Pumps (Hydraulics) | ★★★★☆ | |

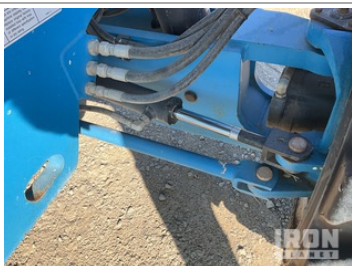
| Hydraulics | | |
|---|---|---|
| Steering Cylinders | ★★★★☆ | |

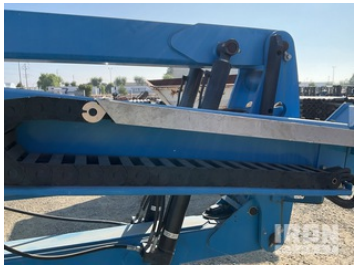
| Secondary Boom Cylinder | ★★★★☆ | |

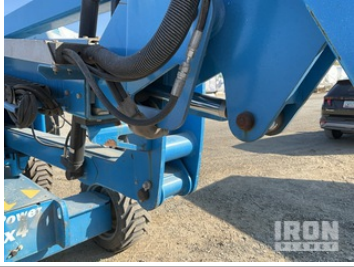
| Jib Cylinder | ★★★★☆ | |

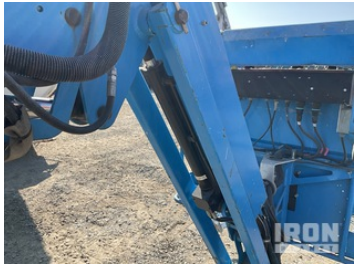
| Basket Tilt Cylinder | ★★★★☆ | |

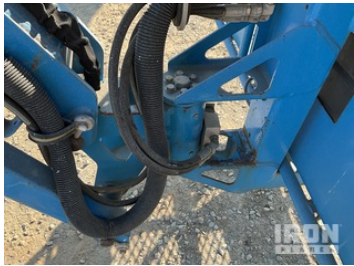
| Basket Rotator Motor | ★★★★☆ | |

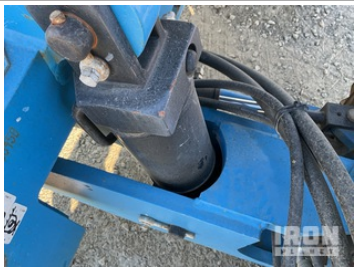
| Frame Leveling Cylinders | ★★★★☆ | |

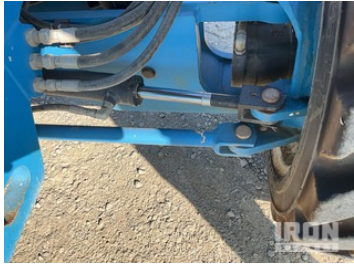
| Chassis | | |
|---|---|---|
| Steering Linkage | ★★★★☆ | |

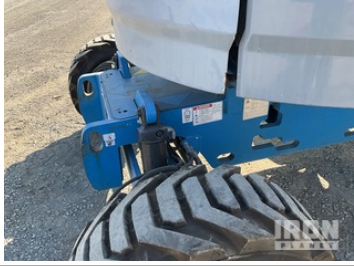
| Chassis | | |
|---|---|---|
| Frame Condition | ★★★★☆ | |

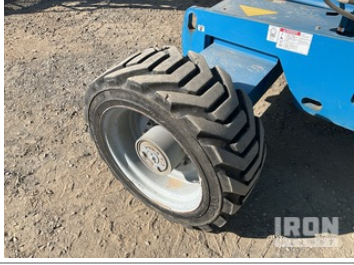
| Chassis | | |
|---|---|---|
| Left Front Tire | No visible defects | |

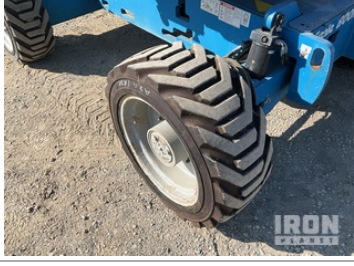
| Chassis | | |
|---|---|---|
| Left Rear Tire | No visible defects | |

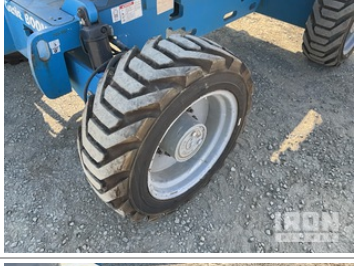
| Chassis | | |
|---|---|---|
| Right Rear Tire | No visible defects | |

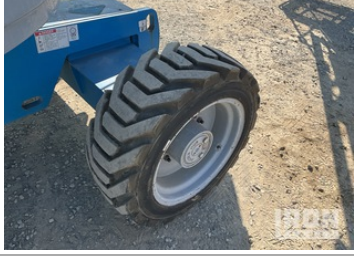
| Chassis | | |
|---|---|---|
| Right Front Tire | No visible defects | |

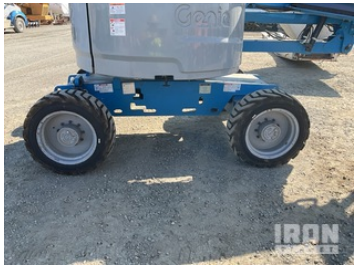
| Wheel Condition | No visible damage or missing components | |

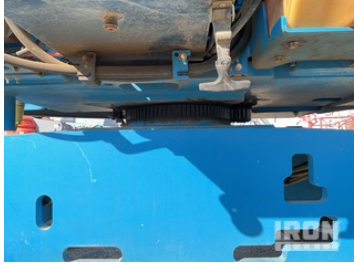
| Turntable Bearing | ★★★★☆ | |

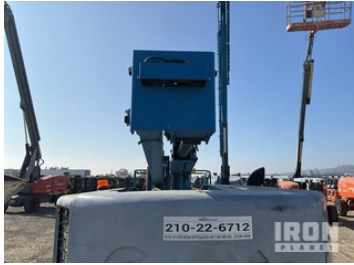
| Boom Condition | ★★★★☆ | |

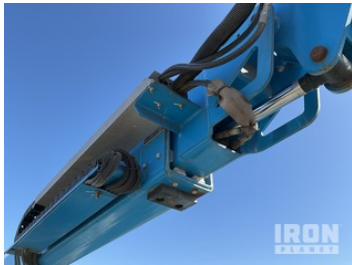
| Boom Wear Guides | ★★★★☆ | |

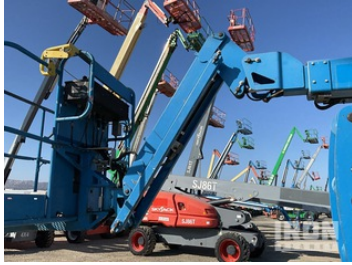
| Jib Condition | ★★★★☆ | |
