## Item #14095012 - 2016 Skyjack SJ63AJ 4WD Diesel Articulating Boom Lift

# Inspection Report

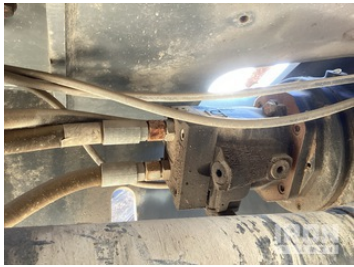
| Front Center Drive Motor | ★★☆☆<br>Noise | |
| Limited Function Check | The drivetrain was operational as noted., Noise | |

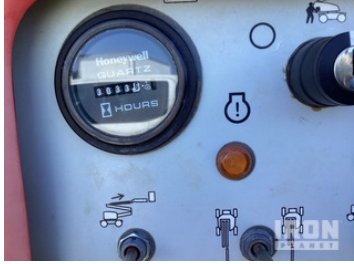
| Control Station Ground | | |
|---|---|---|
| Oil Pressure | Warning light inoperable | |

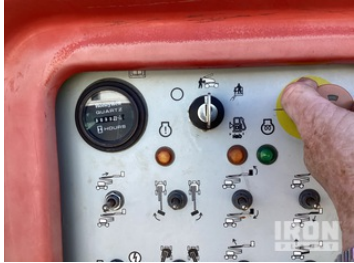
| Control Station Ground | | |
|---|---|---|
| Warning Lights | engine light not working light stays on | |

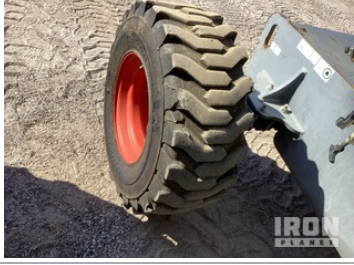
| Chassis | | |
|---|---|---|
| Left Front Tire | Chunks missing | |

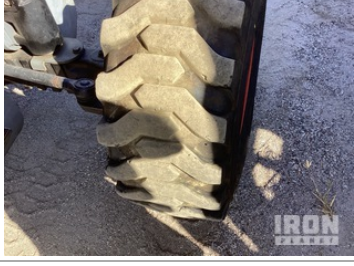
| Chassis | | |
|---|---|---|
| Left Rear Tire | Chunks missing | |

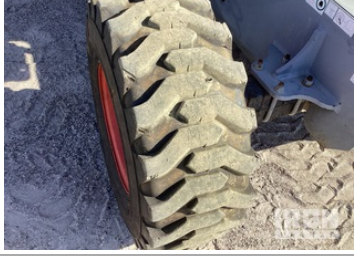
| Chassis | | |
|---|---|---|
| Right Front Tire | Chunks missing | |

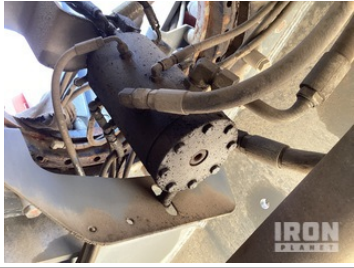
| Hydraulic Center Swivel | ★★★☆☆<br>Seepage | |
