## Item #13869127 - 2017 Genie Z60/37FE 4WD Diesel Articulating Boom Lift

# Inspection Report

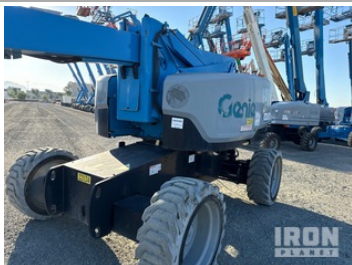
| Paint | No visible damage | |

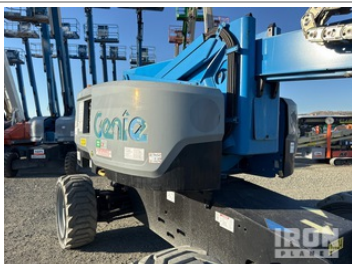
| Body Panels | No visible damage or missing components | |

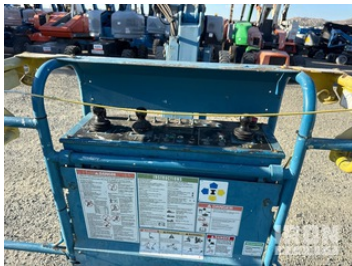
| Control Station | | |
|---|---|---|
| Control Console | No visible damage or missing components | |

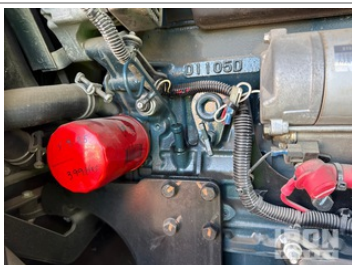
| Engine | | |
|---|---|---|
| Oil Leaks | No dripping leaks | |

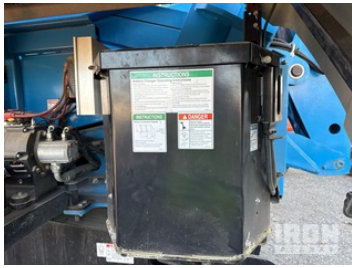
| Electrical Operating System | | |
|---|---|---|
| Cables and Connections | No visible damage or missing components | |

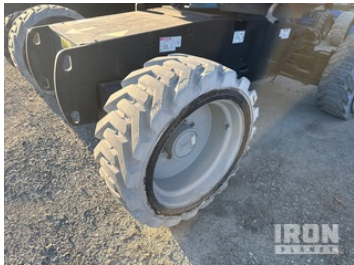
| Left Front Tire | Cracks, Chunks missing, Tears | |

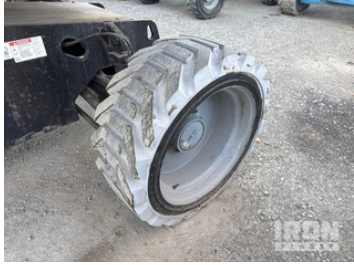
| Left Rear Tire | Cracks, Chunks missing, Flat spots | |

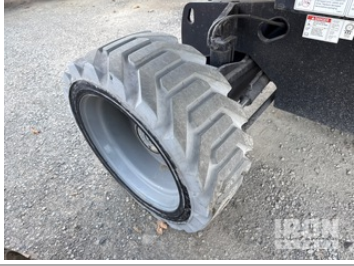
| Right Rear Tire | Cracks, Chunks missing, Flat spots, Tears | |

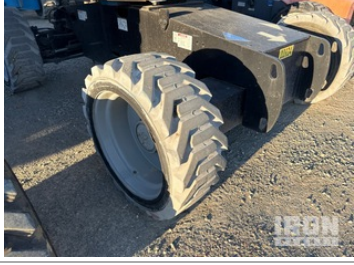
| Right Front Tire | Cracks, Chunks missing, Flat spots, Tears | |

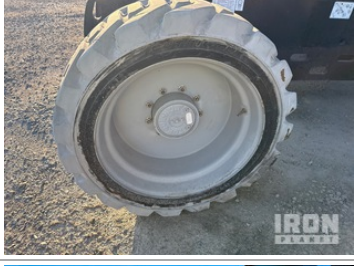
| Wheel Condition | No visible damage or missing components | |
