## Item #14177561 - 2022 Skyjack SJ45 AJ 4WD Diesel Articulating Boom Lift

# Inspection Report

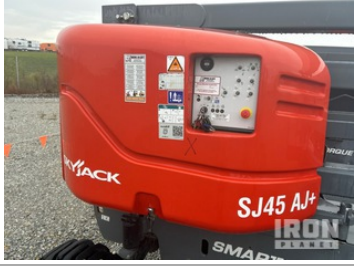
| Paint | No visible damage | |

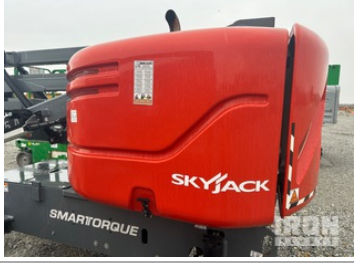
| Body Panels | No visible damage or missing components | |

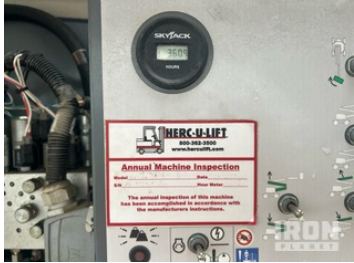
| Safety | | |
|---|---|---|
| ANSI Guidelines | No | |

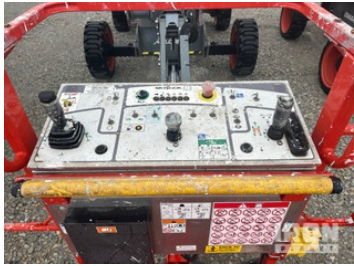
| Item | Assessment | Photo |
|---|---|---|
| Control Console | No visible damage or missing components | |

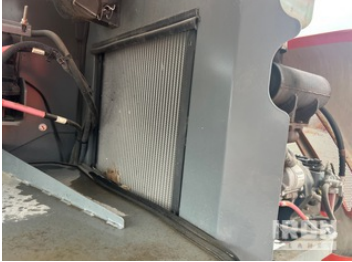
| Engine | | |
|---|---|---|
| Radiator | ★★★★☆ | |

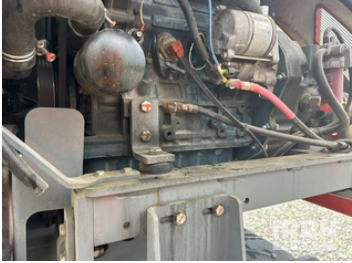
| Engine | | |
|---|---|---|
| Oil Leaks | No dripping leaks | |

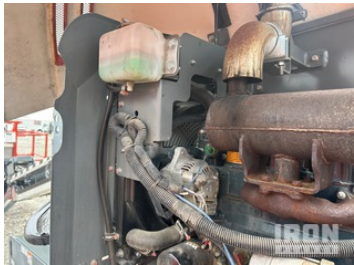
| Cooling System Leaks | No dripping leaks | |

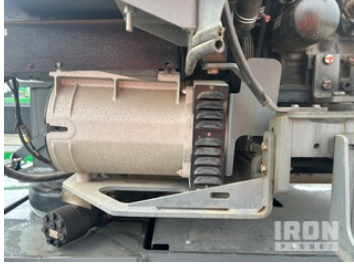
| Onboard Generator | Not operationally checked | |

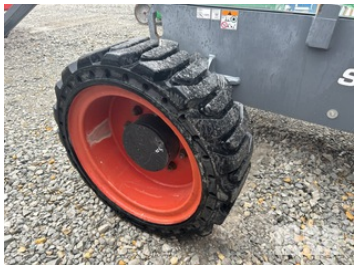
| Item | Assessment | Photo |
|---|---|---|
| Left Front Final Drive | ★★★★☆ | |

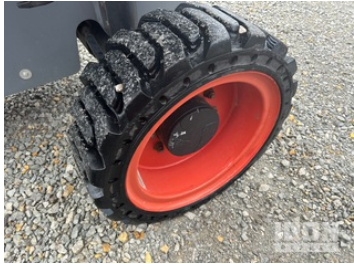
| Item | Assessment | Photo |
|---|---|---|
| Left Rear Final Drive | ★★★★☆ | |

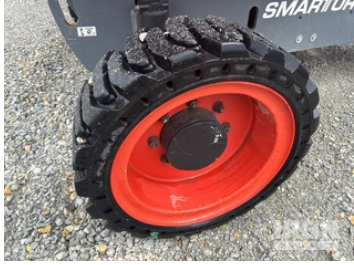
| Item | Assessment | Photo |
|---|---|---|
| Right Rear Final Drive | ★★★★☆ | |

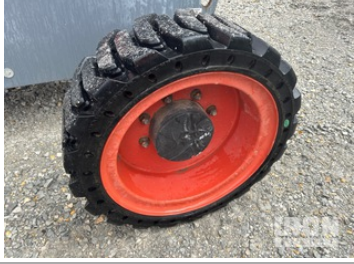
| Item | Assessment | Photo |
|---|---|---|
| Right Front Final Drive | ★★★★☆ | |

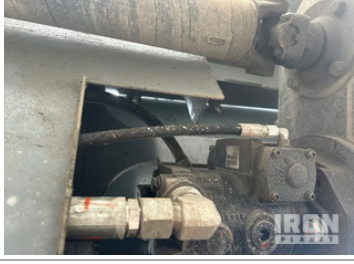
| Item | Assessment | Photo |
|---|---|---|
| Front Center Drive Motor | ★★★★☆ | |

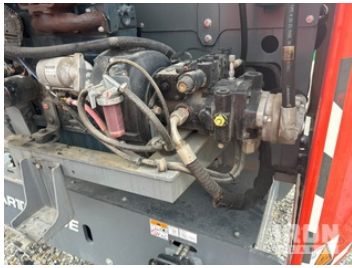
| Hydraulics | | |
|---|---|---|
| Pumps (Hydraulics) | ★★★★☆ | |

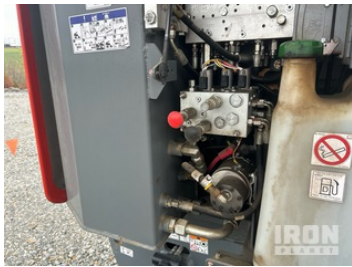
| Hydraulics | | |
|---|---|---|
| Hydraulic Tank | ★★★★☆ | |

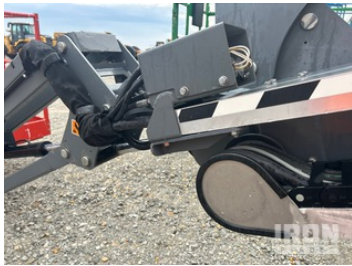
| Hydraulics | | |
|---|---|---|
| Hoses (Hydraulic) | ★★★★☆ | |

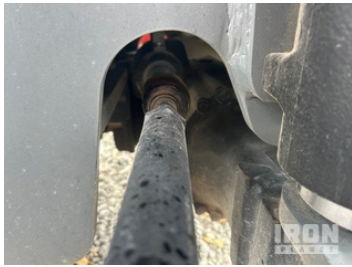
| Hydraulics | | |
|---|---|---|
| Steering Cylinders | ★★★★☆ | |

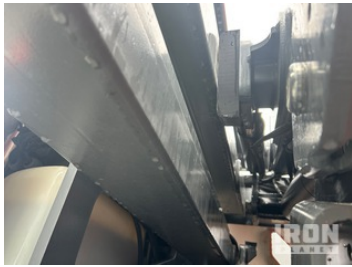
| Hydraulics | | |
|---|---|---|
| Boom Lift Cylinder | ★★★★☆ | |

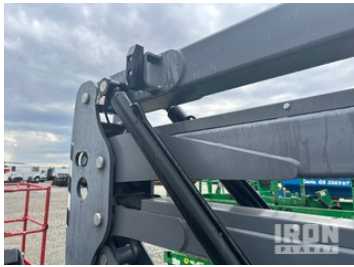
| Secondary Boom Cylinder | ★★★★☆ | |

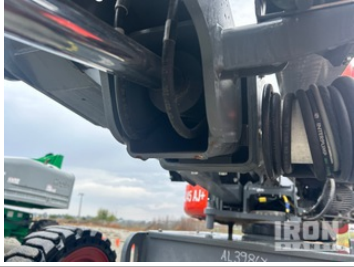
| Jib Cylinder | ★★★★☆ | |

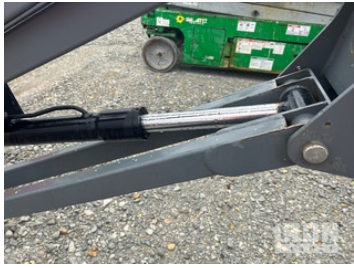
| Basket Tilt Cylinder | ★★★★☆ | |

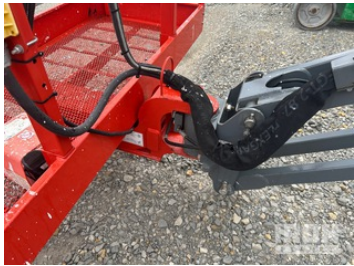
| Basket Rotator Motor | ★★★★☆ | |

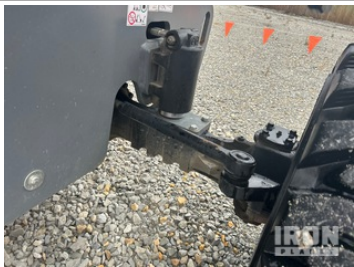
| Frame Leveling Cylinders | ★★★★☆ | |

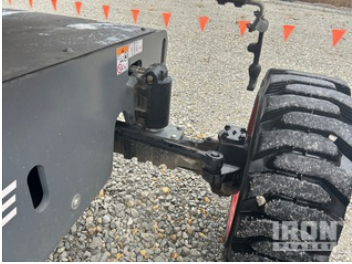
| Chassis | | |
|---|---|---|
| Steering Linkage | ★★★★☆ | |

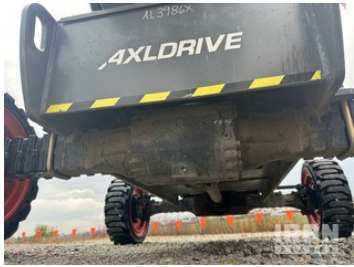
| Frame Condition | ★★★★☆ | |

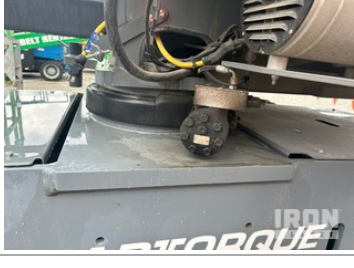
| Turntable Bearing | ★★★★☆ | |

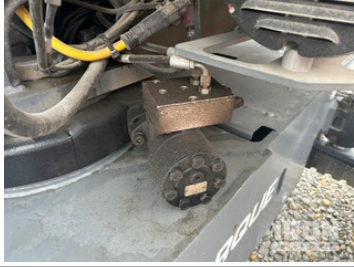
| Swing Motor | ★★★★☆ | |

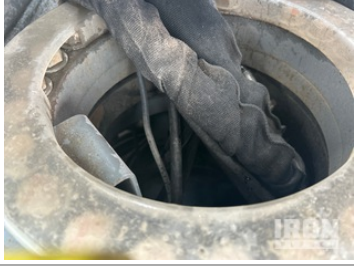
| Hydraulic Center Swivel | ★★★★☆ | |

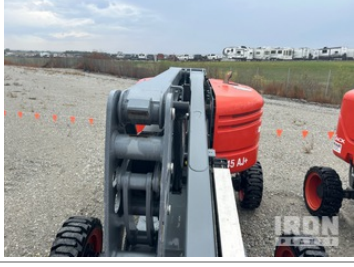
| Boom Condition | ★★★★☆ | |

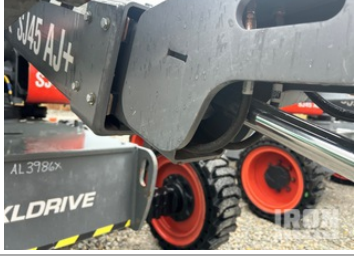
| Boom Wear Guides | ★★★★☆ | |
