## Item #14095010 - 2016 JLG E450A 2WD Electric Articulating Boom Lift

# Inspection Report

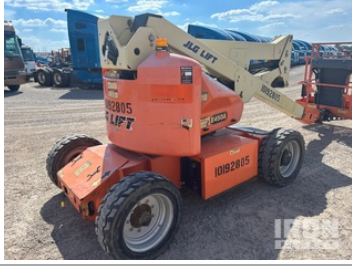
| Paint | No visible damage | |

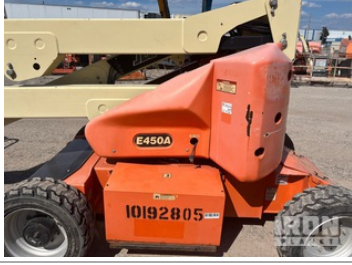
| Body Panels | No visible damage or missing components | |

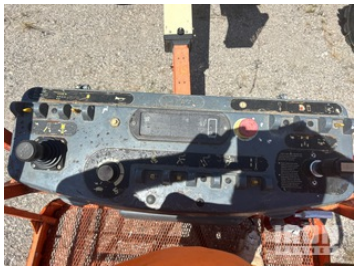
| Item | Assessment | Photo |
|---|---|---|
| Control Console | No visible damage or missing components | |

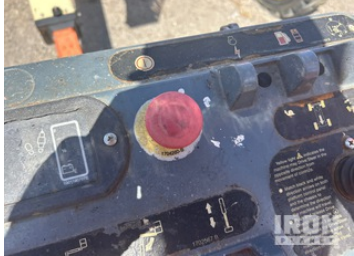
| Item | Assessment | Photo |
|---|---|---|
| Emergency Shut Off Switch | Operational | |

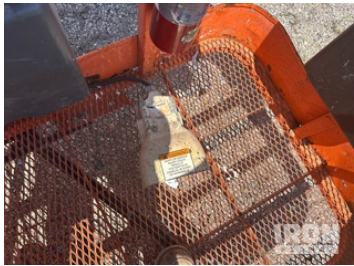
| Item | Assessment | Photo |
|---|---|---|
| Safety Control Hand/Foot Switch | ★★★★☆<br>Operational | |

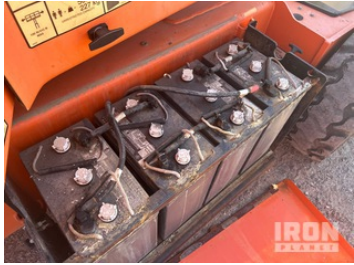
| Electrical Operating System | | |
|---|---|---|
| Cables and Connections | No visible damage or missing components | |

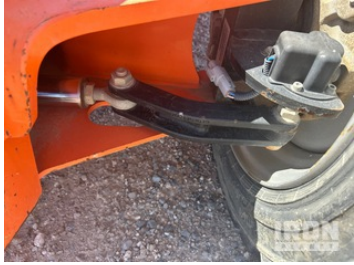
| Steering Linkage | ★★★☆☆ | |

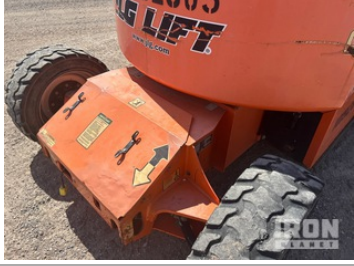
| Frame Condition | ★★★☆☆ | |

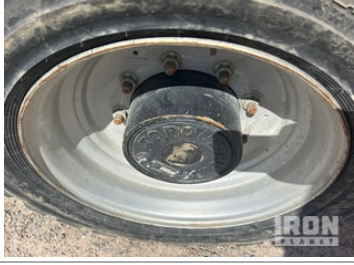
| Brake System | ★★★☆☆<br>The brake system functioned, stopping and holding the machine. | |

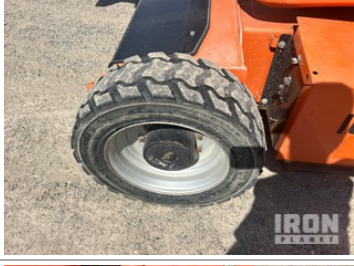
| Left Front Tire | Cracks, Chunks missing | |

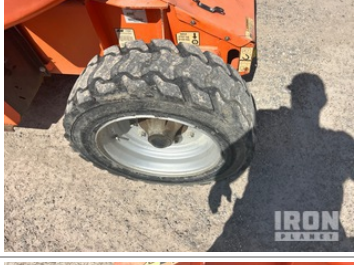
| Left Rear Tire | Cracks, Chunks missing | |

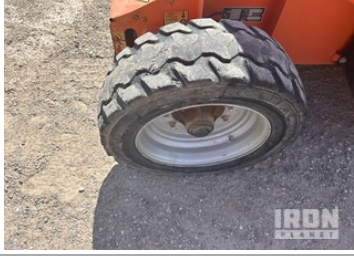
| Right Rear Tire | Cracks, Chunks missing | |

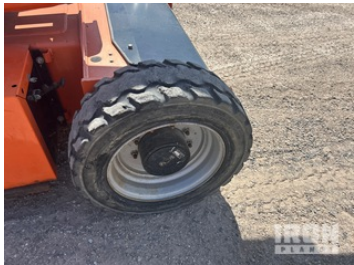
| Right Front Tire | Cracks, Chunks missing | |

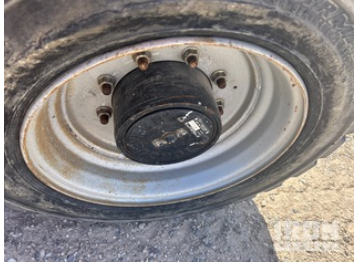
| Wheel Condition | No visible damage or missing components | |
