## Item #13810727 - 2016 JLG 800 AJ 4WD Diesel Articulating Boom Lift

# Inspection Report

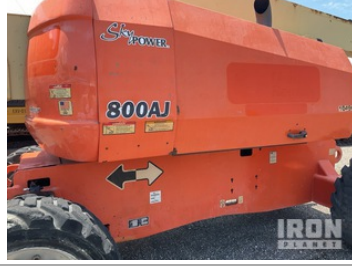
| Paint | Concrete residue | |

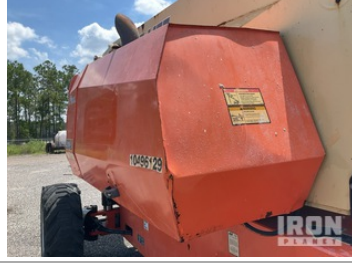
| Body Panels | Engine compartment door damaged, Hydraulic compartment door damaged | |

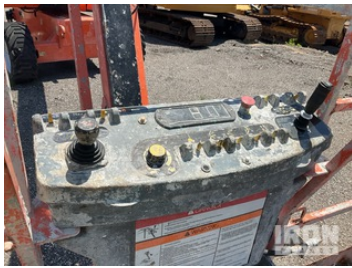
| Item | Assessment | Photo |
|---|---|---|
| Control Console | Material buildup | |

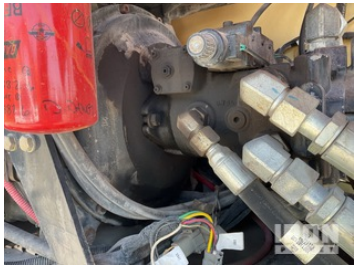
| Hydraulics | | |
|---|---|---|
| Pumps (Hydraulics) | ★★☆☆<br>seepage present | |

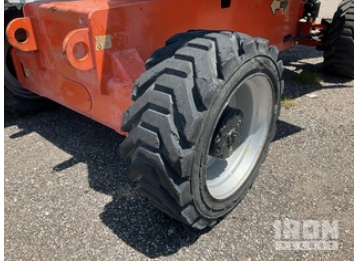
| Chassis | | |
|---|---|---|
| Left Front Tire | Chunks missing | |

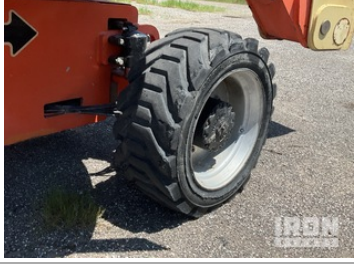
| Chassis | | |
|---|---|---|
| Left Rear Tire | Chunks missing | |

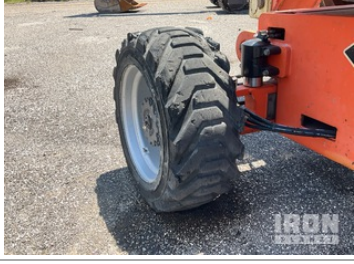
| Chassis | | |
|---|---|---|
| Right Rear Tire | Chunks missing | |

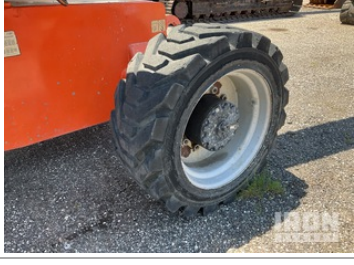
| Chassis | | |
|---|---|---|
| Right Front Tire | Chunks missing | |

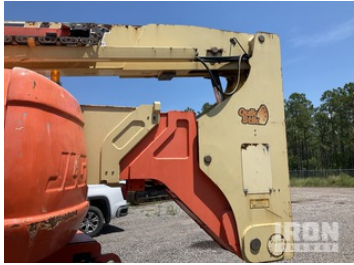
| Boom Condition | ★★★☆☆<br>rust & corrosion present | |
