## Item #13811347 - 2016 JLG 600AJ 4WD Diesel Articulating Boom Lift

# Inspection Report

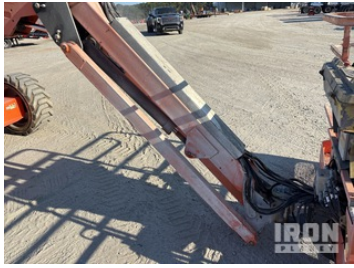
| Paint | Paint residue | |

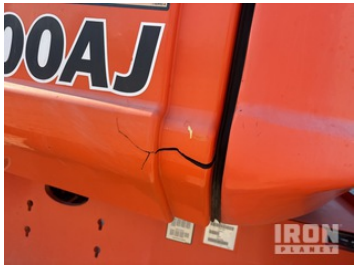
| Body Panels | Hydraulic compartment door damaged | |

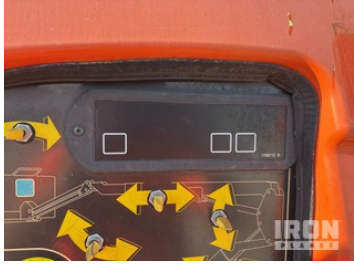
| Control Station Ground | | |
|---|---|---|
| Oil Pressure | The fault indicator shuts off after the engine oil pressure rises. | |

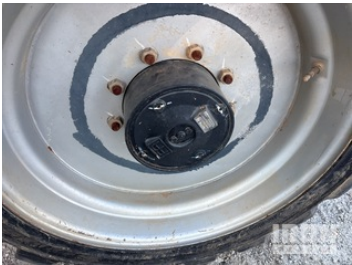
| Right Front Final Drive | ☆☆☆☆ | |

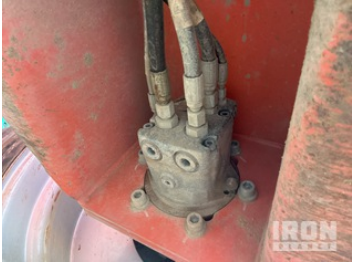
| Right Front Drive Motor | ☆☆☆☆ | |

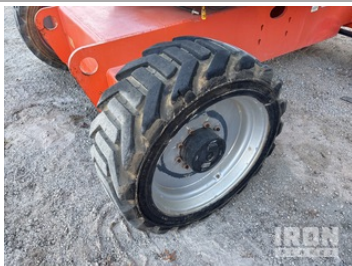
| Chassis | | |
|---|---|---|
| Left Front Tire | Cracks, Chunks missing, Tears | |

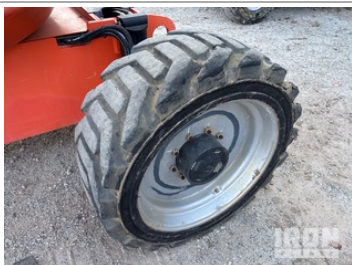
| Chassis | | |
|---|---|---|
| Left Rear Tire | Cracks, Chunks missing, Tears | |

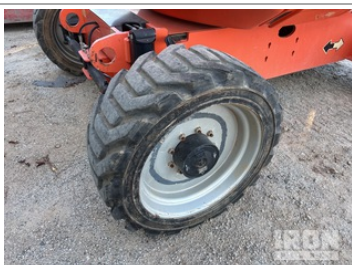
| Chassis | | |
|---|---|---|
| Right Rear Tire | Chunks missing, Tears | |

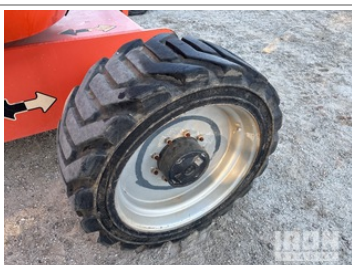
| Chassis | | |
|---|---|---|
| Right Front Tire | Cracks, Chunks missing, Tears | |

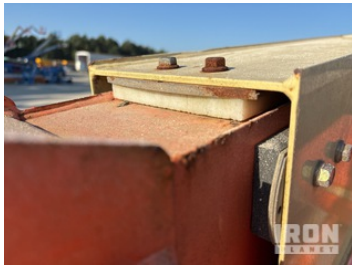
| Boom Wear Guides | ☆☆☆☆ | |

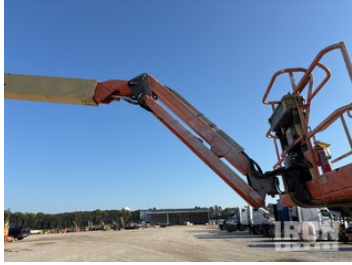
| Jib Condition | ☆☆☆☆ | |
