## Item #13810611 - 2017 Skyjack SJ63AJ 4WD Dual Fuel Articulating Boom Lift

# Inspection Report

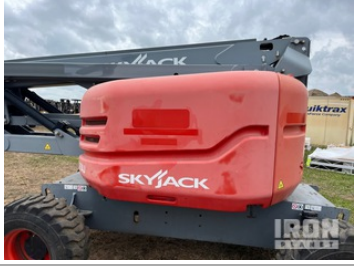
| Paint | No visible damage | |

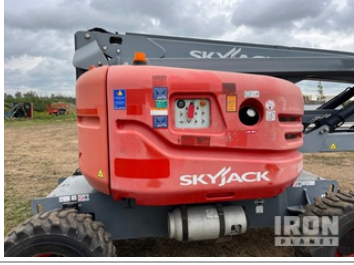
| Body Panels | No visible damage or missing components | |

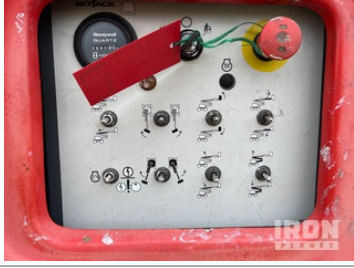
| Control Station Ground | | |
|---|---|---|
| Oil Pressure | No oil pressure indicator | |

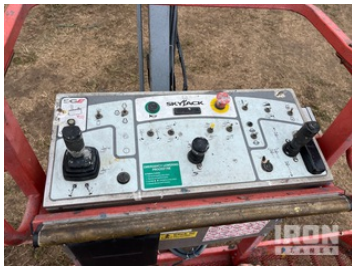
| Item | Assessment | Photo |
|---|---|---|
| Control Console | No visible damage or missing components | |

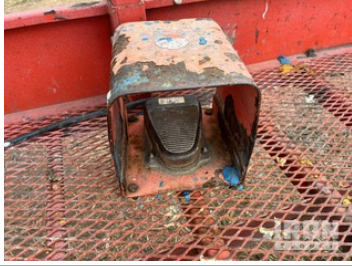
| Item | Assessment | Photo |
|---|---|---|
| Safety Control Foot Switch | ☆☆☆☆<br>Operational | |

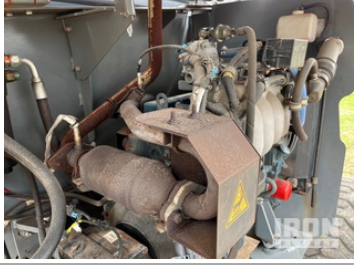
| Engine | | |
|---|---|---|
| Exhaust System | No visible damage or missing components | |

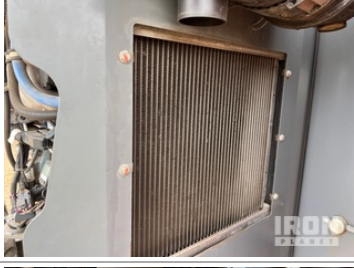
| Engine | | |
|---|---|---|
| Radiator | ★★★★☆ | |

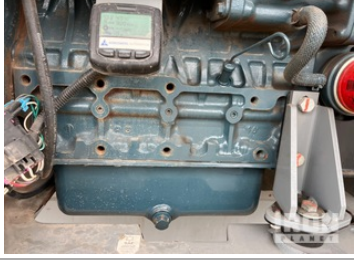
| Engine | | |
|---|---|---|
| Oil Leaks | No dripping leaks | |

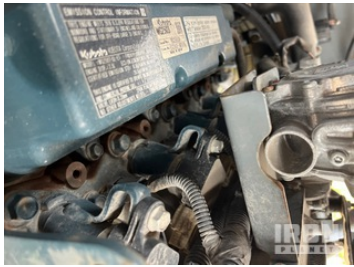
| Fuel Leaks | No dripping leaks | |

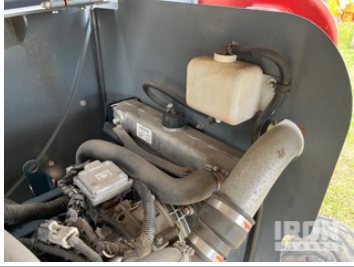
| Cooling System Leaks | No dripping leaks Low coolant | |

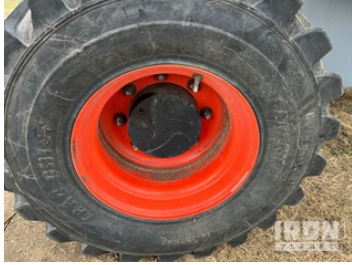
| Item | Assessment | Photo |
|---|---|---|
| Left Front Final Drive | ★★★★☆ | |

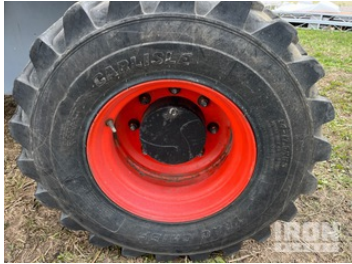
| Item | Assessment | Photo |
|---|---|---|
| Left Rear Final Drive | ★★★★☆ | |

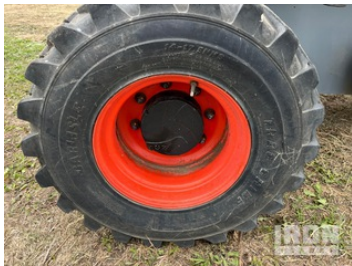
| Item | Assessment | Photo |
|---|---|---|
| Right Rear Final Drive | ★★★★☆ | |

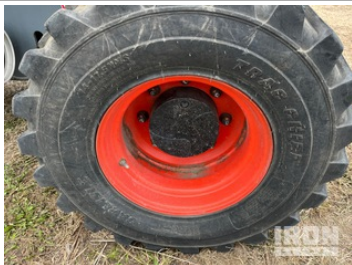
| Item | Assessment | Photo |
|---|---|---|
| Right Front Final Drive | ★★★★☆ | |

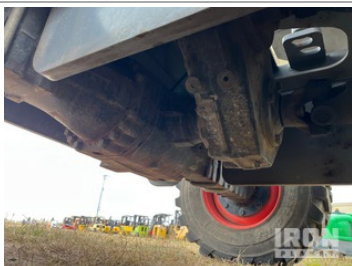
| Item | Assessment | Photo |
|---|---|---|
| Front Center Drive Motor | ★★★★☆ | |

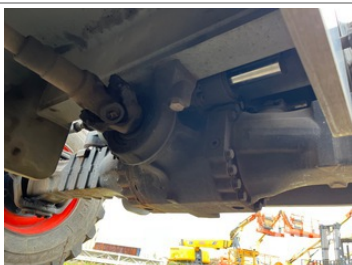
| Item | Assessment | Photo |
|---|---|---|
| Rear Center Drive Motor | ★★★★☆ | |

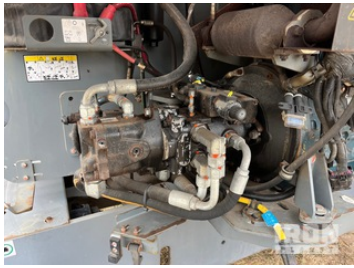
| Hydraulics | | |
|---|---|---|
| Pumps (Hydraulics) | ★★★★☆ | |

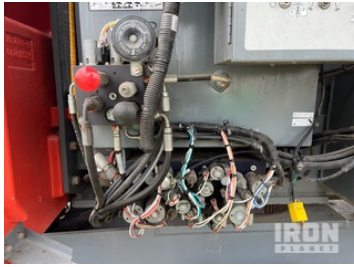
| Hydraulics | | |
|---|---|---|
| Valves | ★★★★☆ | |

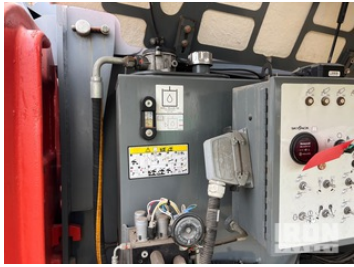
| Hydraulics | | |
|---|---|---|
| Hydraulic Tank | ★★★★☆ | |

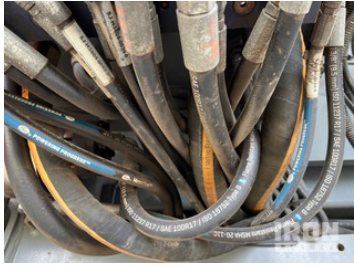
| Hydraulics | | |
|---|---|---|
| Hoses (Hydraulic) | ★★★★☆ | |

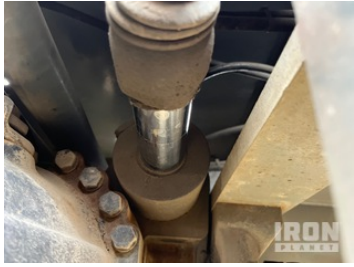
| Hydraulics | | |
|---|---|---|
| Steering Cylinders | ★★★★☆ | |

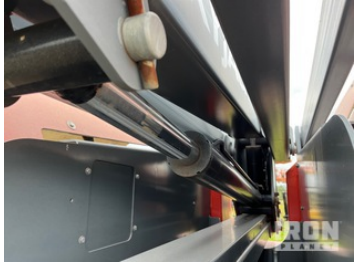
| Hydraulics | | |
|---|---|---|
| Boom Lift Cylinder | ★★★★☆ | |

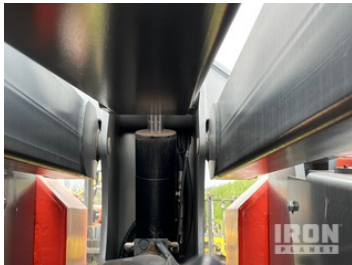
| Secondary Boom Cylinder | ★★★★☆ | |

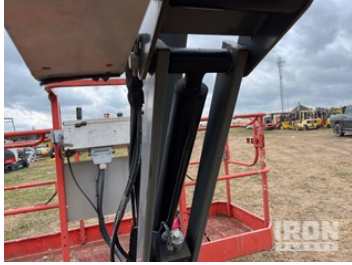
| Jib Cylinder | ★★★★☆ | |

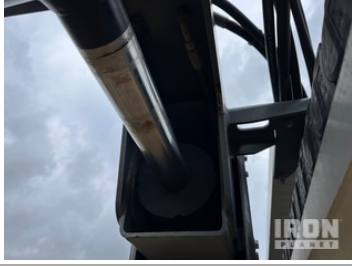
| Basket Tilt Cylinder | ★★★★☆ | |

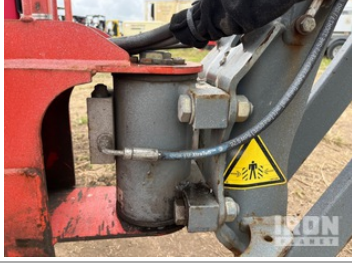
| Basket Rotator Motor | ★★★★☆ | |

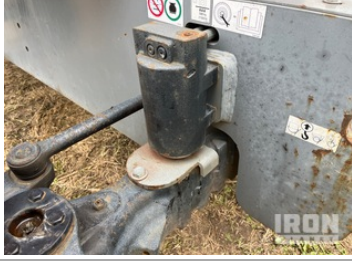
| Frame Leveling Cylinders | ★★★★☆ | |

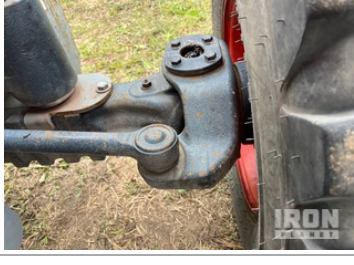
| Chassis | | |
|---|---|---|
| Steering Linkage | ★★★★☆ | |

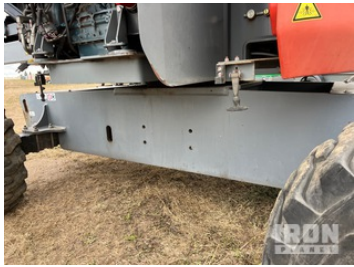
| Frame Condition | ★★★★☆ | |

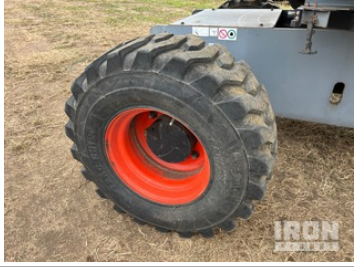
| Left Front Tire | No visible defects | |

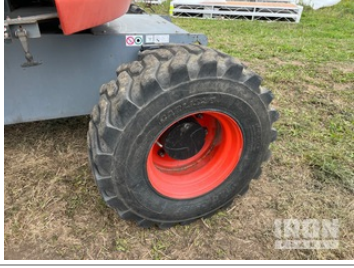
| Left Rear Tire | No visible defects | |

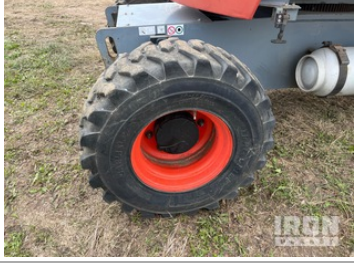
| Right Rear Tire | No visible defects | |

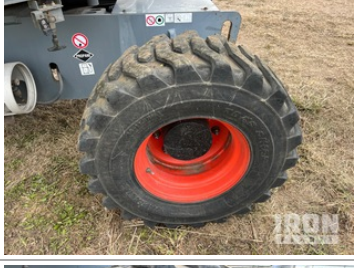
| Right Front Tire | No visible defects | |

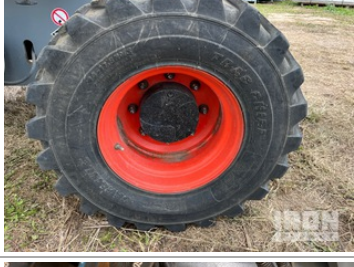
| Wheel Condition | No visible damage or missing components | |

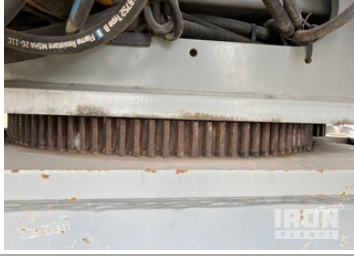
| Turntable Bearing | ★★★★☆ | |

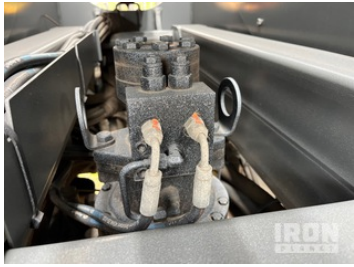
| Swing Motor | ★★★★☆ | |

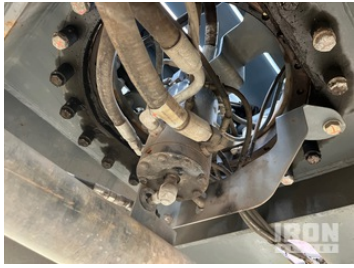
| Hydraulic Center Swivel | ★★★★☆ | |

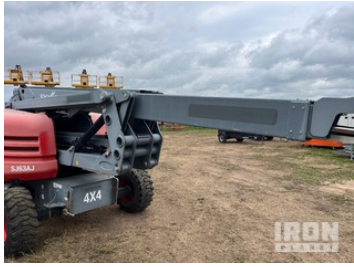
| Boom Condition | ★★★★☆ | |

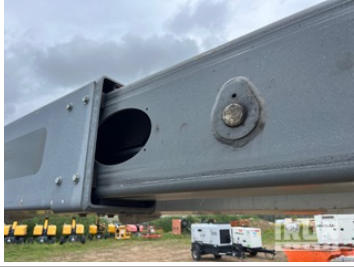
| Boom Wear Guides | ★★★★☆ | |
