## Item #14251160 - 2005 JLG E450AJ 2WD Electric Articulating Boom Lift

- Features: 45 ft Max Platform Height, 500 lb Max Weight Capacity, Jib, Power to Platform, 240/55D17.5 Tires
- Meter Reading: 2,159 Hours
- Serial # : 0300083101
- Inspection Completed: 12/16/25

# Inspection Report

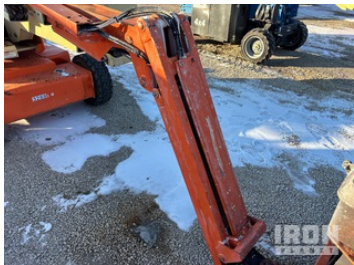
| Paint | Concrete residue | |

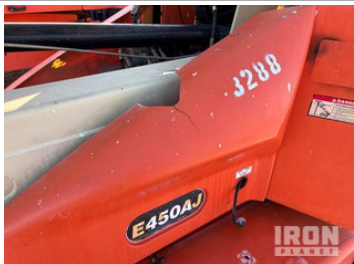
| Body Panels | Left side panel is damaged. | |

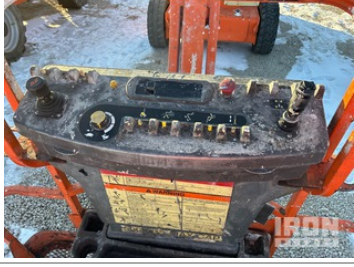
| Item | Assessment | Photo |
|---|---|---|
| Function Controls | ★★★☆☆<br>Right stick top button cover is missing. | |

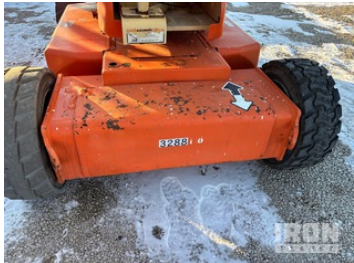
| Chassis | | |
|---|---|---|
| Brake System | ★★★★☆<br>The brake system functioned, stopping and holding the machine. | |

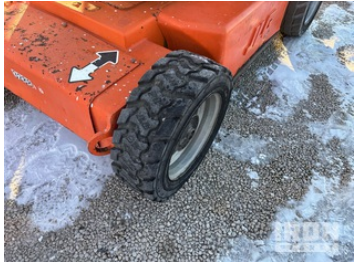
| Chassis | | |
|---|---|---|
| Left Front Tire | Cracks, Tears | |

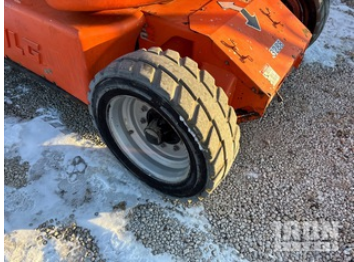
| Chassis | | |
|---|---|---|
| Left Rear Tire | Cracks, Tears | |

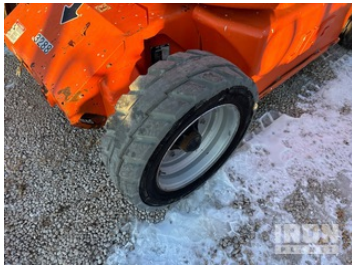
| Right Rear Tire | Cracks, Tears | |

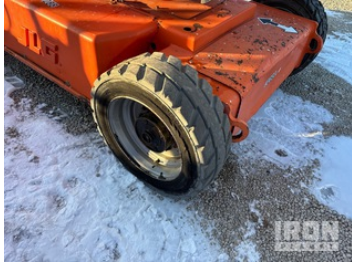
| Right Front Tire | Cracks, Tears | |
