## Item #14339885 - 2016 JLG 600AJ 4WD Dual Fuel Articulating Boom Lift

- Features: 60 ft Max Platform Height, 500 lb Max Weight Capacity, Jib, Power to Platform, PSI 4 Cylinder 3 L Dual Fuel Engine, 355/55D625 Foam-Filled Tires
- Meter Reading: 3,021 Hours
- Serial # : 0300213470
- Inspection Completed: 11/6/25

# Inspection Report

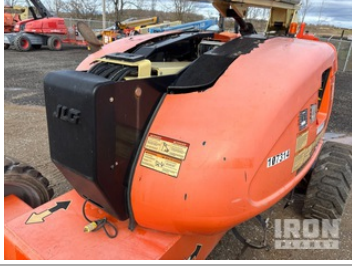
| Paint | No visible damage | |

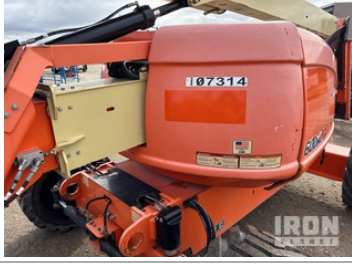
| Body Panels | No visible damage or missing components | |

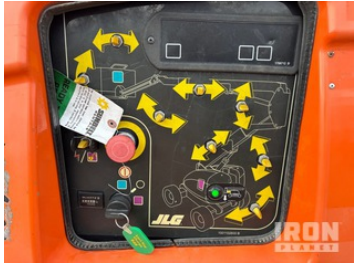
| Control Station Ground | | |
|---|---|---|
| Gauges | Operational | |

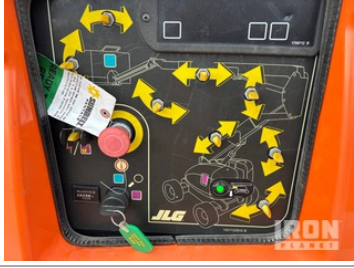
| Control Station Ground | | |
|---|---|---|
| Function Controls | ★★★★☆ | |

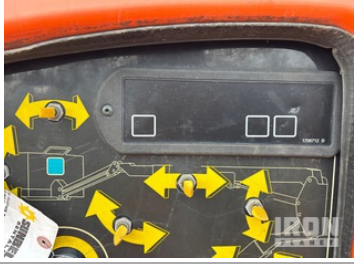
| Control Station Ground | | |
|---|---|---|
| Oil Pressure | No oil pressure indicator | |

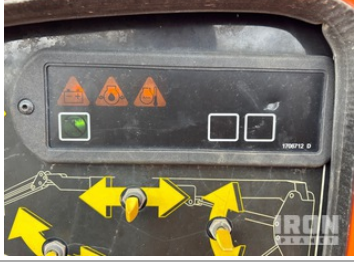
| Control Station Ground | | |
|---|---|---|
| Warning Lights | Operational | |

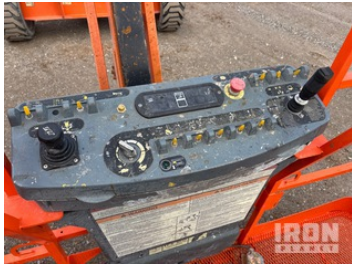
| Item | Assessment | Photo |
|---|---|---|
| Control Console | No visible damage or missing components | |

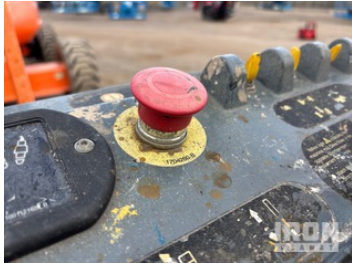
| Item | Assessment | Photo |
|---|---|---|
| Emergency Shut Off Switch | Operational | |

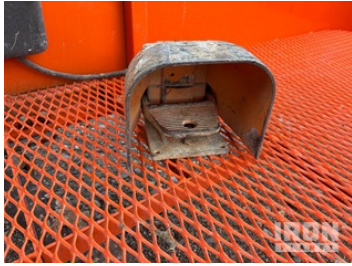
| Item | Assessment | Photo |
|---|---|---|
| Safety Control Hand/Foot Switch | ★★★★☆<br>Operational | |

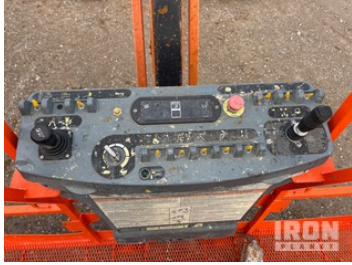
| Item | Assessment | Photo |
|---|---|---|
| Function Controls | ★★★★☆ | |

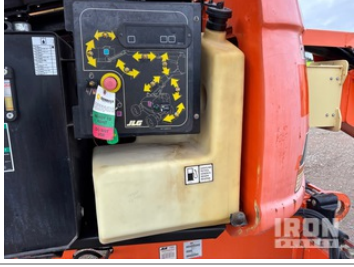
| Engine | | |
|---|---|---|
| Fuel System | Operational | |

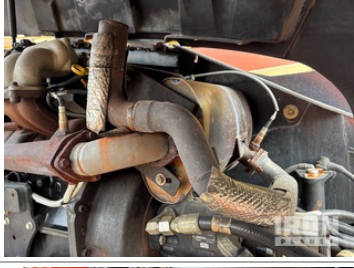
| Engine | | |
|---|---|---|
| Exhaust System | No visible damage or missing components | |

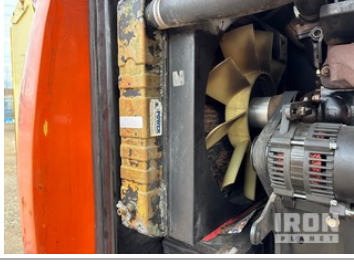
| Engine | | |
|---|---|---|
| Radiator | ★★★★☆ | |

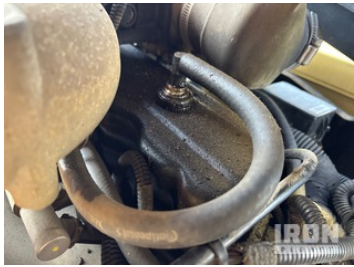
| Oil Leaks | No dripping leaks | |

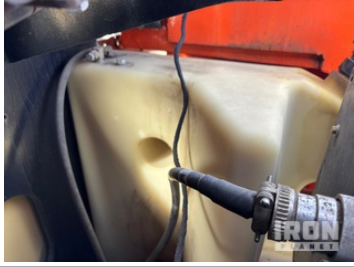
| Fuel Leaks | No dripping leaks | |

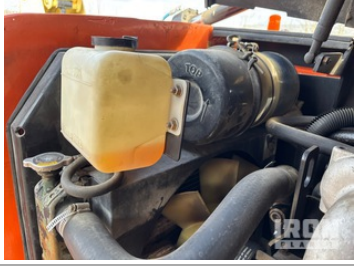
| Cooling System Leaks | No dripping leaks | |

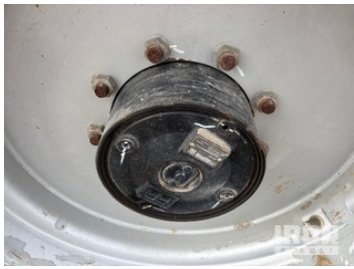
| Item | Assessment | Photo |
|---|---|---|
| Left Front Final Drive | ★★★★☆ | |

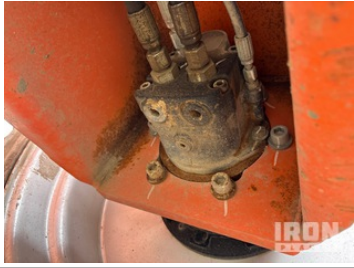
| Item | Assessment | Photo |
|---|---|---|
| Left Front Drive Motor | ★★★★☆ | |

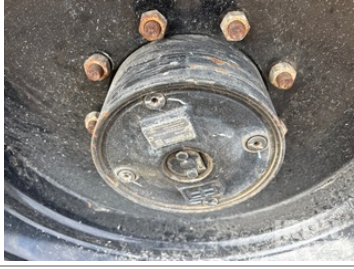
| Item | Assessment | Photo |
|---|---|---|
| Left Rear Final Drive | ★★★★☆ | |

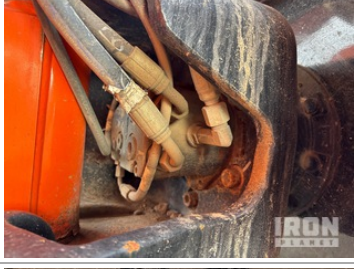
| Item | Assessment | Photo |
|---|---|---|
| Left Rear Drive Motor | ★★★★☆ | |

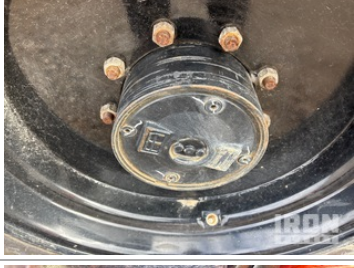
| Item | Assessment | Photo |
|---|---|---|
| Right Rear Final Drive | ★★★★☆ | |

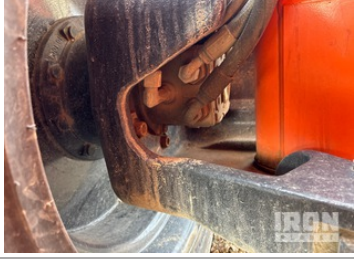
| Item | Assessment | Photo |
|---|---|---|
| Right Rear Drive Motor | ★★★★☆ | |

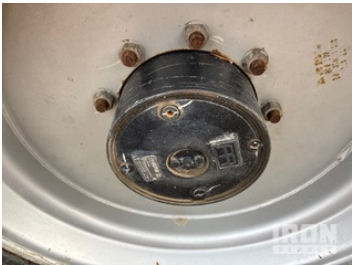
| Right Front Final Drive | ☆☆☆☆ | |

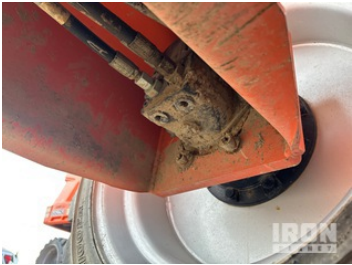
| Right Front Drive Motor | ☆☆☆☆ | |

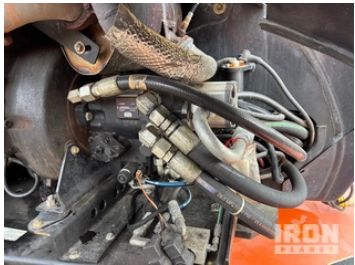
| Hydraulics | | |
|---|---|---|
| Pumps (Hydraulics) | ★★★★☆ | |

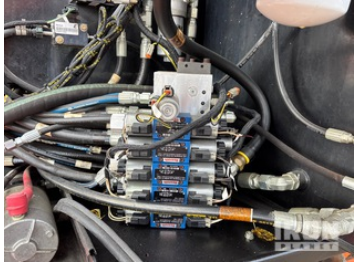
| Hydraulics | | |
|---|---|---|
| Valves | ★★★★☆ | |

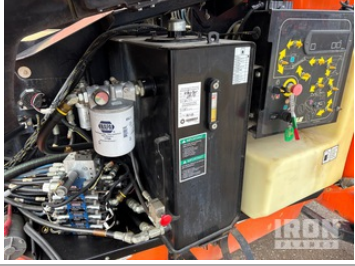
| Hydraulics | | |
|---|---|---|
| Hydraulic Tank | ★★★★☆ | |

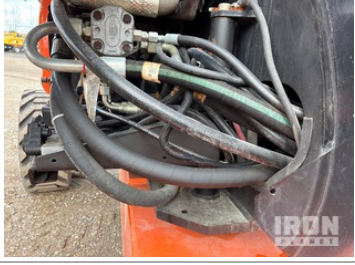
| Hydraulics | | |
|---|---|---|
| Hoses (Hydraulic) | ★★★★☆ | |

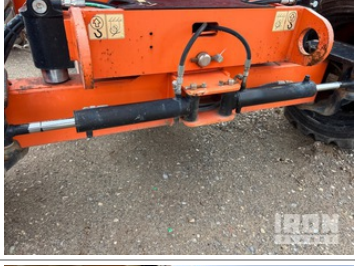
| Hydraulics | | |
|---|---|---|
| Steering Cylinders | ★★★★☆ | |

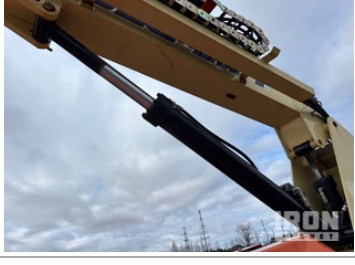
| Hydraulics | | |
|---|---|---|
| Boom Lift Cylinder | ★★★★☆ | |

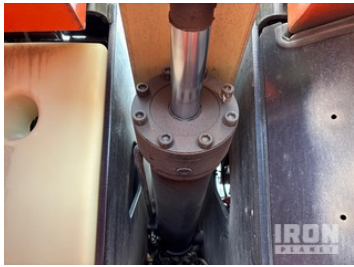
| Secondary Boom Cylinder | ★★★★☆ | |

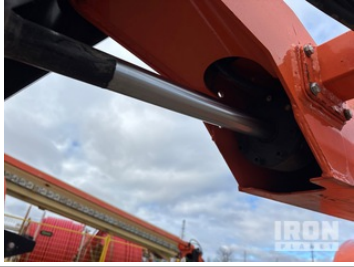
| Jib Cylinder | ★★★★☆ | |

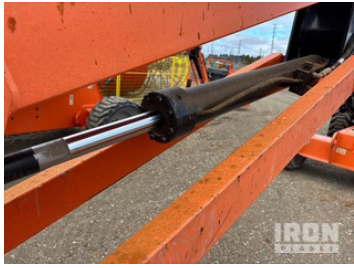
| Basket Tilt Cylinder | ★★★★☆ | |

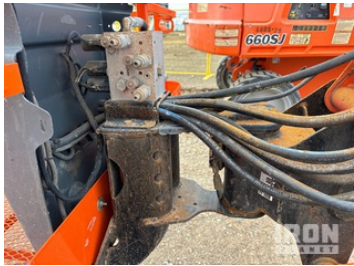
| Basket Rotator Motor | ★★★★☆ | |

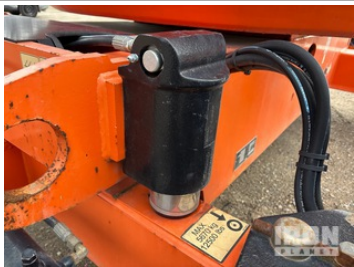
| Frame Leveling Cylinders | ★★★★☆ | |

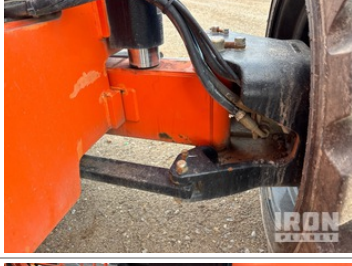
| Chassis | | |
|---|---|---|
| Steering Linkage | ★★★★☆ | |

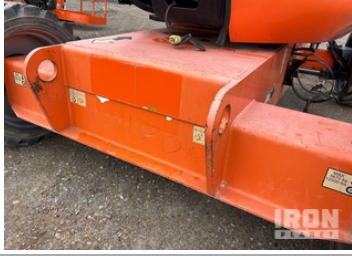
| Chassis | | |
|---|---|---|
| Frame Condition | ★★★★☆ | |

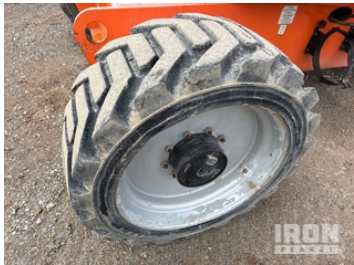
| Left Front Tire | Cracks, Chunks missing | |

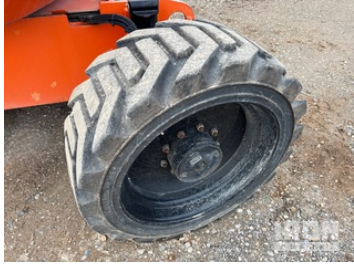
| Left Rear Tire | No visible defects | |

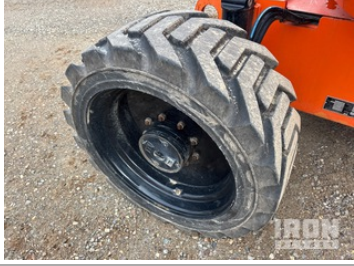
| Right Rear Tire | Screws in tire | |

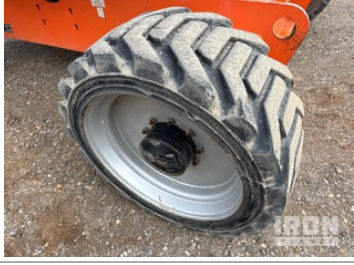
| Right Front Tire | Cracks, Chunks missing | |

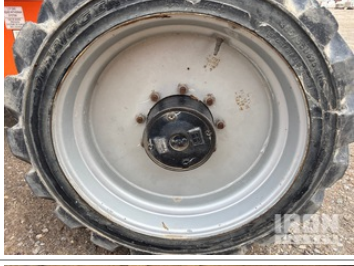
| Wheel Condition | No visible damage or missing components | |

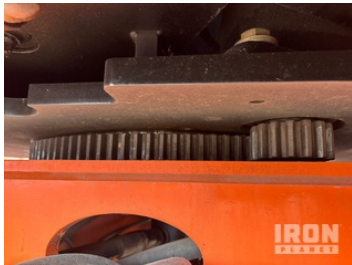
| Hydraulic Center Swivel | ★★★★☆ | |

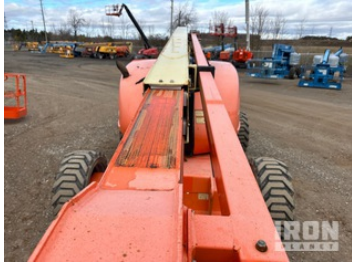
| Boom Condition | ★★★★☆ | |

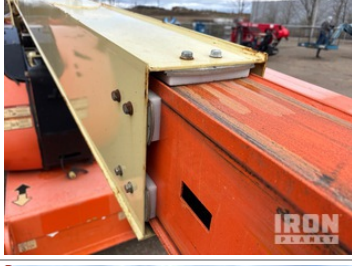
| Boom Wear Guides | ★★★★☆ | |

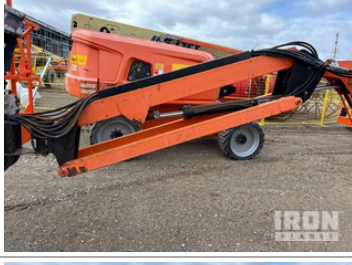
| Jib Condition | ★★★★☆ | |
