## Item #14177574 - 2023 Skyjack SJ45 AJ 4WD Diesel Articulating Boom Lift

## Inspection Report

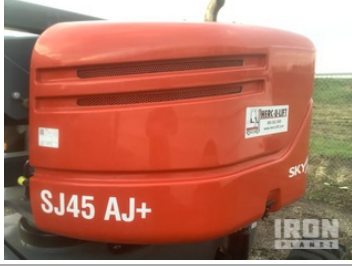
| Paint | No visible damage | |

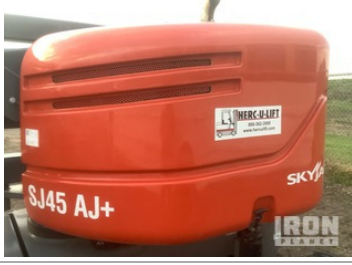
| Body Panels | No visible damage or missing components | |

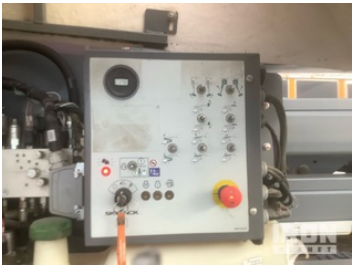
| Control Station Ground | | |
|---|---|---|
| Function Controls | ☆☆☆☆ | |

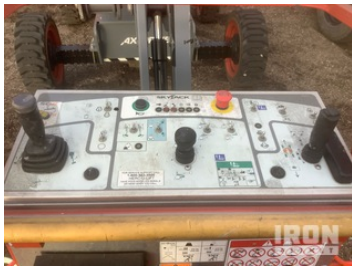
| Item | Assessment | Photo |
|---|---|---|
| Control Console | No visible damage or missing components | |

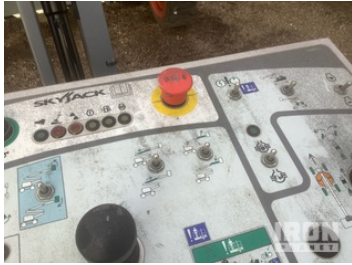
| Item | Assessment | Photo |
|---|---|---|
| Emergency Shut Off Switch | Operational | |

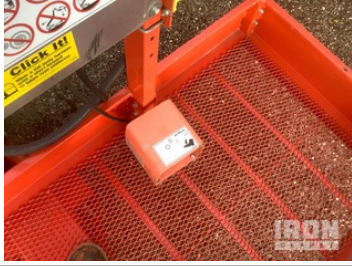
| Item | Assessment | Photo |
|---|---|---|
| Safety Control Hand/Foot Switch | ☆☆☆☆<br>Operational | |

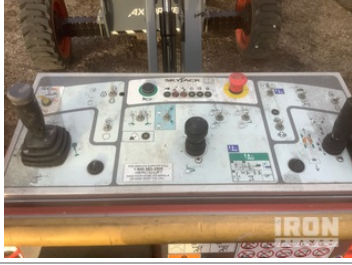
| Item | Assessment | Photo |
|---|---|---|
| Function Controls | ☆☆☆☆ | |

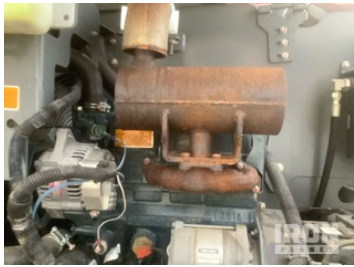
| Engine | | |
|---|---|---|
| Exhaust System | No visible damage or missing components | |

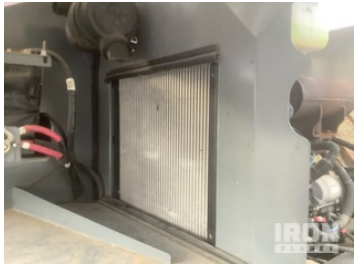
| Engine | | |
|---|---|---|
| Radiator | ★★★★☆ | |

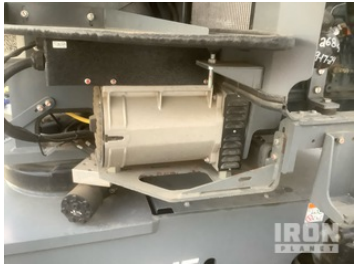
| Engine | | |
|---|---|---|
| Onboard Generator | Not operationally checked | |

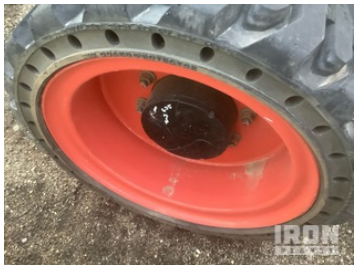
| Item | Assessment | Photo |
|---|---|---|
| Left Front Final Drive | ★★★★☆ | |

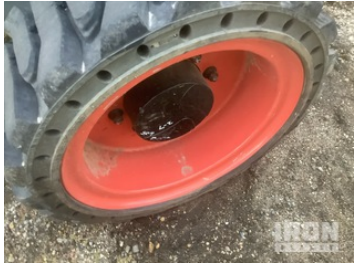
| Item | Assessment | Photo |
|---|---|---|
| Left Rear Final Drive | ★★★★☆ | |

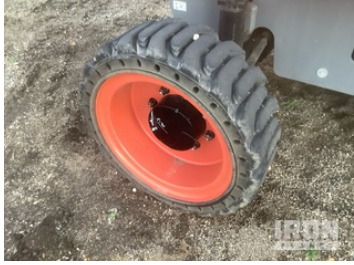
| Item | Assessment | Photo |
|---|---|---|
| Right Rear Final Drive | ★★★★☆ | |

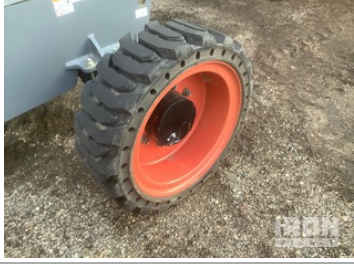
| Item | Assessment | Photo |
|---|---|---|
| Right Front Final Drive | ★★★★☆ | |

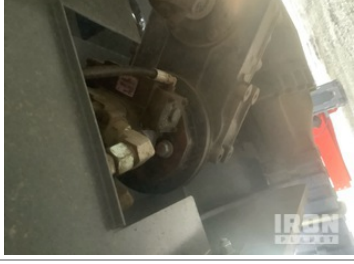
| Item | Assessment | Photo |
|---|---|---|
| Front Center Drive Motor | ★★★★☆ | |

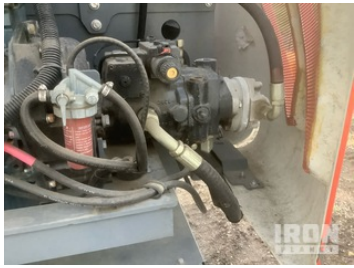
| Hydraulics | | |
|---|---|---|
| Pumps (Hydraulics) | ★★★★☆ | |

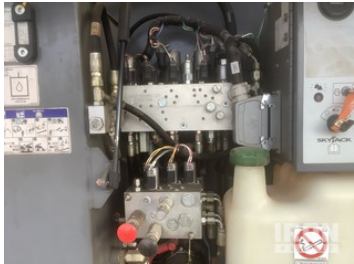
| Hydraulics | | |
|---|---|---|
| Valves | ★★★★☆ | |

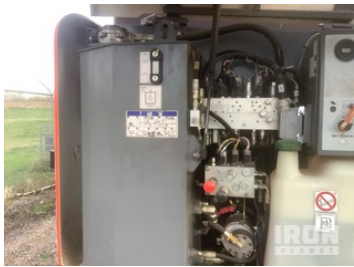
| Hydraulics | | |
|---|---|---|
| Hydraulic Tank | ★★★★☆ | |

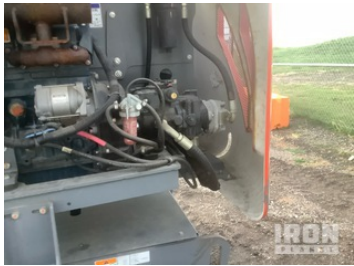
| Hydraulics | | |
|---|---|---|
| Hoses (Hydraulic) | ★★★★☆ | |

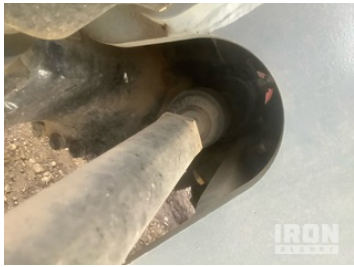
| Hydraulics | | |
|---|---|---|
| Steering Cylinders | ★★★★☆ | |

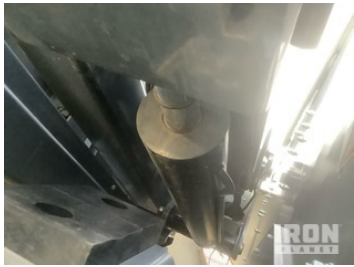
| Hydraulics | | |
|---|---|---|
| Boom Lift Cylinder | ★★★★☆ | |

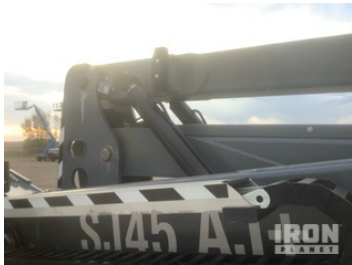
| Secondary Boom Cylinder | ★★★★☆ | |

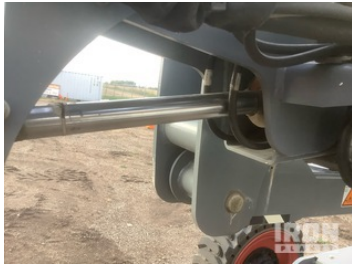
| Jib Cylinder | ★★★★☆ | |

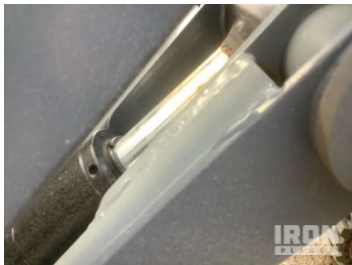
| Basket Tilt Cylinder | ★★★★☆ | |

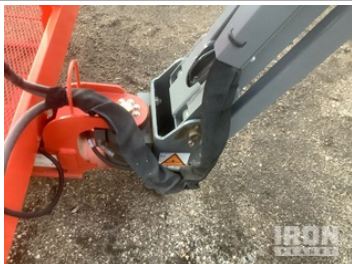
| Basket Rotator Motor | ★★★★☆ | |

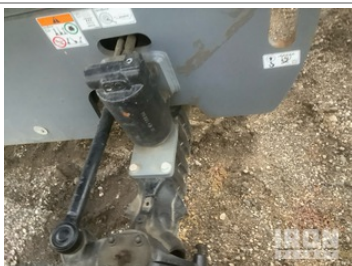
| Frame Leveling Cylinders | ★★★★☆ | |

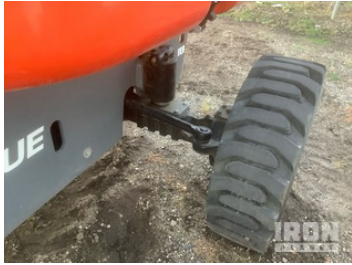
| Chassis | | |
|---|---|---|
| Steering Linkage | ★★★★☆ | |

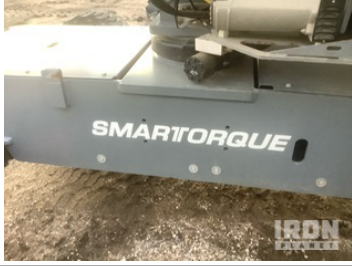
| Chassis | | |
|---|---|---|
| Frame Condition | ★★★★☆ | |

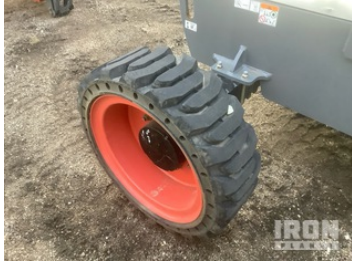
| Chassis | | |
|---|---|---|
| Left Front Tire | No visible defects | |

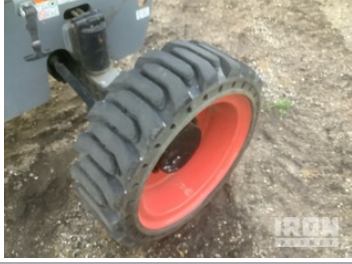
| Chassis | | |
|---|---|---|
| Left Rear Tire | No visible defects | |

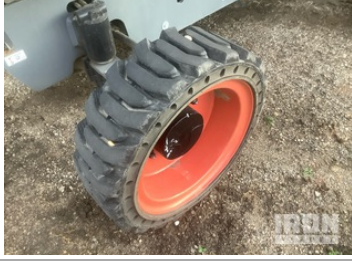
| Chassis | | |
|---|---|---|
| Right Rear Tire | No visible defects | |

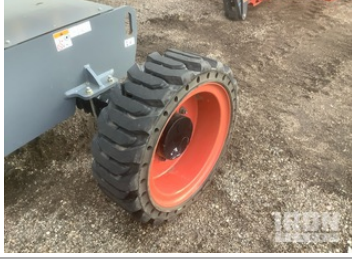
| Chassis | | |
|---|---|---|
| Right Front Tire | No visible defects | |

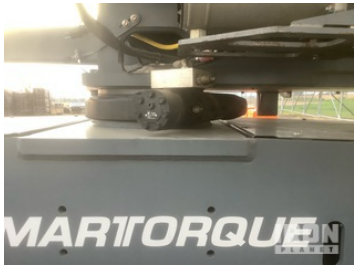
| Turntable Bearing | ★★★★☆ | |

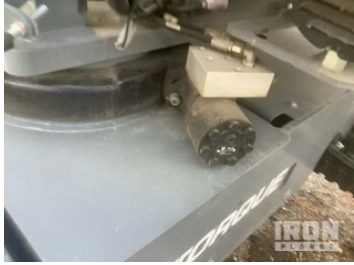
| Swing Motor | ★★★★☆ | |

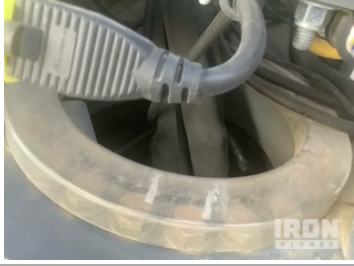
| Hydraulic Center Swivel | ★★★★☆ | |

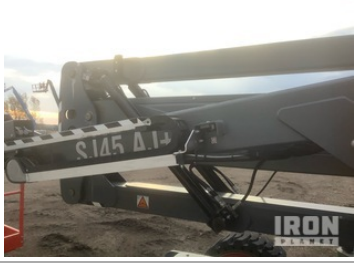
| Boom Condition | ★★★★☆ | |

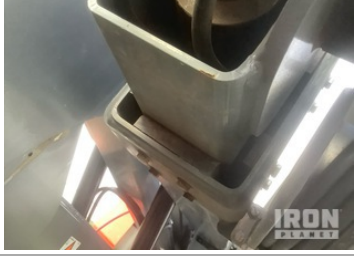
| Boom Wear Guides | ★★★★☆ | |

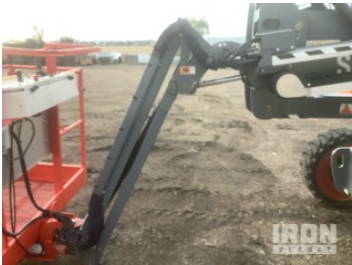
| Jib Condition | ☆☆☆☆ | |
