Item #14301233 - 2017 Skyjack SJ46AJ 4WD Dual Fuel Articulating Boom Lift

Inspection Report

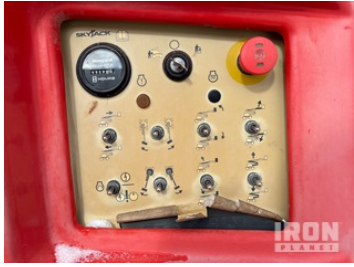
Control Station Ground		
Item	Assessment	Photo
Function Controls	★★★☆☆

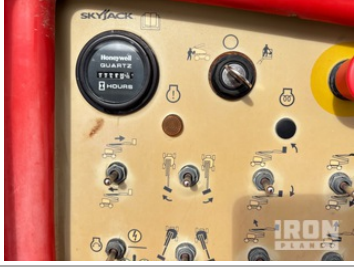
Warning Lights	Inoperable

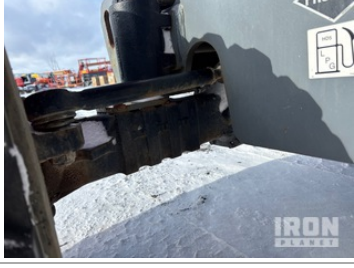
Steering Linkage	★ ★ ★ ☆

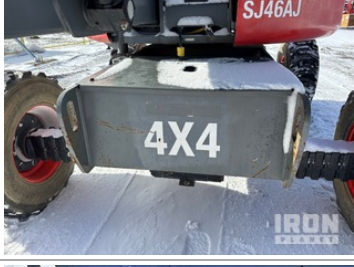
Frame Condition	★ ★ ★ ☆

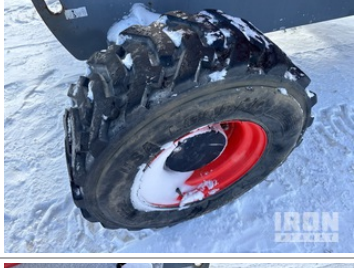
Left Front Tire	Cracks

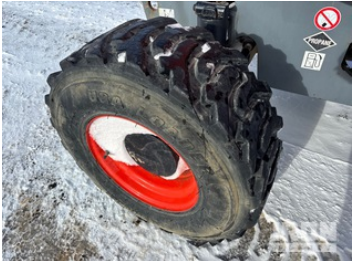
Right Rear Tire	Cracks

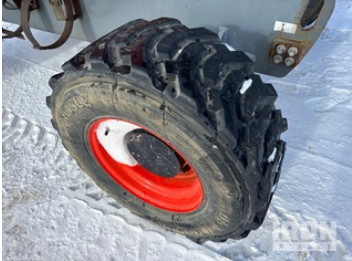
Right Front Tire	Cracks
