Item #14177566 - 2022 Skyjack SJ45 AJ 4WD Diesel Articulating Boom Lift

Inspection Report

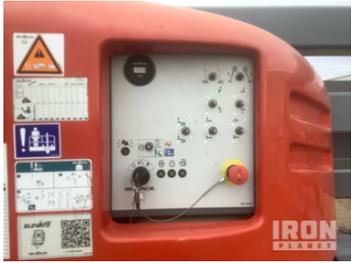
Control Station Ground		
Item	Assessment	Photo
Function Controls	★ ★ ★ ☆

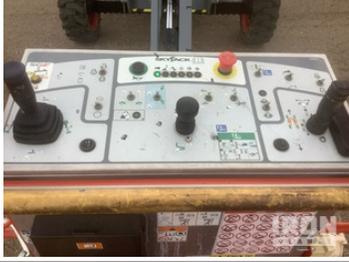
Control Station		
Pin connection pivot point wear inspections are limited to sound, sight and feel observations. Dial indicator testing is not performed.		
Item	Assessment	Photo
Control Console	No visible damage or missing components

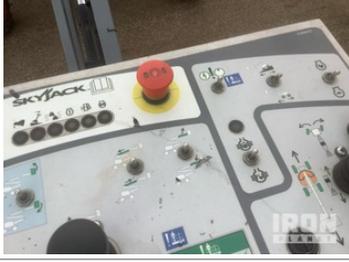
Emergency Shut Off Switch	Operational

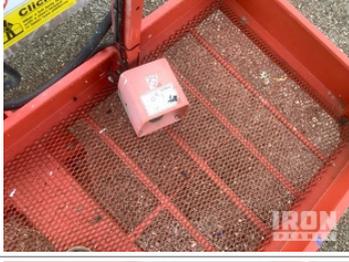
Safety Control Hand/Foot Switch	★★★★☆ Operational

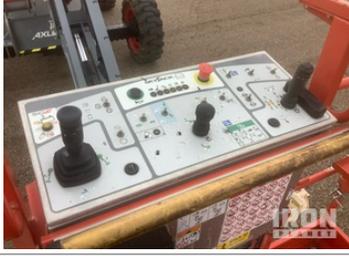
Function Controls	★★★★☆

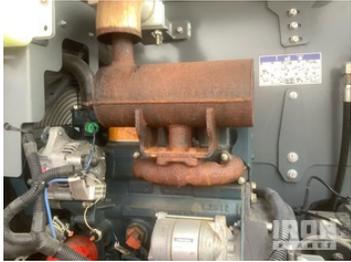
Engine		
Item	Assessment	Photo
Starter	Operational	
Fuel System	Operational	
Exhaust System	No visible damage or missing components

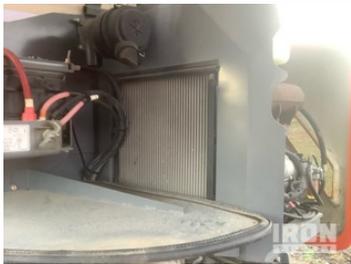
Radiator	★★★★☆

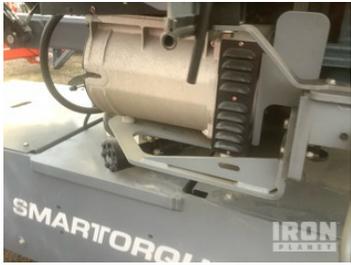
Oil Leaks	No dripping leaks	
Onboard Generator	Not operationally checked

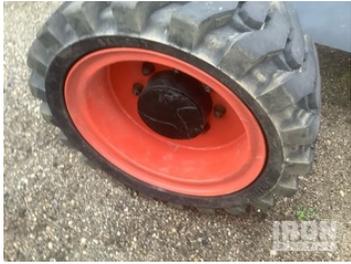
Drivetrain		
Operational test is limited to low speed in a confined flat area without load. Differential interlocks, full transmission shifting and functionality of all drive axles cannot be fully verified. Inspector listens for abnormal noises, observes leaks and notes physical damage.		
Item	Assessment	Photo
Left Front Final Drive	★ ★ ★ ☆

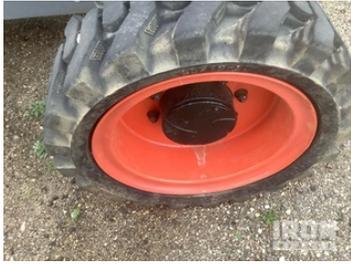
Left Rear Final Drive	★ ★ ★ ☆

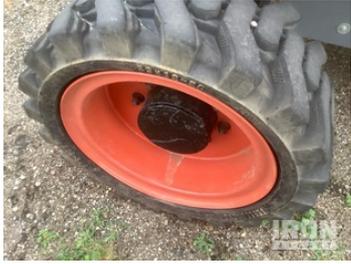
Right Rear Final Drive	★ ★ ★ ☆

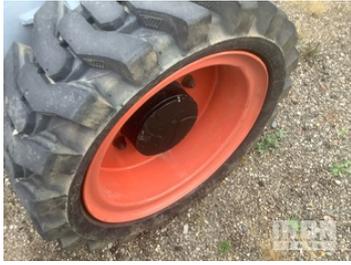
Right Front Final Drive	★ ★ ★ ☆

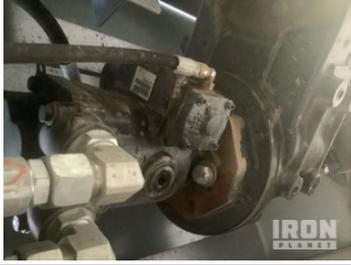
Front Center Drive Motor	★ ★ ★ ☆

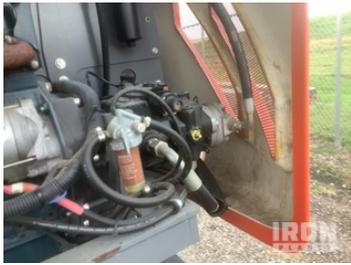
<h2>Hydraulics</h2>		
See photos for condition		
Item	Assessment	Photo
Pumps (Hydraulics)	★ ★ ★ ☆

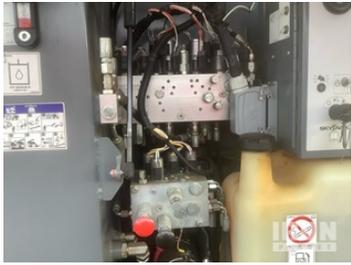
Valves	★ ★ ★ ☆

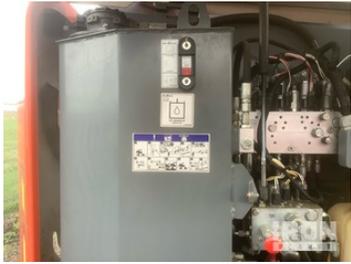
Hydraulic Tank	★ ★ ★ ☆

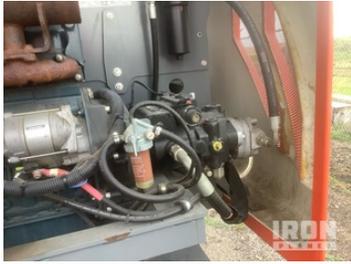
Hoses (Hydraulic)	★ ★ ★ ☆

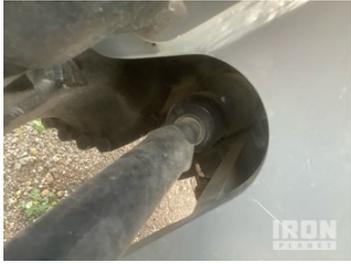
Steering Cylinders	★ ★ ★ ☆

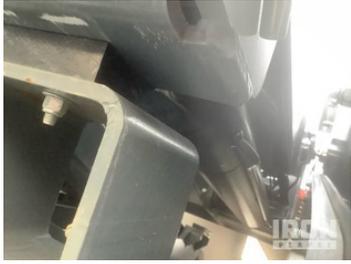
Boom Lift Cylinder	★ ★ ★ ☆

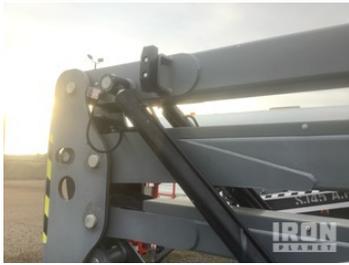
Secondary Boom Cylinder	★★☆☆

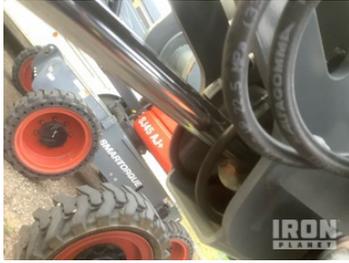
Boom Extension Cylinder	★★☆☆	
Jib Cylinder	★★☆☆

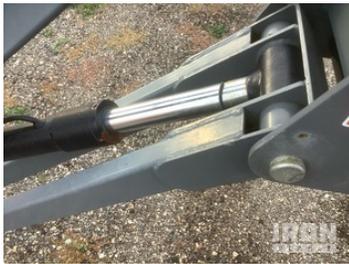
Basket Tilt Cylinder	★★☆☆

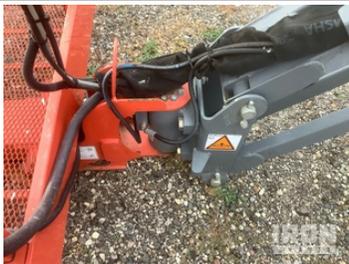
Basket Rotator Motor	★★☆☆

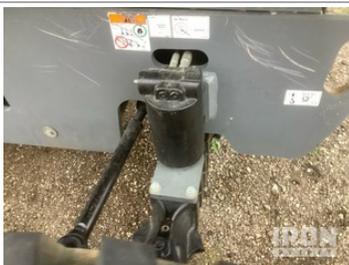
Frame Leveling Cylinders	★★☆☆

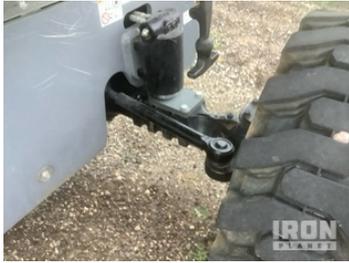
Chassis		
Item	Assessment	Photo
Steering Linkage	★★★★☆

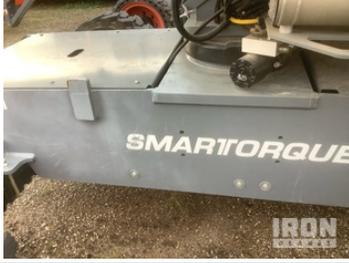
Frame Condition	★★★★☆

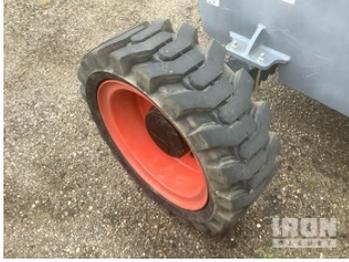
Brake System	★★★★☆ The brake system functioned, stopping and holding the machine.	
Left Front Tire	No visible defects

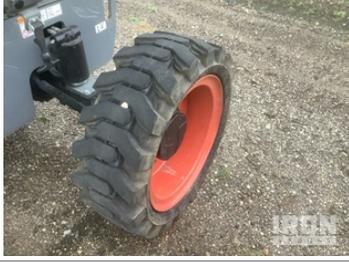
Left Rear Tire	No visible defects

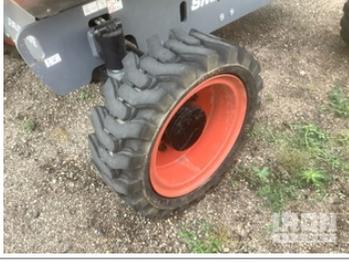
Right Rear Tire	No visible defects

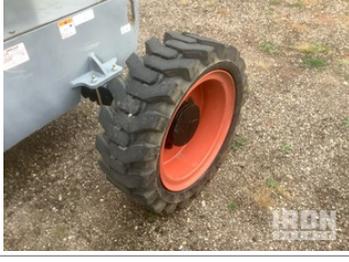
Right Front Tire	No visible defects

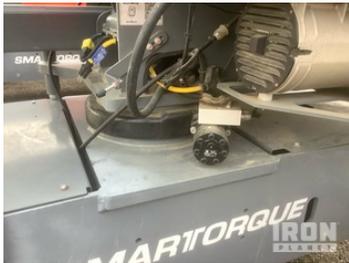
Turntable Bearing	★★★★☆

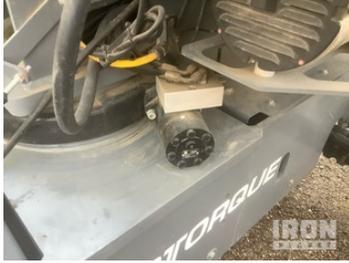
Swing Motor	★★★★☆

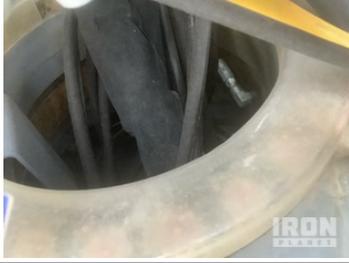
Hydraulic Center Swivel	★★★★☆

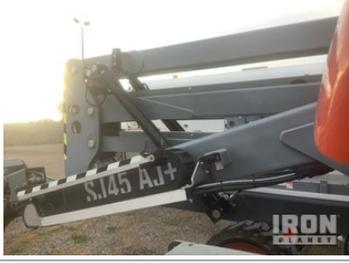
Boom Condition	★★★★☆

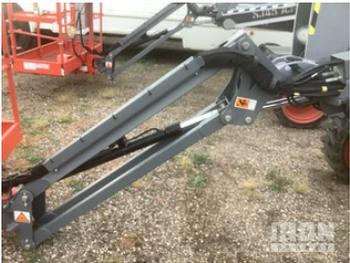
Jib Condition	★★★★☆
