## Item #14339882 - 2017 Genie Z45/45J 4WD Dual Fuel Articulating Boom Lift

# Inspection Report

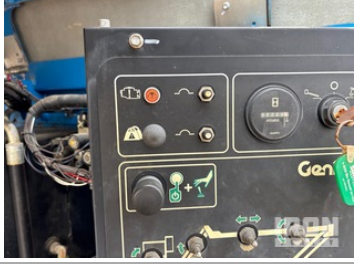
| Control Station Ground | | |
|---|---|---|
| Oil Pressure | No oil pressure indicator | |

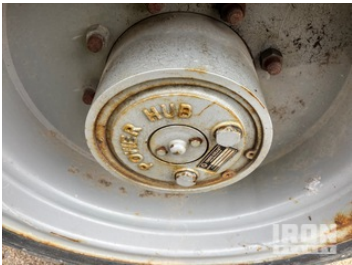
| Right Front Final Drive | ☆☆☆☆ | |

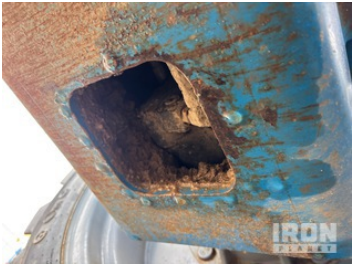
| Right Front Drive Motor | ☆☆☆☆ | |

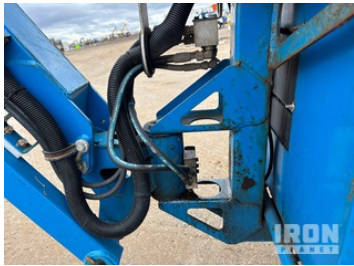
| Basket Rotator Motor | ★★★☆☆<br>Dripping leak | |

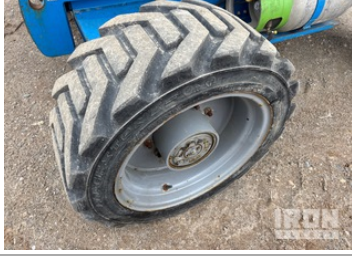
| Chassis | | |
|---|---|---|
| Left Front Tire | Chunks missing, Tears | |

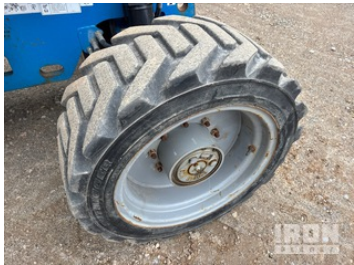
| Left Rear Tire | Tears | |

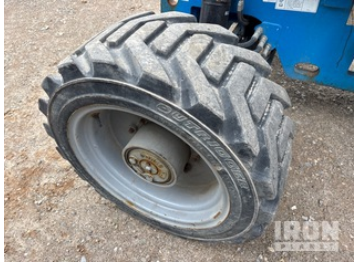
| Right Rear Tire | Cracks, Tears | |

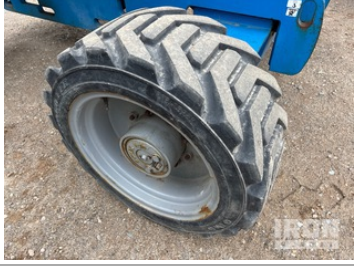
| Right Front Tire | Cracks | |
