## Item #14177569 - 2022 Skyjack SJ45 AJ 4WD Diesel Articulating Boom Lift

# Inspection Report

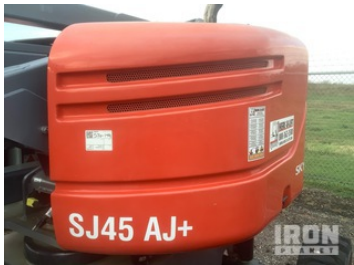
| Paint | No visible damage | |

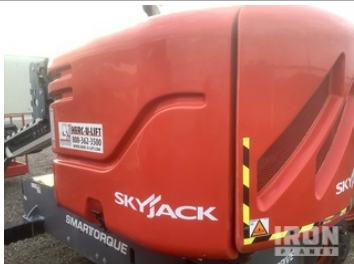
| Body Panels | No visible damage or missing components | |

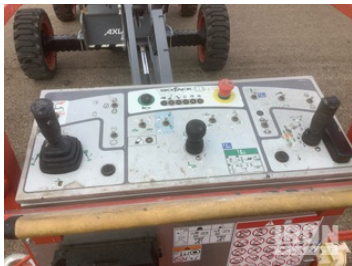
| Item | Assessment | Photo |
|---|---|---|
| Control Console | No visible damage or missing components | |

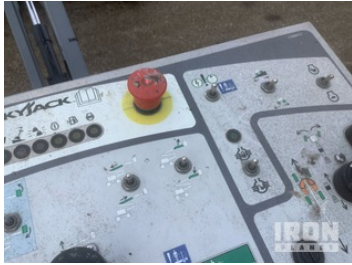
| Item | Assessment | Photo |
|---|---|---|
| Emergency Shut Off Switch | Operational | |

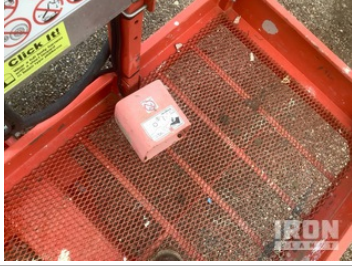
| Item | Assessment | Photo |
|---|---|---|
| Safety Control Hand/Foot Switch | ★★★★☆<br>Operational | |

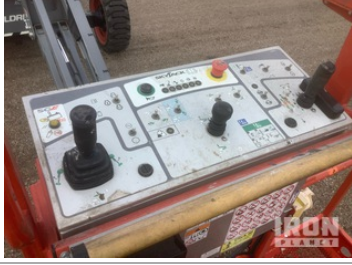
| Item | Assessment | Photo |
|---|---|---|
| Function Controls | ★★★★☆ | |

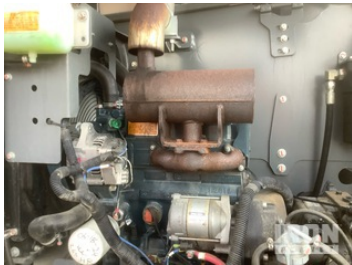
| Engine | | |
|---|---|---|
| Exhaust System | No visible damage or missing components | |

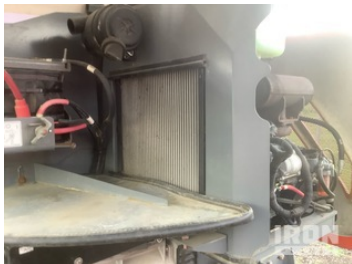
| Engine | | |
|---|---|---|
| Radiator | ★★★★☆ | |

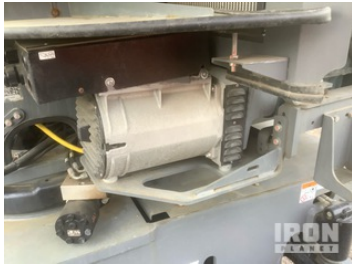
| Engine | | |
|---|---|---|
| Onboard Generator | Not operationally checked | |

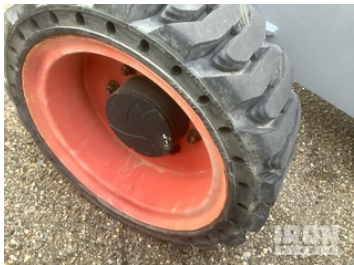
| Item | Assessment | Photo |
|---|---|---|
| Left Front Final Drive | ★★★★☆ | |

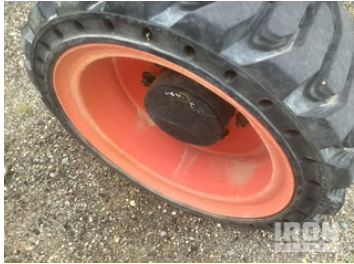
| Item | Assessment | Photo |
|---|---|---|
| Left Rear Final Drive | ★★★★☆ | |

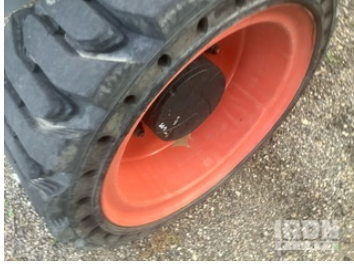
| Item | Assessment | Photo |
|---|---|---|
| Right Rear Final Drive | ★★★★☆ | |

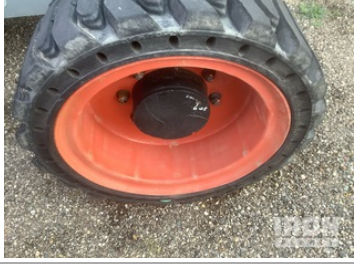
| Item | Assessment | Photo |
|---|---|---|
| Right Front Final Drive | ★★★★☆ | |

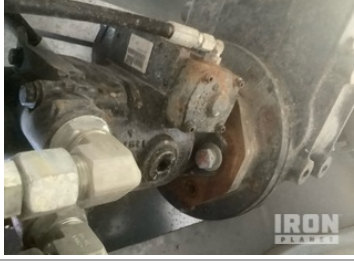
| Item | Assessment | Photo |
|---|---|---|
| Front Center Drive Motor | ★★★★☆ | |

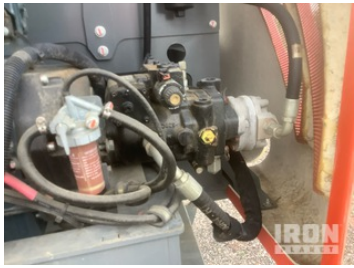
| Hydraulics | | |
|---|---|---|
| Pumps (Hydraulics) | ★★★★☆ | |

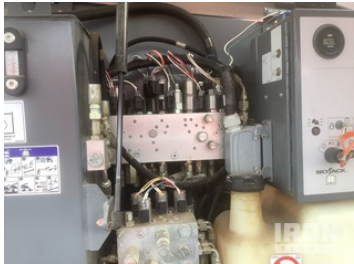
| Hydraulics | | |
|---|---|---|
| Valves | ★★★★☆ | |

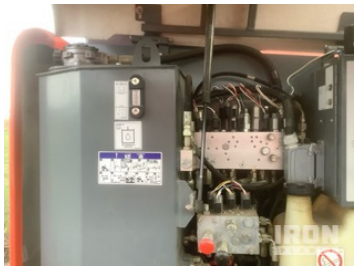
| Hydraulics | | |
|---|---|---|
| Hydraulic Tank | ★★★★☆ | |

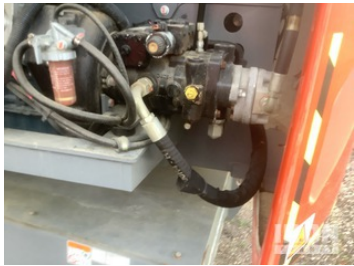
| Hydraulics | | |
|---|---|---|
| Hoses (Hydraulic) | ★★★★☆ | |

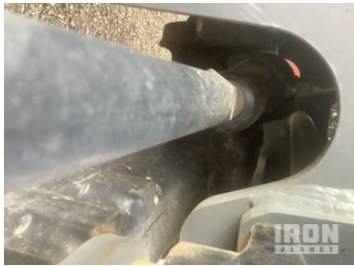
| Hydraulics | | |
|---|---|---|
| Steering Cylinders | ★★★★☆ | |

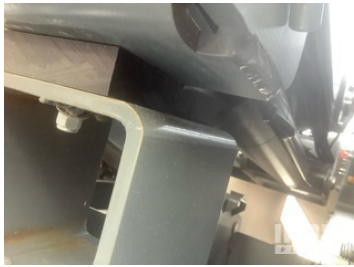
| Hydraulics | | |
|---|---|---|
| Boom Lift Cylinder | ★★★★☆ | |

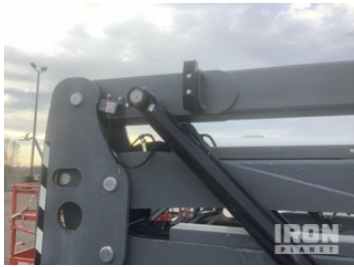
| Secondary Boom Cylinder | ★★★★☆ | |

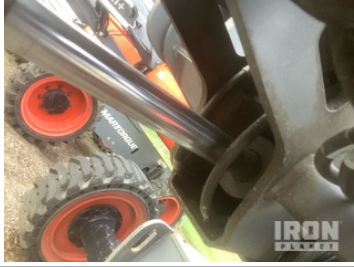
| Jib Cylinder | ★★★★☆ | |

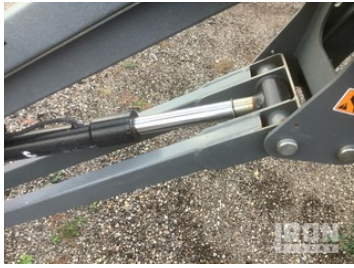
| Basket Tilt Cylinder | ★★★★☆ | |

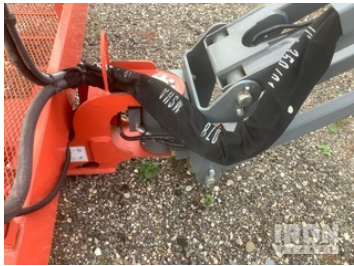
| Basket Rotator Motor | ★★★★☆ | |

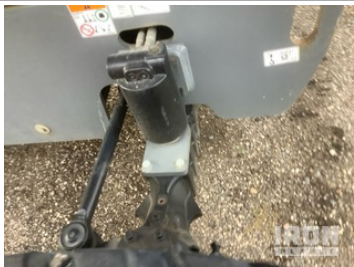
| Frame Leveling Cylinders | ★★★★☆ | |

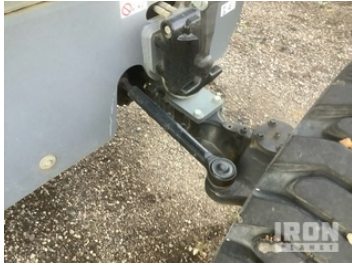
| Chassis | | |
|---|---|---|
| Steering Linkage | ★★★★☆ | |

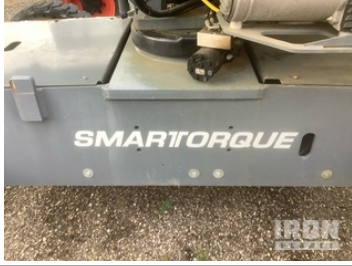
| Chassis | | |
|---|---|---|
| Frame Condition | ★★★★☆ | |

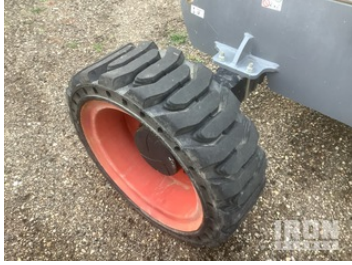
| Chassis | | |
|---|---|---|
| Left Front Tire | No visible defects | |

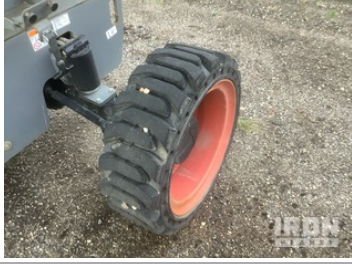
| Chassis | | |
|---|---|---|
| Left Rear Tire | No visible defects | |

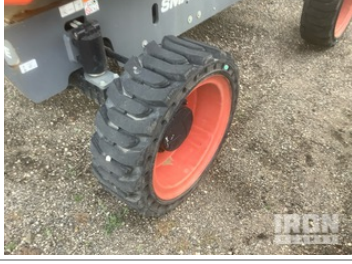
| Chassis | | |
|---|---|---|
| Right Rear Tire | No visible defects | |

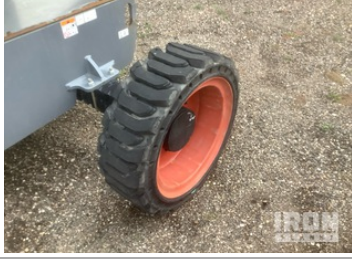
| Chassis | | |
|---|---|---|
| Right Front Tire | Cracks | |

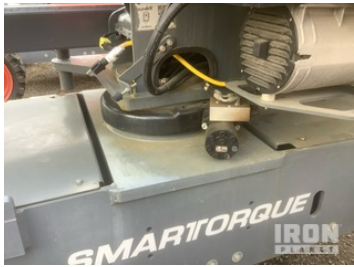
| Turntable Bearing | ★★★★☆ | |

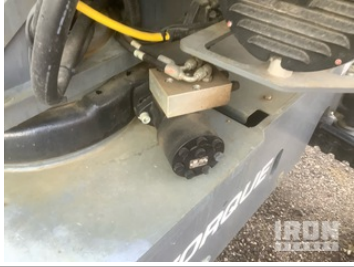
| Swing Motor | ★★★★☆ | |

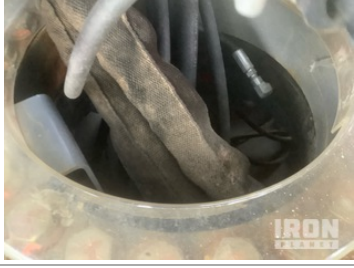
| Hydraulic Center Swivel | ★★★★☆ | |

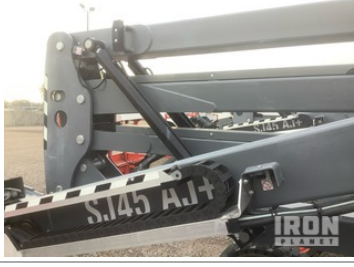
| Boom Condition | ★★★★☆ | |

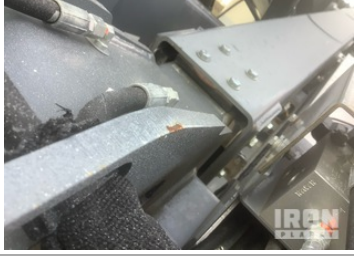
| Boom Wear Guides | ★★★★☆ | |
