## Item #14340564 - 2017 Genie Z-30/20N RJ 2WD Electric Articulating Boom Lift

- Features: 29 ft 2 in Max Platform Height, 500 lb Max Weight Capacity, Jib, Power to Platform, 22x7x17 3/4 Non-Marking Tires
- Meter Reading: 381 Hours
- Serial # : Z30NF-19645
- Inspection Completed: 11/24/25

# Inspection Report

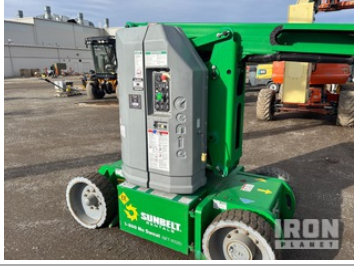
| Paint | No visible damage | |

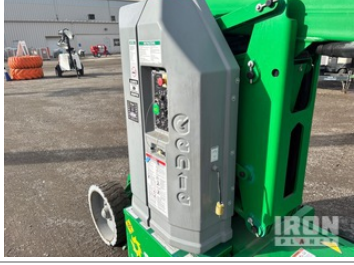
| Body Panels | No visible damage or missing components | |

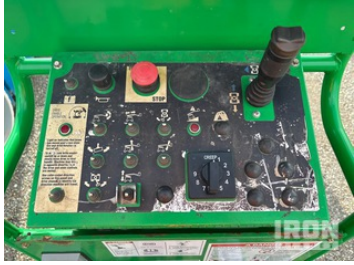
| Item | Assessment | Photo |
|---|---|---|
| Control Console | No visible damage or missing components | |

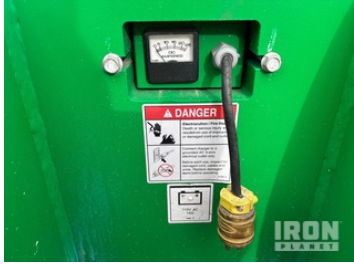
| Electrical Operating System | | |
|---|---|---|
| Battery Charger | Appears normal - Not operationally checked, 115 Volt | |

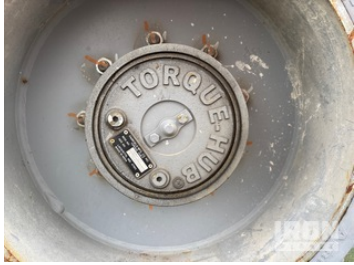
| Item | Assessment | Photo |
|---|---|---|
| Left Front Final Drive | ★★★★☆ | |

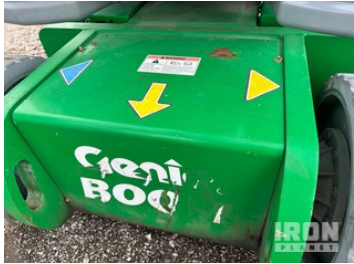
| Item | Assessment | Photo |
|---|---|---|
| Left Front Drive Motor | ★★★★☆ | |

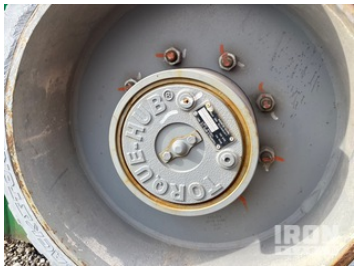
| Item | Assessment | Photo |
|---|---|---|
| Right Front Final Drive | ★★★★☆ | |

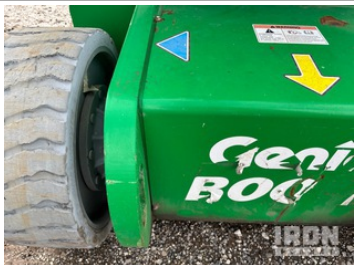
| Item | Assessment | Photo |
|---|---|---|
| Right Front Drive Motor | ★★★★☆ | |

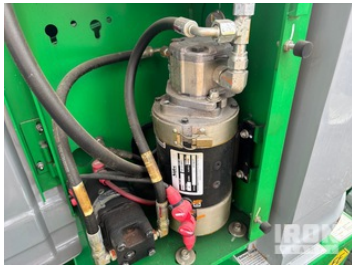
| Hydraulics | | |
|---|---|---|
| Pumps (Hydraulics) | ★★★★☆ | |

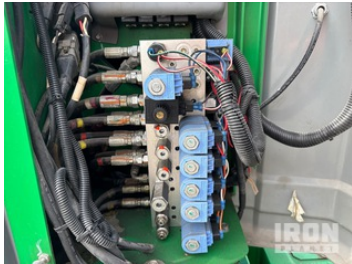
| Hydraulics | | |
|---|---|---|
| Valves | ★★★★☆ | |

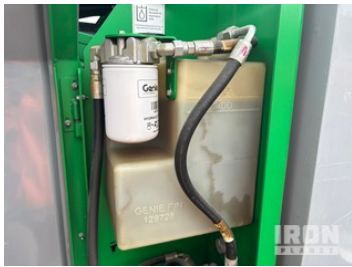
| Hydraulics | | |
|---|---|---|
| Hydraulic Tank | ★★★★☆ | |

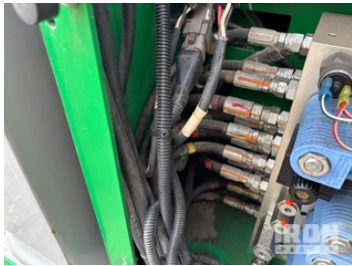
| Hydraulics | | |
|---|---|---|
| Hoses (Hydraulic) | ★★★★☆ | |

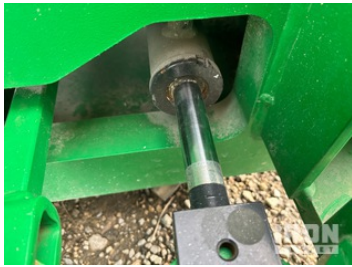
| Hydraulics | | |
|---|---|---|
| Steering Cylinders | ★★★★☆ | |

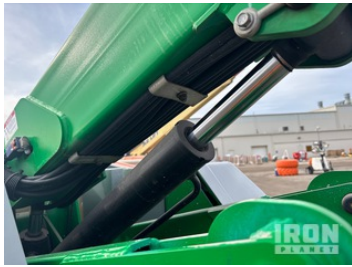
| Hydraulics | | |
|---|---|---|
| Boom Lift Cylinder | ★★★★☆ | |

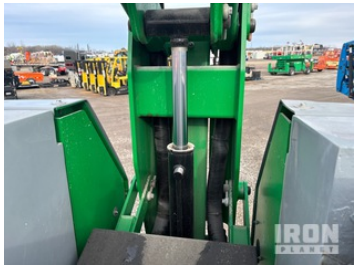
| Secondary Boom Cylinder | ★★★★☆ | |

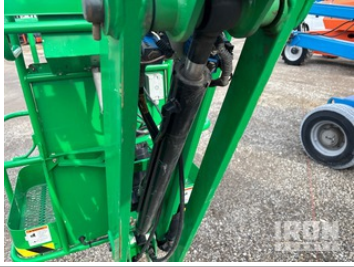
| Jib Cylinder | ★★★★☆ | |

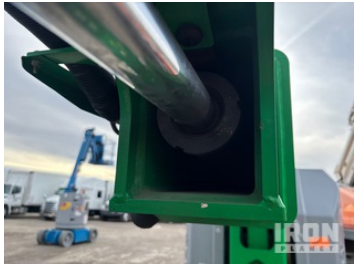
| Basket Tilt Cylinder | ★★★★☆ | |

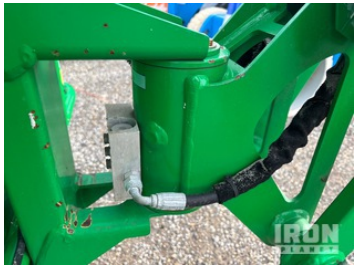
| Basket Rotator Motor | ★★★★☆ | |

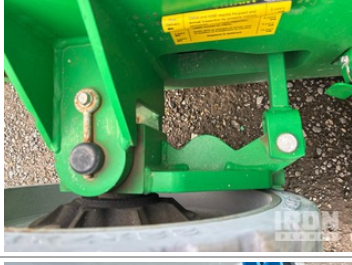
| Steering Linkage | ★★★★☆ | |

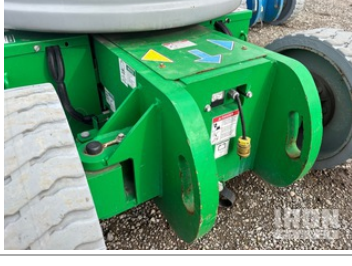
| Frame Condition | ★★★★☆ | |

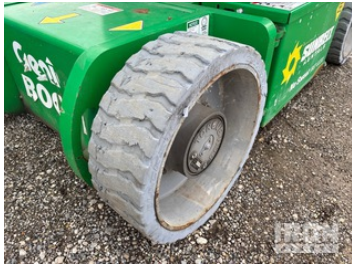
| Left Front Tire | Cracks, Chunks missing, Tears | |

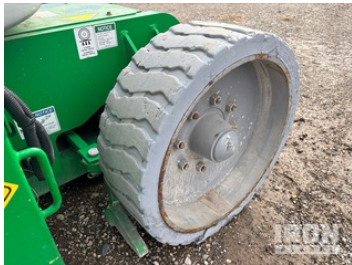
| Left Rear Tire | Cracks, Chunks missing, Tears | |

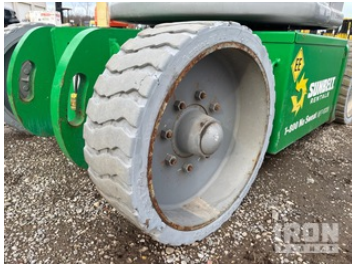
| Right Rear Tire | Cracks, Chunks missing, Tears | |

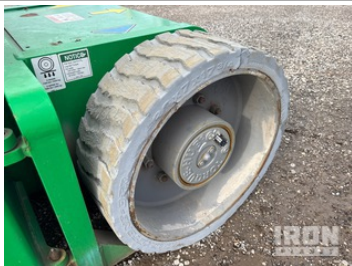
| Right Front Tire | Cracks, Chunks missing, Tears | |

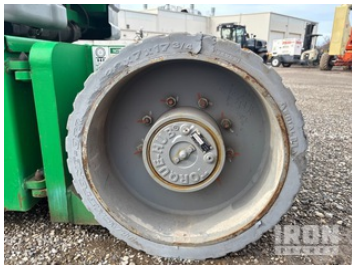
| Wheel Condition | No visible damage or missing components | |

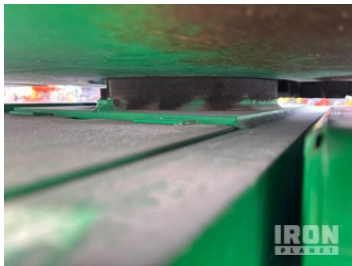
| Turntable Bearing | ★★☆☆ | |

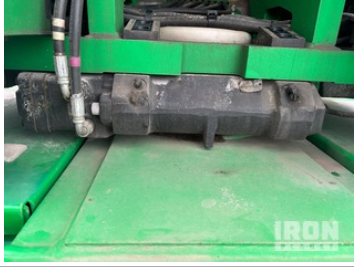
| Swing Motor | ★★★★☆ | |

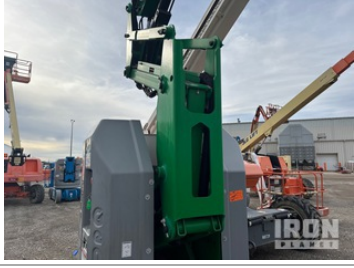
| Boom Condition | ★★★★☆ | |

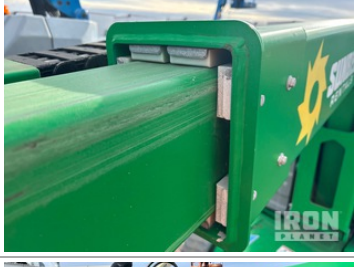
| Boom Wear Guides | ★★★★☆ | |

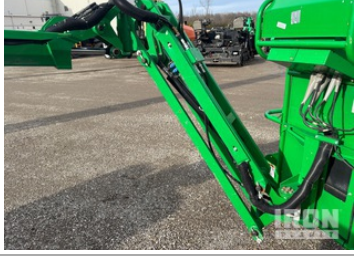
| Jib Condition | ★★★★☆ | |
