## Item #13810845 - 2016 JLG 600AJ 4WD Diesel Articulating Boom Lift

## Inspection Report

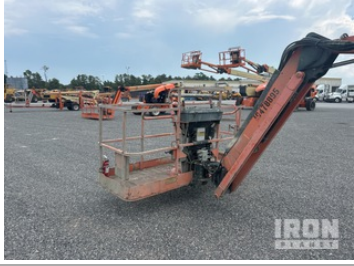
| Paint | Concrete residue Anus chipped and scratched, and some of the paints coming off one of the doors | |

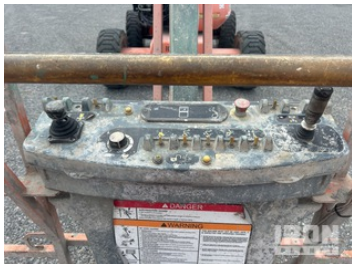
| Item | Assessment | Photo |
|---|---|---|
| Function Controls | ★★★★☆ | |
| Limited Function Check | The main components are in place and operational as noted. Has concrete all over | |

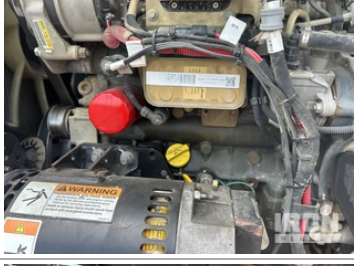
| Engine | | |
|---|---|---|
| Oil Leaks | Side of engine | |

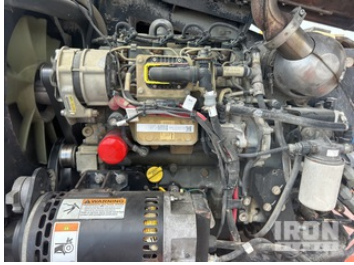
| Limited Function Check | The engine started and ran. Carter has a bad vibration and a noise | |

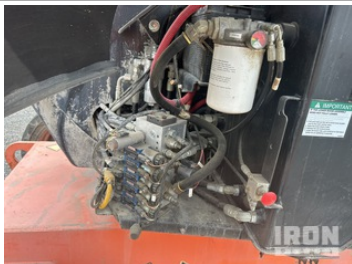
| Hydraulics | | |
|---|---|---|
| Hoses (Hydraulic) | ★★★☆☆<br>Some hoses are dry rotted | |

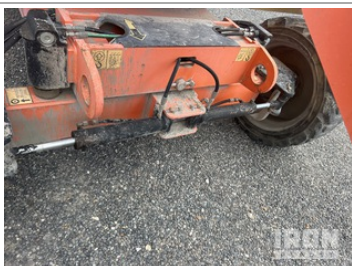
| Hydraulics | | |
|---|---|---|
| Steering Cylinders | ★★★☆☆<br>Dripping leak on the left cylinder,<br>Dripping leak on the right cylinder | |

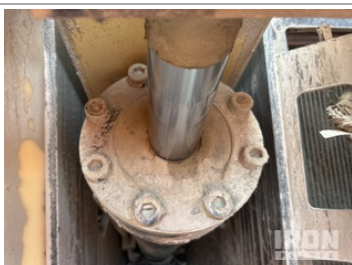
| Hydraulics | | |
|---|---|---|
| Boom Lift Cylinder | On e is leaking | |

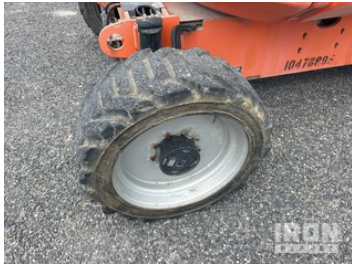
| Chassis | | |
|---|---|---|
| Left Front Tire | Cracks, Chunks missing, Tears | |

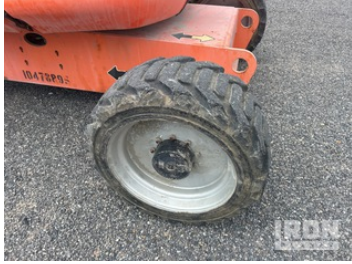
| Chassis | | |
|---|---|---|
| Left Rear Tire | Cracks, Chunks missing, Tears | |

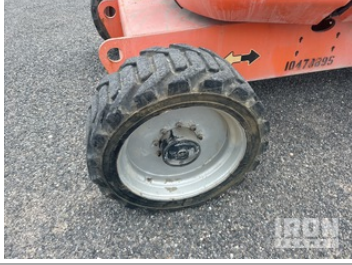
| Chassis | | |
|---|---|---|
| Right Rear Tire | Cracks, Chunks missing, Tears | |

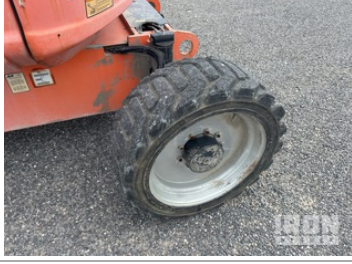
| Chassis | | |
|---|---|---|
| Right Front Tire | Cracks, Chunks missing, Tears | |

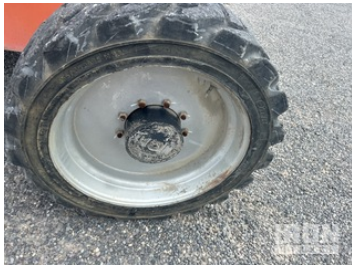
| Wheel Condition | Left front bent, Right front bent, Right rear bent, Left rear bent | |

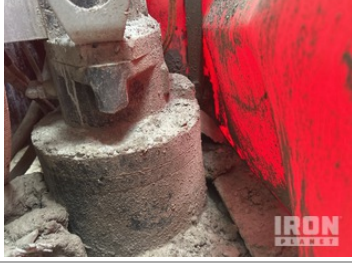
| Swing Motor | ★★★☆☆<br>Has concrete on it | |

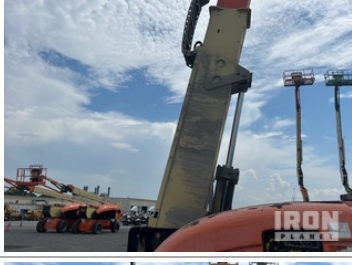
| Boom Condition | ★★★☆☆<br>As concrete all over it | |

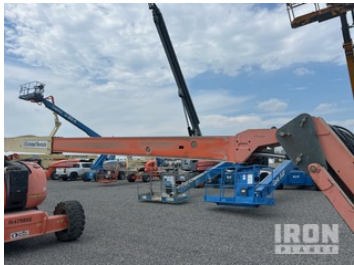
| Right Side of Boom | Has concrete on it | |

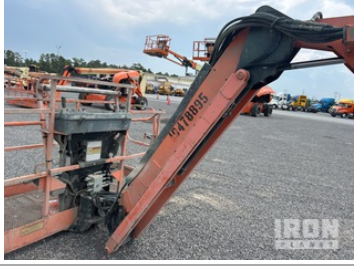
| Jib Condition | ★★☆☆☆<br>Has a cover bent | |

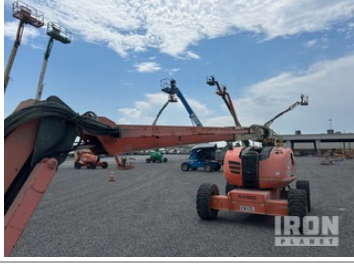
| Cable Tray Ladder | Part of it is bent. | |

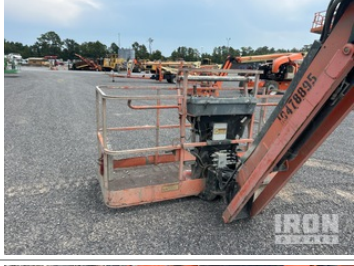
| Work Basket | Basket has bent up | |
