## Item #14251147 - 2008 Genie Z40/23N DC 2WD Electric Articulating Boom Lift

# Inspection Report

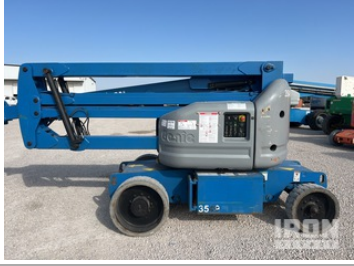
| Paint | No visible damage | |

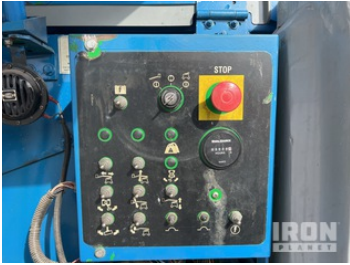
| Control Station Ground | | |
|---|---|---|
| Function Controls | ★★★★☆ | |

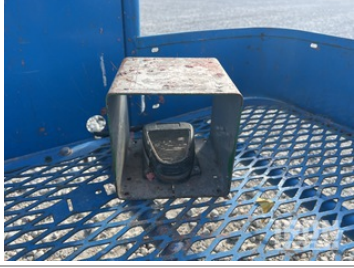
| Item | Assessment | Photo |
|---|---|---|
| Safety Control Hand/Foot Switch | ★★★★☆<br>Operational | |

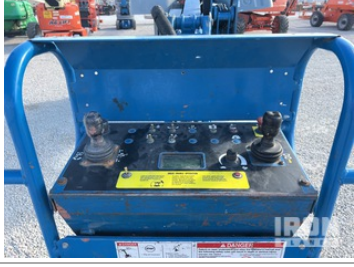
| Item | Assessment | Photo |
|---|---|---|
| Function Controls | ★★★★☆<br>Inoperable Switches, note variable speed dial Inop inoperable | |

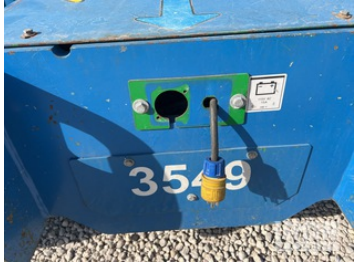
| Electrical Operating System | | |
|---|---|---|
| Battery Charger | Included Appears normal - Not operationally checked, 115 Volt, Single Phase | |

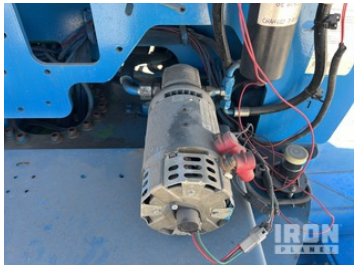
| Hydraulics | | |
|---|---|---|
| Pumps (Hydraulics) | ★★★★☆ | A close-up photograph of a hydraulic pump assembly mounted on a blue metal frame. The pump is a cylindrical unit with various hoses and electrical wiring connected to it. The 'IRON PLANET' logo is visible on the blue frame. |

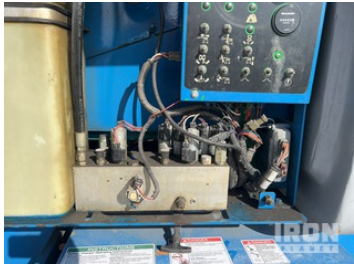
| Hydraulics | | |
|---|---|---|
| Valves | ★★★★☆ | A photograph showing a hydraulic valve manifold with multiple ports and hoses. It is mounted on a blue frame. A yellow hydraulic tank is partially visible on the left. The 'IRON PLANET' logo is visible on the blue frame. |

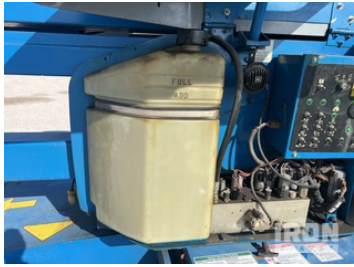
| Hydraulics | | |
|---|---|---|
| Hydraulic Tank | ★★★★☆ | A photograph of a yellow hydraulic tank with a 'FILL' cap. It is mounted on a blue frame. Various hoses and electrical components are visible around the tank. The 'IRON PLANET' logo is visible on the blue frame. |

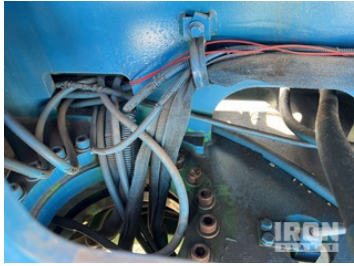
| Hydraulics | | |
|---|---|---|
| Hoses (Hydraulic) | ★★★★☆ | A photograph showing a bundle of hydraulic hoses and wires bundled together and secured with a metal strap. They are located within a blue metal structure. The 'IRON PLANET' logo is visible on the blue frame. |

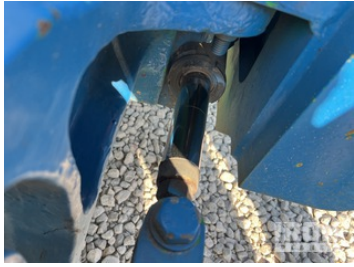
| Hydraulics | | |
|---|---|---|
| Steering Cylinders | ★★★★☆ | A photograph of a steering cylinder, which is a long, dark metal rod with a blue cap, mounted on a blue frame. The cylinder is surrounded by a protective mesh. The 'IRON PLANET' logo is visible on the blue frame. |

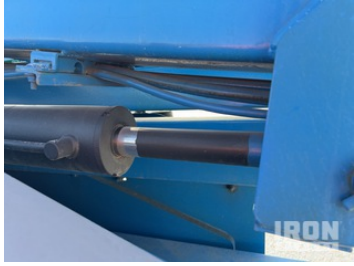
| Hydraulics | | |
|---|---|---|
| Boom Lift Cylinder | ★★★★☆ | A photograph of a boom lift cylinder, showing a long, dark metal rod with a blue cap, mounted on a blue frame. The 'IRON PLANET' logo is visible on the blue frame. |

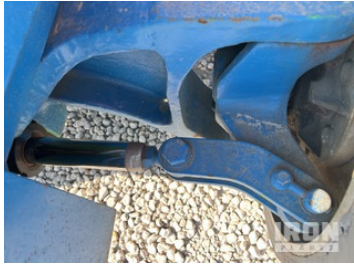
| Chassis | | |
|---|---|---|
| Steering Linkage | ★★★☆☆ | |

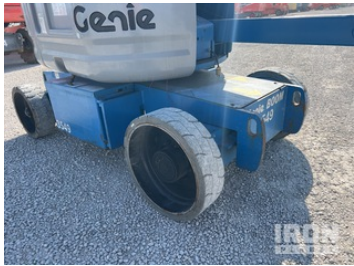
| Chassis | | |
|---|---|---|
| Frame Condition | ★★★☆☆ | |

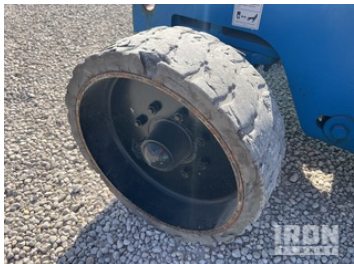
| Chassis | | |
|---|---|---|
| Left Front Tire | Cracks, Chunks missing, Tears | |

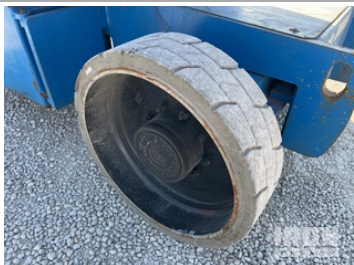
| Chassis | | |
|---|---|---|
| Left Rear Tire | Chunks missing, Tears | |

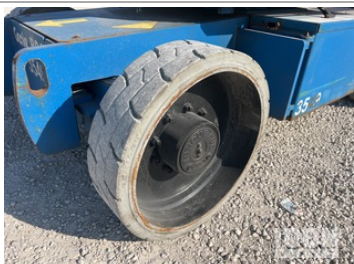
| Chassis | | |
|---|---|---|
| Right Rear Tire | Cracks, Chunks missing, Tears | |

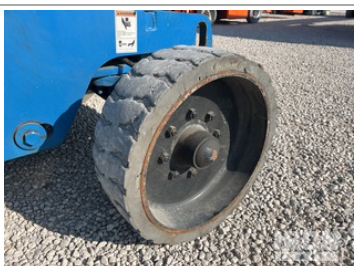
| Chassis | | |
|---|---|---|
| Right Front Tire | Cracks, Chunks missing, Tears | |

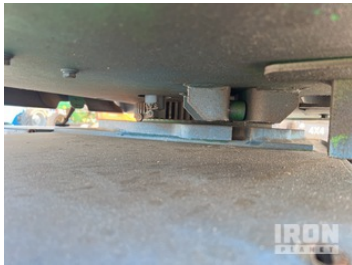
| Turntable Bearing | ★★★★☆ | |

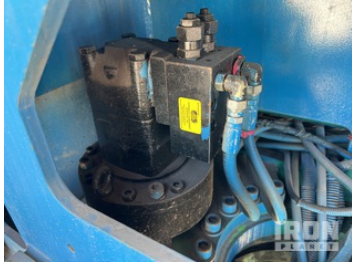
| Swing Motor | ★★★★☆ | |

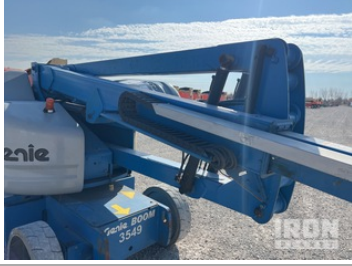
| Boom Condition | ★★★★☆ | |

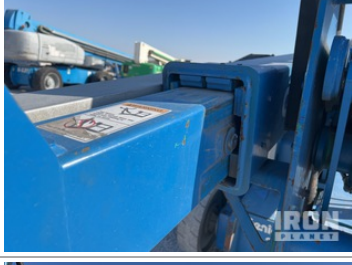
| Boom Wear Guides | ★★★★☆ | |

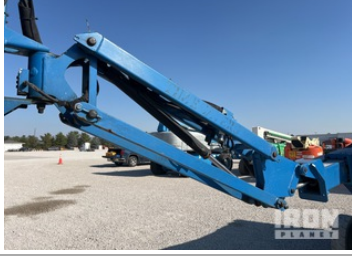
| Jib Condition | ★★★★☆ | |
