## Item #13810858 - 2016 JLG 600S 4WD Diesel Telescopic Boom Lift

# Inspection Report

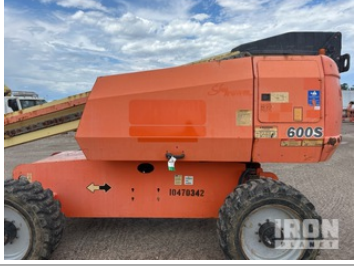
| Paint | Has a lot of rust on it | |

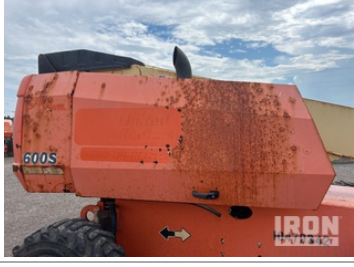
| Body Panels | Has a lot of rust on it | |

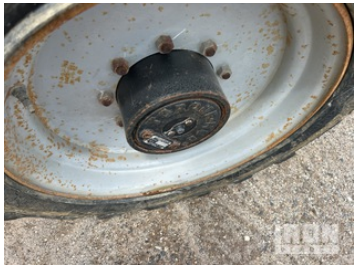
| Right Front Final Drive | ★ ★ ★ ☆ | |

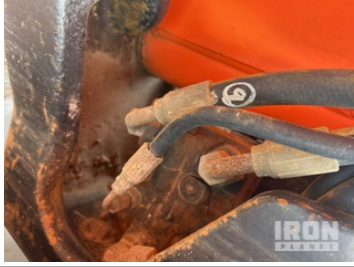
| Right Front Drive Motor | ★ ★ ★ ☆ | |

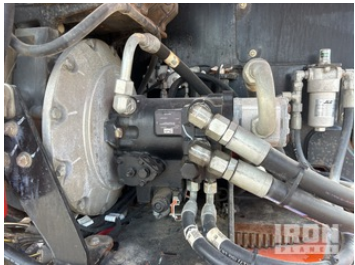
| Hydraulics | | |
|---|---|---|
| Pumps (Hydraulics) | ★★☆☆<br>Has residue on it | |

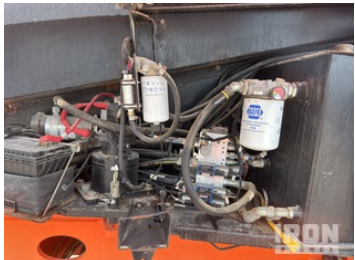
| Hydraulics | | |
|---|---|---|
| Hoses (Hydraulic) | ★★☆☆<br>Some of the hoses are dry rotted | |

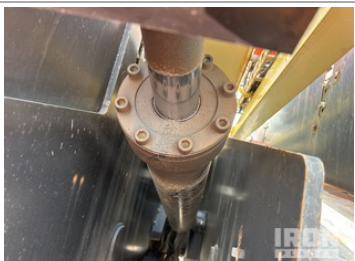
| Hydraulics | | |
|---|---|---|
| Boom Lift Cylinder | ★★☆☆<br>Dripping leak | |

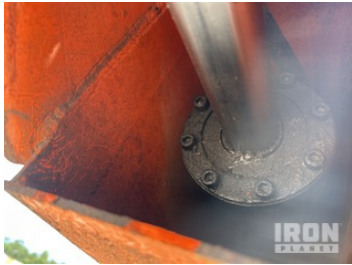
| Basket Tilt Cylinder | Dripping leak | |

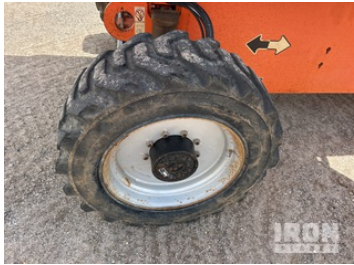
| Chassis | | |
|---|---|---|
| Left Front Tire | Cracks, Chunks missing, Tears | |

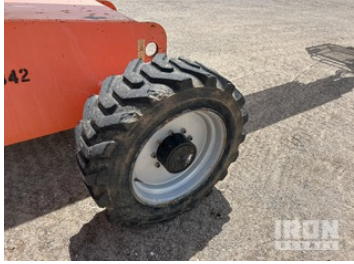
| Chassis | | |
|---|---|---|
| Left Rear Tire | Cracks, Chunks missing, Tears | |

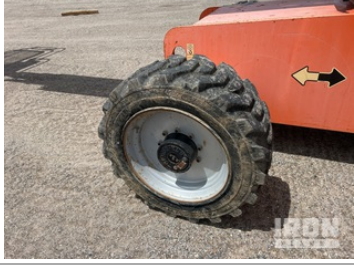
| Chassis | | |
|---|---|---|
| Right Rear Tire | Cracks, Chunks missing, Tears | |

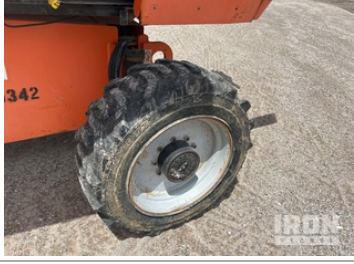
| Chassis | | |
|---|---|---|
| Right Front Tire | Cracks, Chunks missing, Tears | |

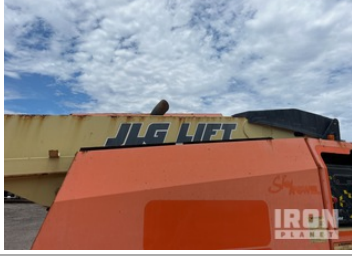
| Left Side of Boom | Has a lot of rust | |

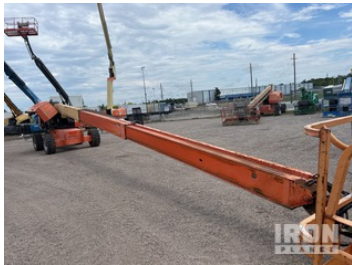
| Right Side of Boom | Has a lot of rust | |
