## Item #13811008 - 2016 JLG 800S 4WD Diesel Telescopic Boom Lift

# Inspection Report

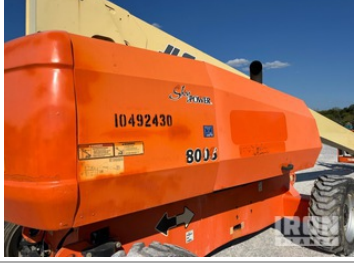
| Body Panels | Hydraulic compartment door damaged | |

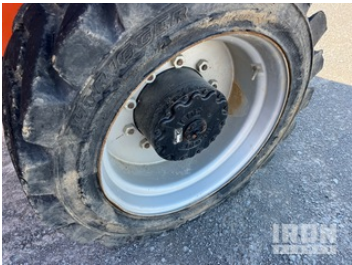
| Right Front Final Drive | ☆☆☆☆ | |

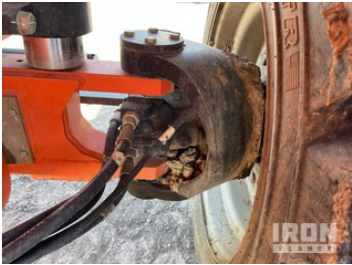
| Right Front Drive Motor | ☆☆☆☆ | |

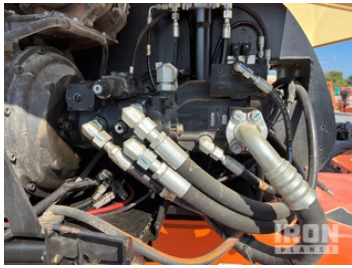
| Hydraulics | | |
|---|---|---|
| Pumps (Hydraulics) | ★★☆☆☆<br>Dripping leak | |

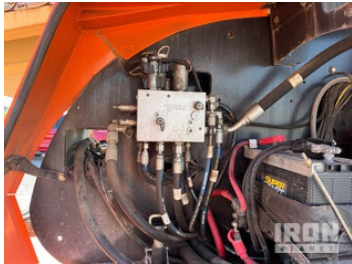
| Hydraulics | | |
|---|---|---|
| Valves | ★★☆☆☆<br>Dripping leak | |

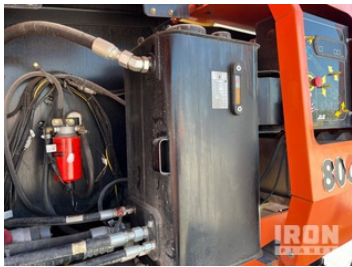
| Hydraulics | | |
|---|---|---|
| Hydraulic Tank | ★★★☆☆ | |

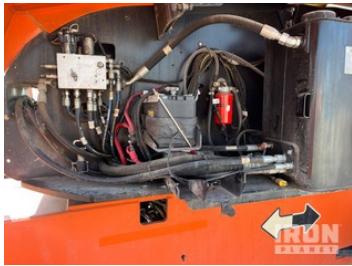
| Hydraulics | | |
|---|---|---|
| Hoses (Hydraulic) | ★★★☆☆ | |

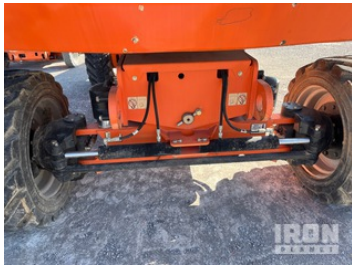
| Hydraulics | | |
|---|---|---|
| Steering Cylinders | ★★★☆☆ | |

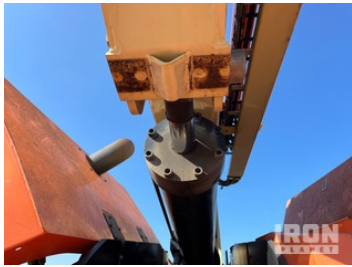
| Hydraulics | | |
|---|---|---|
| Boom Lift Cylinder | ★★★☆☆ | |

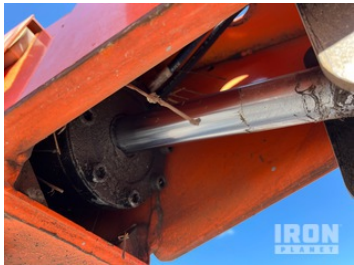
| Basket Tilt Cylinder | ★ ★ ★ ☆ | |

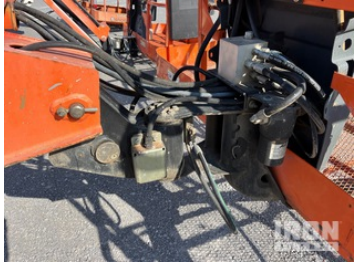
| Basket Rotator Motor | ★ ★ ★ ☆ | |

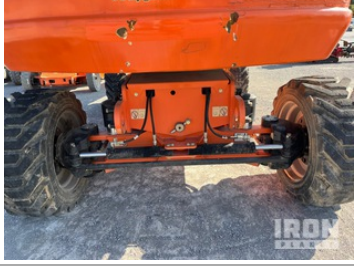
| Frame Leveling Cylinders | ★ ★ ★ ☆ | |

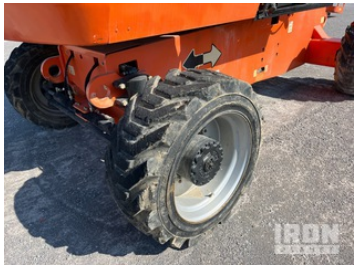
| Left Front Tire | Cracks, Flat spots | |

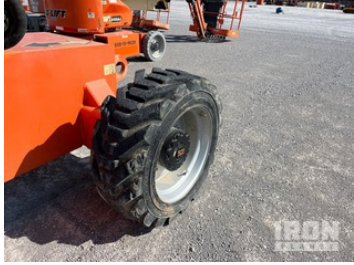
| Left Rear Tire | Cracks, Tears | |

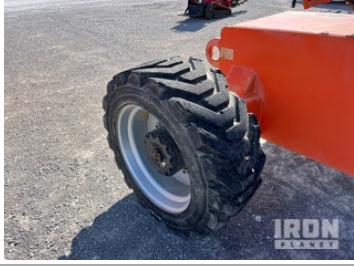
| Right Rear Tire | Cracks, Tears | |

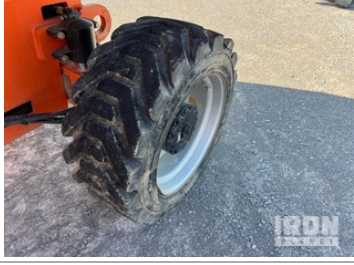
| Right Front Tire | Cracks, Tears | |
