## Item #13810892 - 2016 Skyjack SJ45T Dual Fuel Telescopic Boom Lift

- Features: 45 ft Max Platform Height, 500 lb Max Weight Capacity, Power to Platform, 4 Cylinder Dual Fuel Engine, 12-16.5 Tires
- Meter Reading: 4,539 Hours
- Serial # : 98001768
- Inspection Completed: 9/29/25

# Inspection Report

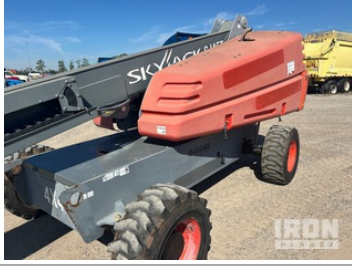
| Paint | No visible damage | |

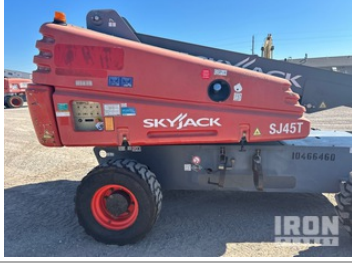
| Body Panels | No visible damage or missing components | |

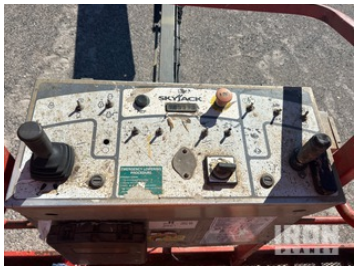
| Item | Assessment | Photo |
|---|---|---|
| Control Console | No visible damage or missing components | |

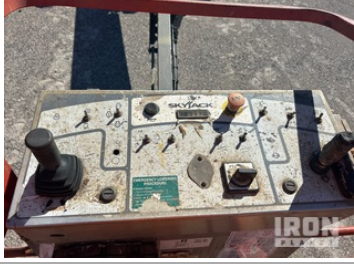
| Item | Assessment | Photo |
|---|---|---|
| Function Controls | ★★★★☆<br>Damaged boots | |

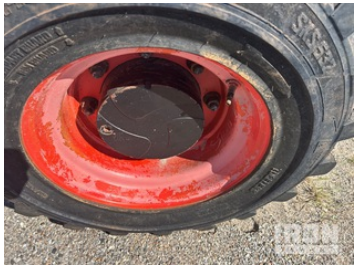
| Brake System | ★★★★☆<br>The brake system functioned, stopping and holding the machine. | |

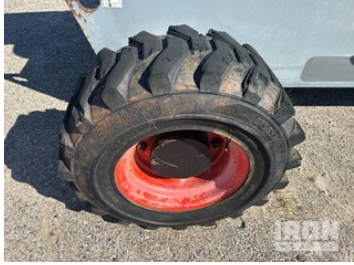
| Left Front Tire | Cracks, Chunks missing | |

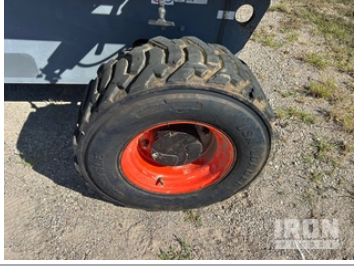
| Left Rear Tire | Cracks, Chunks missing | |

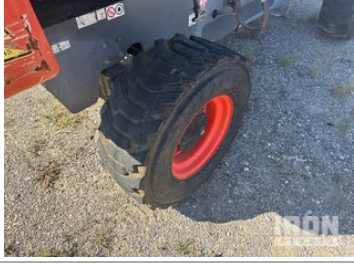
| Right Rear Tire | Cracks, Chunks missing | |

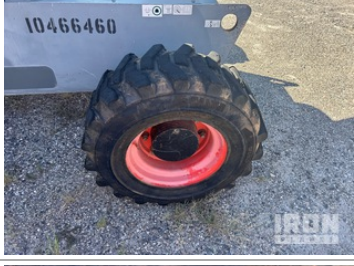
| Right Front Tire | Cracks, Chunks missing | |

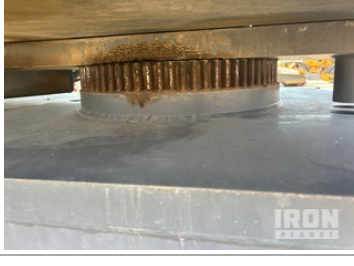
| Turntable Bearing | ★★★☆☆<br>Heavy movement | |
