Item #14095044 - 2017 Skyjack SJ61T 4WD Diesel Telescopic Boom Lift

Inspection Report

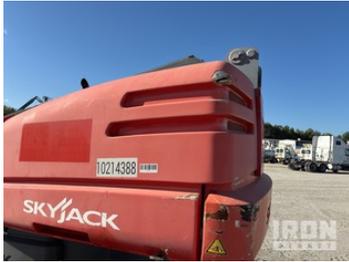
Body Panels	Engine compartment door damaged, Hydraulic compartment door damaged

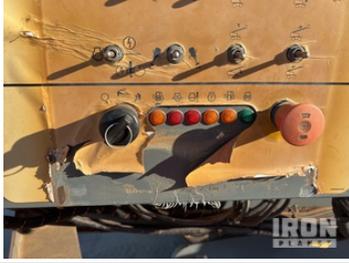
Oil Pressure	Warning light inoperable

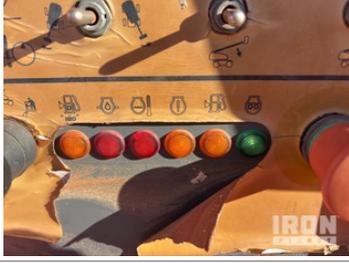
Warning Lights	Warning light self-test not functioning: engine oil pressure and coolant temperature lights do not illuminate during key-on cycle. Unable to verify operability.

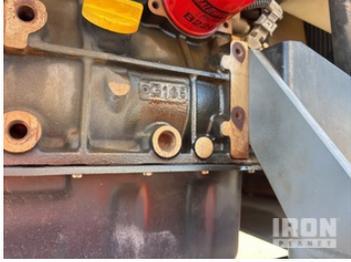
Oil Leaks	Oil Pan

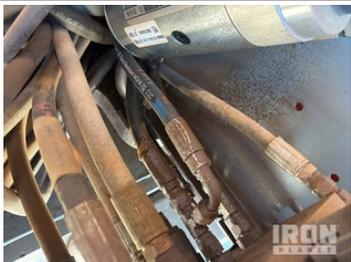
Hoses (Hydraulic)	★ ★ ☆ ☆ Dripping leak from hose's behind valve body

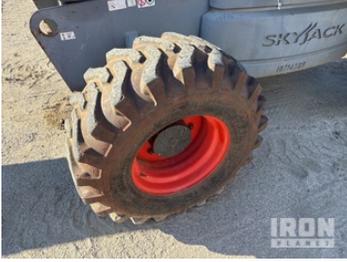
Brake System	★★★★★ The brake system functioned, stopping and holding the machine.	
Left Front Tire	Cracks, Chunks missing, Tears

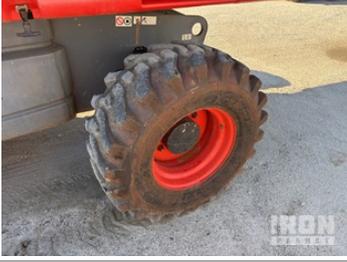
Left Rear Tire	Cracks, Chunks missing, Tears

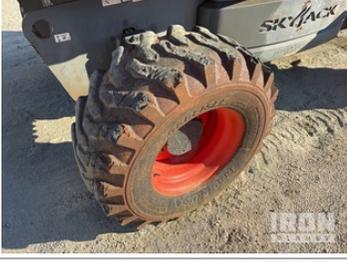
Right Rear Tire	Cracks, Chunks missing, Tears

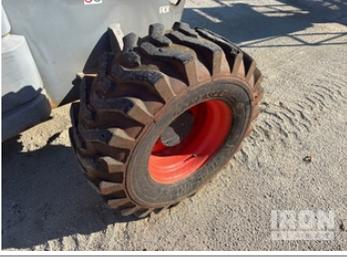
Right Front Tire	Cracks, Chunks missing, Tears
