## Item #14095013 - 2018 Skyjack SJ 66T 4WD Diesel Articulating Boom Lift

# Inspection Report

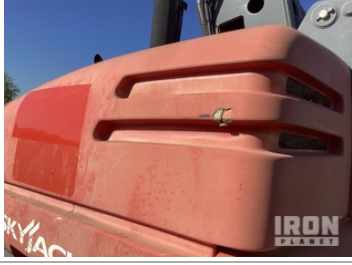
| Body Panels | Engine compartment door damaged | |

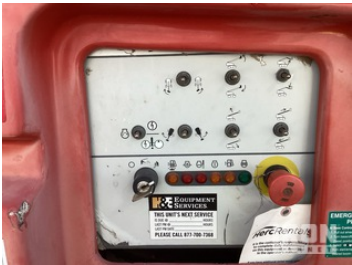
| Item | Assessment | Photo |
|---|---|---|
| Function Controls | ☆☆☆☆ | |

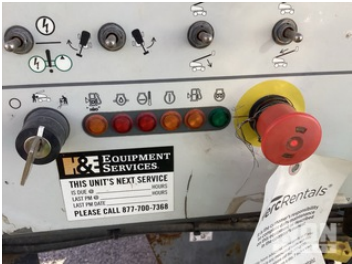
| Item | Assessment | Photo |
|---|---|---|
| Oil Pressure | Warning light inoperable | |
| Warning Lights | Inoperable | |

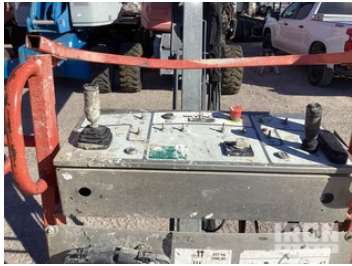
| Item | Assessment | Photo |
|---|---|---|
| Control Console | Control area (top) damaged Material buildup | |

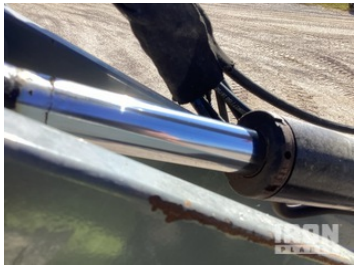
| Jib Cylinder | ☆☆☆☆ | |

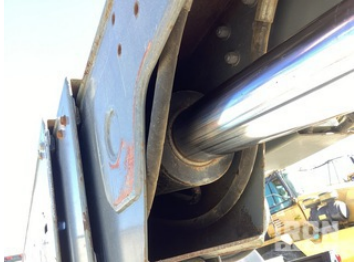
| Basket Tilt Cylinder | ☆☆☆☆ | |

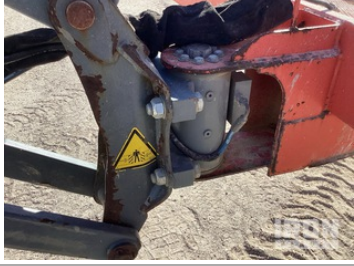
| Basket Rotator Motor | ☆☆☆☆ | |

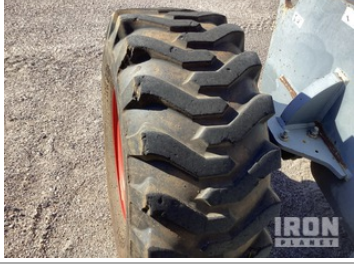
| Chassis | | |
|---|---|---|
| Left Front Tire | Chunks missing | |

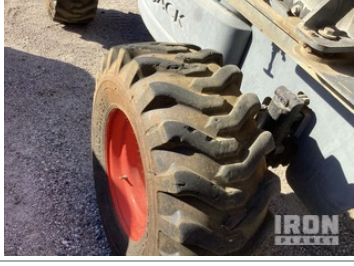
| Chassis | | |
|---|---|---|
| Left Rear Tire | Chunks missing | |

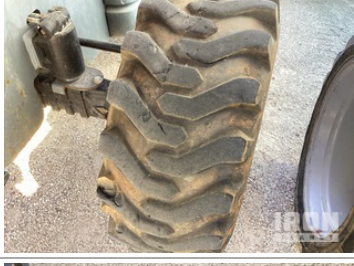
| Chassis | | |
|---|---|---|
| Right Rear Tire | Chunks missing | |

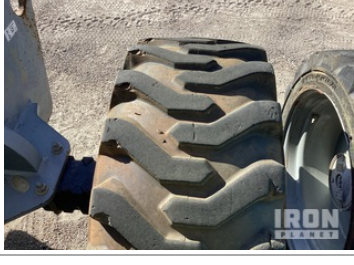
| Chassis | | |
|---|---|---|
| Right Front Tire | Chunks missing | |

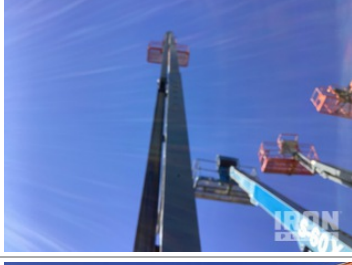
| Hydraulics | | |
|---|---|---|
| Boom Extension Cylinder | ★★★☆☆<br>Grinding noise when extending boom | |

| Boom Condition | ★★★☆☆<br>Grinding noise when extending boom | |

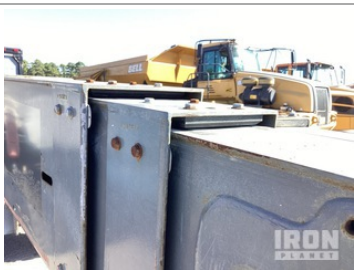
| Boom Wear Guides | ★★☆☆<br>Heavy wear | |

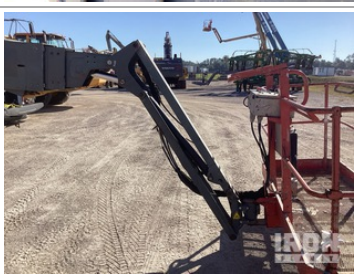
| Jib Condition | ★★★☆☆ | |

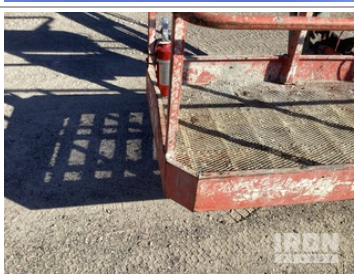
| Work Basket | Bent kick rail | |
