## Item #13869063 - 2017 Skyjack SJ40T 4WD Diesel Telescopic Boom Lift

# Inspection Report

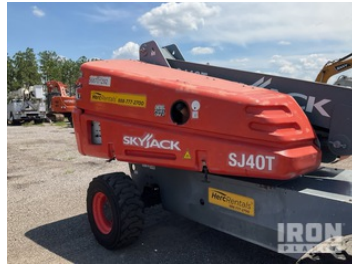
| Paint | No visible damage | |

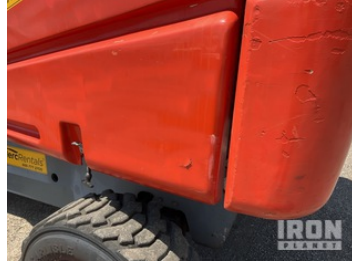
| Body Panels | Engine compartment door damaged | |

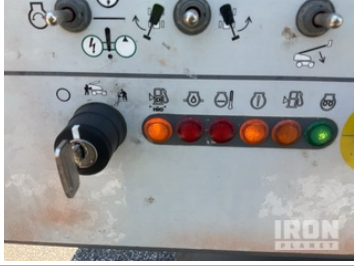
| Control Station Ground | | |
|---|---|---|
| Oil Pressure | The fault indicator shuts off after the engine oil pressure rises. | |

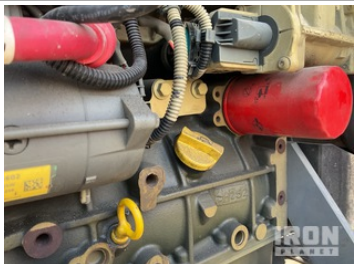
| Engine | | |
|---|---|---|
| Oil Leaks | No dripping leaks | |

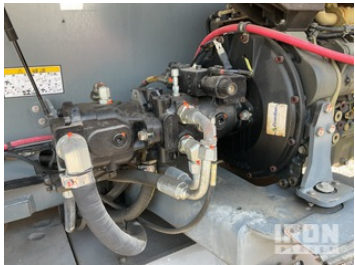
| Hydraulics | | |
|---|---|---|
| Pumps (Hydraulics) | ★★☆☆<br>seepage present | |

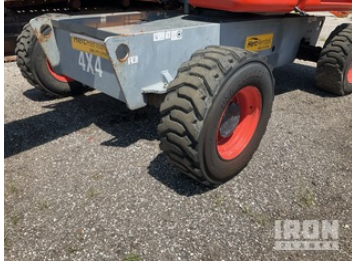
| Chassis | | |
|---|---|---|
| Left Front Tire | Chunks missing | |

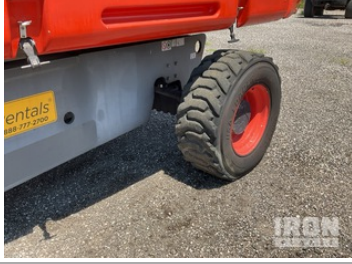
| Chassis | | |
|---|---|---|
| Left Rear Tire | Chunks missing | |

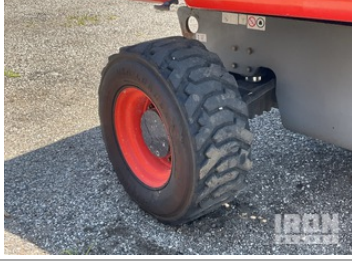
| Chassis | | |
|---|---|---|
| Right Rear Tire | Chunks missing | |

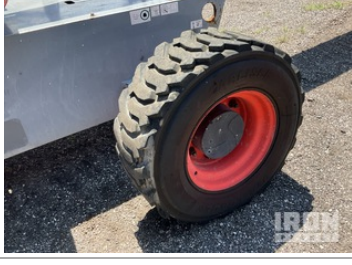
| Chassis | | |
|---|---|---|
| Right Front Tire | Chunks missing | |

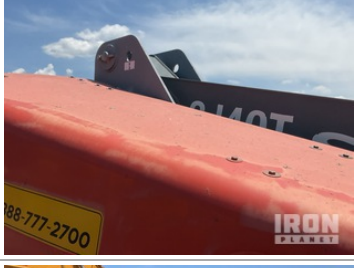
| Boom Condition | ★★★★☆ | |

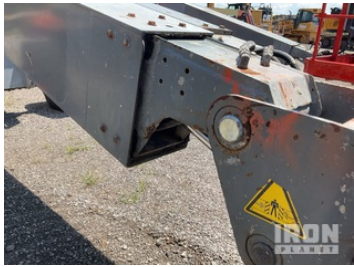
| Boom Wear Guides | ★★★☆☆ | |
