## Item #13971070 - 2015 JLG 600S 4WD Diesel Telescopic Boom Lift

# Inspection Report

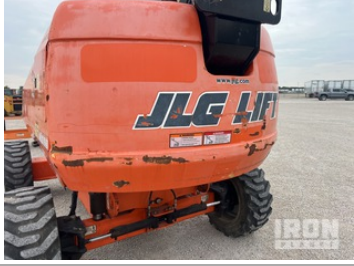
| Paint | No visible damage | |

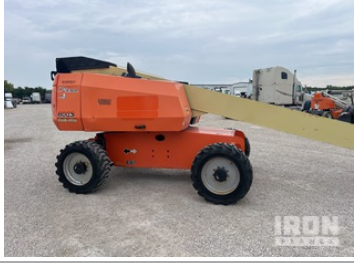
| Body Panels | No visible damage or missing components | |

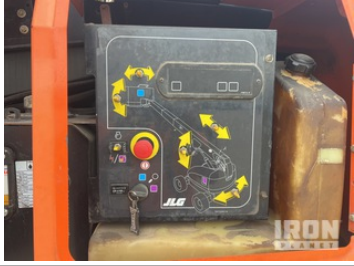
| Control Station Ground | | |
|---|---|---|
| Oil Pressure | The fault indicator shuts off after the engine oil pressure rises. | |

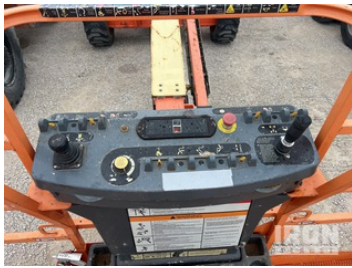
| Item | Assessment | Photo |
|---|---|---|
| Control Console | No visible damage or missing components | |

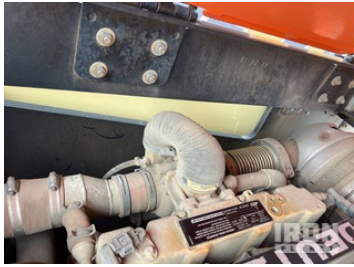
| Engine | | |
|---|---|---|
| Exhaust System | No visible damage or missing components | |

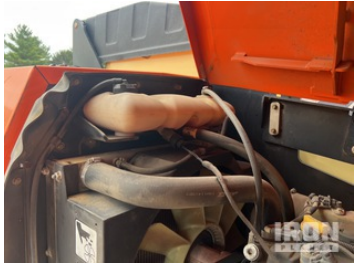
| Engine | | |
|---|---|---|
| Radiator | ★★★★☆ | |

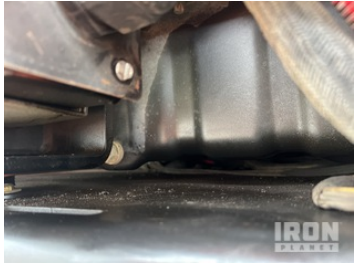
| Engine | | |
|---|---|---|
| Oil Leaks | No dripping leaks | |

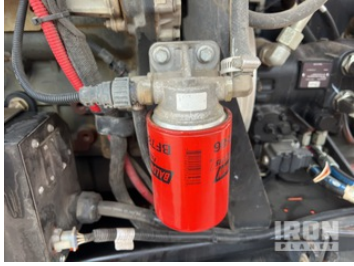
| Engine | | |
|---|---|---|
| Fuel Leaks | No dripping leaks | |

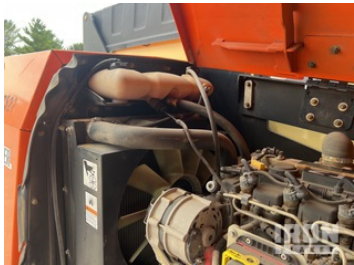
| Cooling System Leaks | No dripping leaks | |

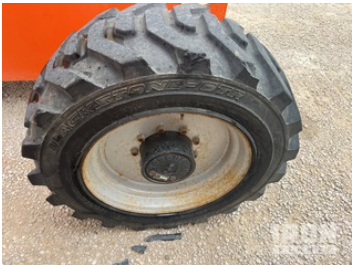
| Right Front Final Drive | ☆☆☆☆ | |

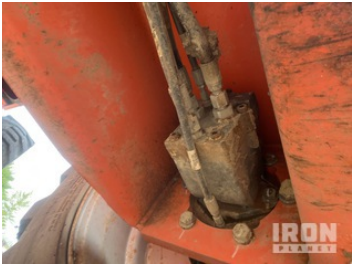
| Right Front Drive Motor | ☆☆☆☆ | |

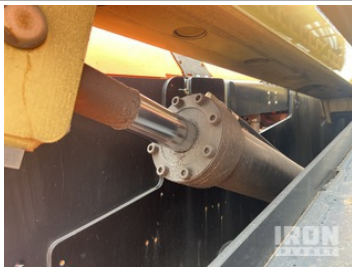
| Hydraulics | | |
|---|---|---|
| Boom Lift Cylinder | ★★★☆☆<br>Accumulation fluid. | |

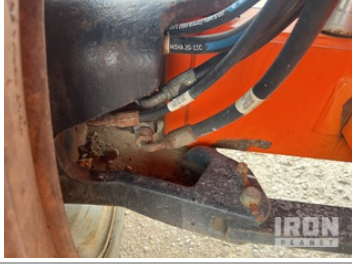
| Chassis | | |
|---|---|---|
| Brake System | ★★★★☆<br>The brake system functioned, stopping and holding the machine. | |

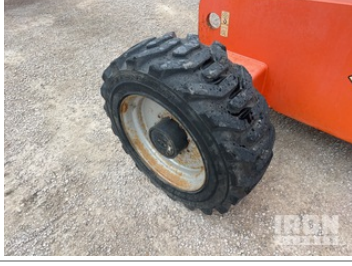
| Chassis | | |
|---|---|---|
| Left Front Tire | No visible defects | |

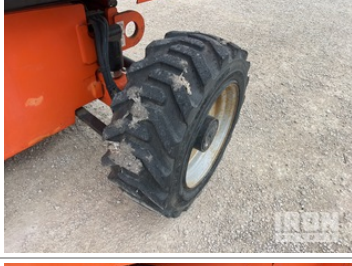
| Chassis | | |
|---|---|---|
| Left Rear Tire | No visible defects | |

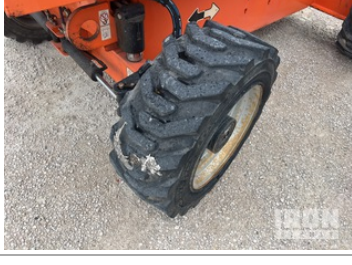
| Chassis | | |
|---|---|---|
| Right Rear Tire | No visible defects | |

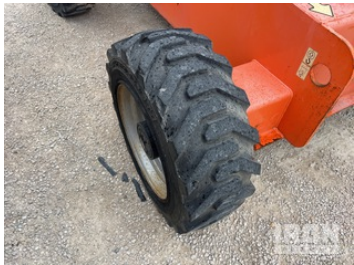
| Right Front Tire | No visible defects | |

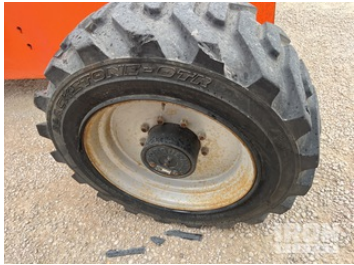
| Wheel Condition | No visible damage or missing components | |
