## Item #13869061 - 2017 Skyjack SJ40T 4WD Diesel Telescopic Boom Lift

# Inspection Report

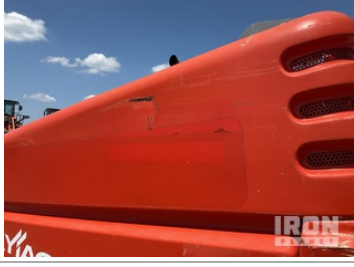
| Body Panels | Engine compartment door damaged | |

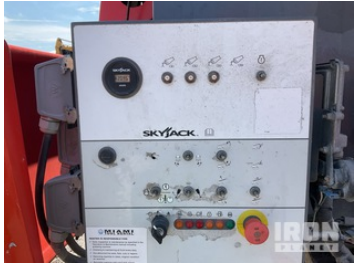
| Control Station Ground | | |
|---|---|---|
| Function Controls | ★★★★☆ | |

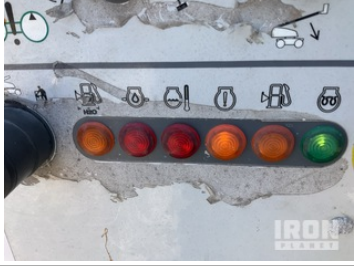
| Control Station Ground | | |
|---|---|---|
| Oil Pressure | The fault indicator shuts off after the engine oil pressure rises. | |

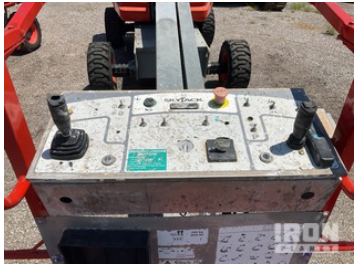
| Item | Assessment | Photo |
|---|---|---|
| Control Console | No visible damage or missing components | |

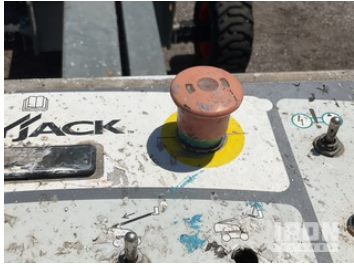
| Item | Assessment | Photo |
|---|---|---|
| Emergency Shut Off Switch | Operational | |

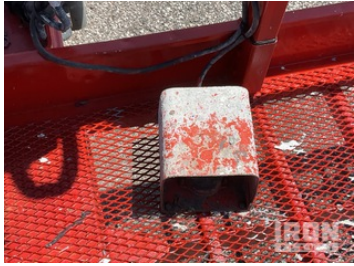
| Item | Assessment | Photo |
|---|---|---|
| Safety Control Hand/Foot Switch | ☆☆☆☆<br>Operational | |

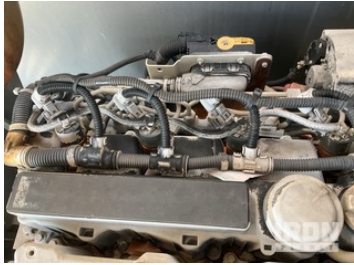
| Engine | | |
|---|---|---|
| Fuel System | Operational | |

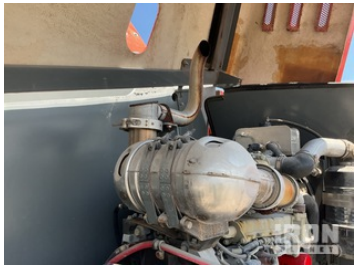
| Engine | | |
|---|---|---|
| Exhaust System | No visible damage or missing components | |

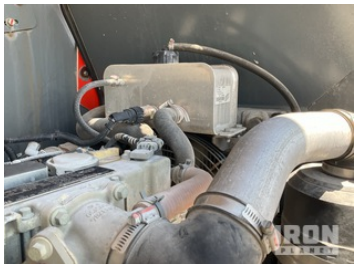
| Engine | | |
|---|---|---|
| Radiator | ★★★★☆ | |

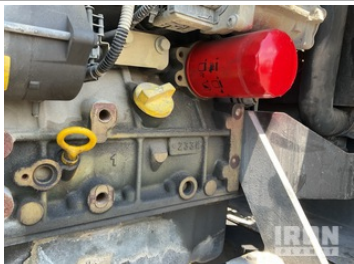
| Engine | | |
|---|---|---|
| Oil Leaks | No dripping leaks | |

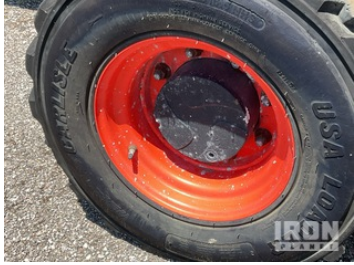
| Item | Assessment | Photo |
|---|---|---|
| Left Front Final Drive | ★★★★☆ | |

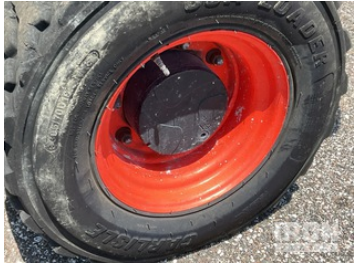
| Item | Assessment | Photo |
|---|---|---|
| Left Rear Final Drive | ★★★★☆ | |

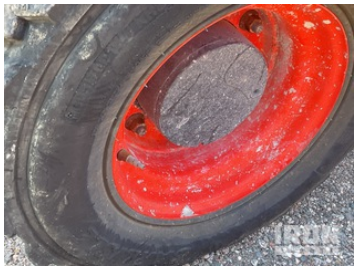
| Item | Assessment | Photo |
|---|---|---|
| Right Rear Final Drive | ★★★★☆ | |

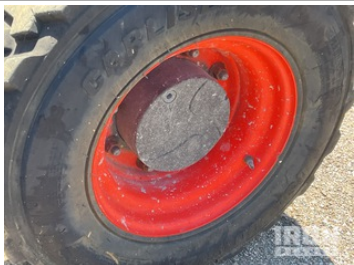
| Item | Assessment | Photo |
|---|---|---|
| Right Front Final Drive | ★★★★☆ | |

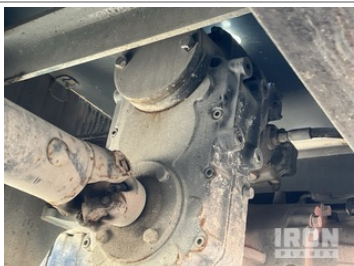
| Item | Assessment | Photo |
|---|---|---|
| Front Center Drive Motor | ★★★★☆ | |

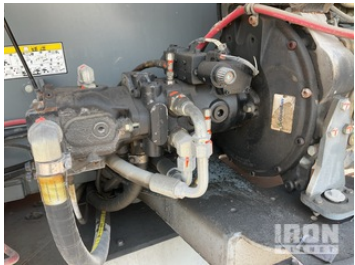
| Hydraulics | | |
|---|---|---|
| Pumps (Hydraulics) | ★★☆☆<br>seepage present | |

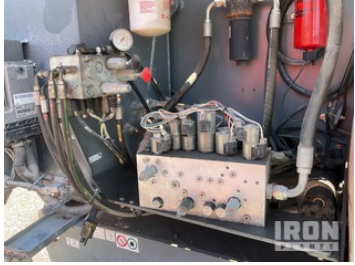
| Hydraulics | | |
|---|---|---|
| Valves | ★★★★ | |

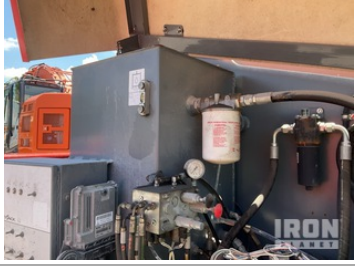
| Hydraulics | | |
|---|---|---|
| Hydraulic Tank | ★★★★ | |

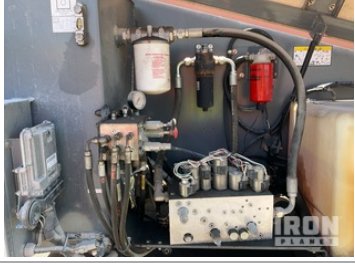
| Hydraulics | | |
|---|---|---|
| Hoses (Hydraulic) | ★★★★ | |

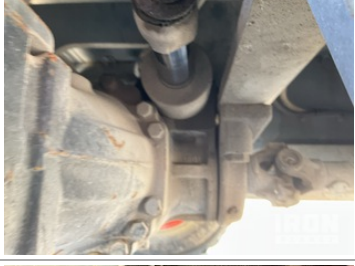
| Hydraulics | | |
|---|---|---|
| Steering Cylinders | ★★★★ | |

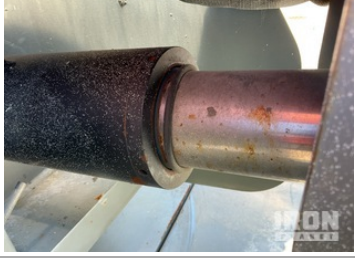
| Hydraulics | | |
|---|---|---|
| Boom Lift Cylinder | ★★★★ | |

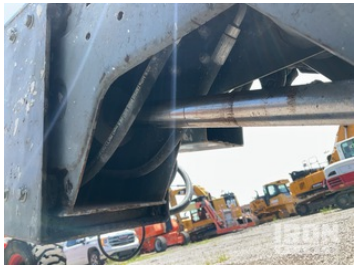
| Basket Tilt Cylinder | ★★☆☆<br>Dripping leak | |

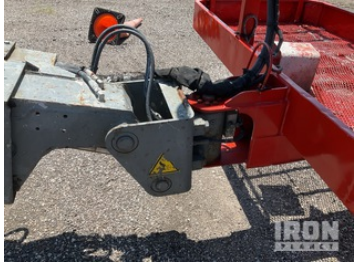
| Basket Rotator Motor | ★★★★ | |

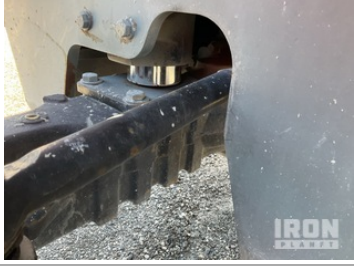
| Frame Leveling Cylinders | ★★★★ | |

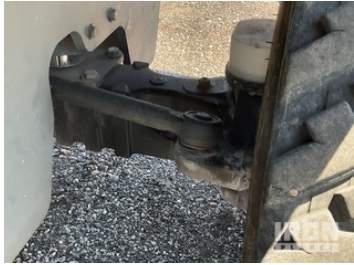
| Chassis | | |
|---|---|---|
| Steering Linkage | ★★★★☆ | |

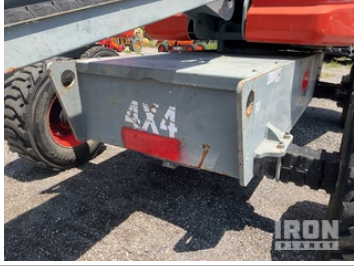
| Chassis | | |
|---|---|---|
| Frame Condition | ★★★★☆ | |

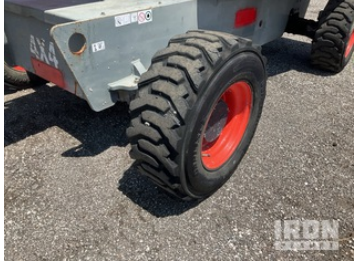
| Chassis | | |
|---|---|---|
| Left Front Tire | Chunks missing | |

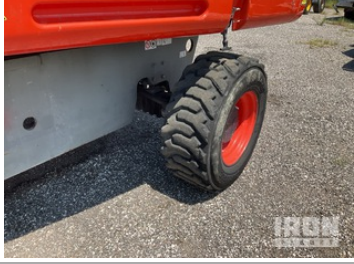
| Chassis | | |
|---|---|---|
| Left Rear Tire | Chunks missing | |

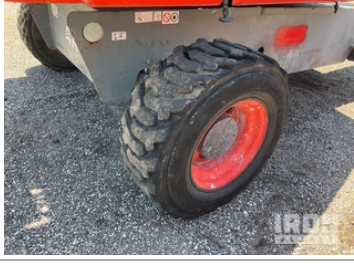
| Chassis | | |
|---|---|---|
| Right Rear Tire | Chunks missing | |

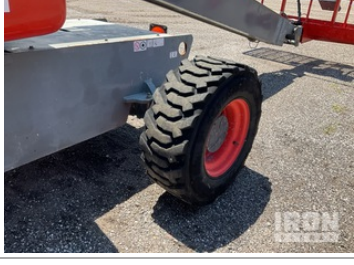
| Chassis | | |
|---|---|---|
| Right Front Tire | Chunks missing | |

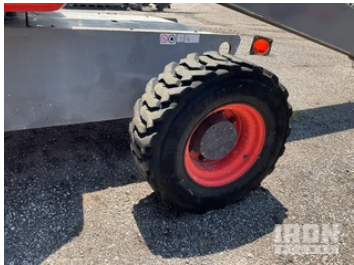
| Wheel Condition | No visible damage or missing components | |

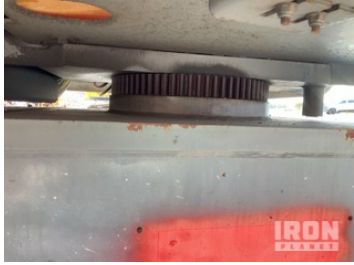
| Turntable Bearing | ★★★★☆ | |

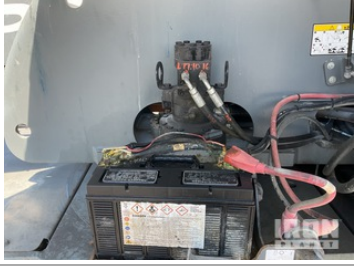
| Swing Motor | ★★★★☆ | |

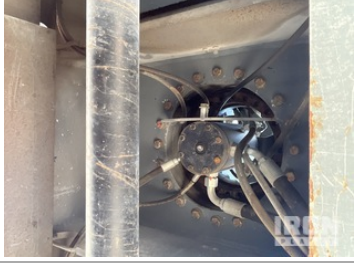
| Hydraulic Center Swivel | ★★★★☆ | |

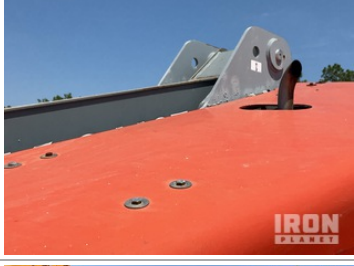
| Boom Condition | ★★★★☆ | |

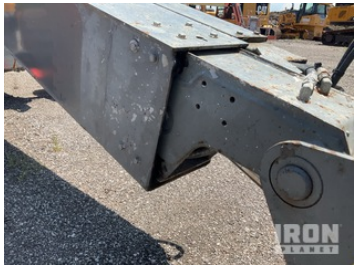
| Boom Wear Guides | ☆☆☆☆ | |
