## Item #14251163 - 2006 JLG 600S 4WD Diesel Telescopic Boom Lift

# Inspection Report

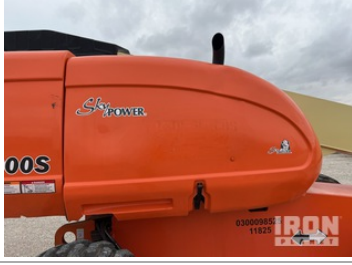
| Body Panels | Engine compartment door damaged,<br>Hydraulic compartment door damaged | |

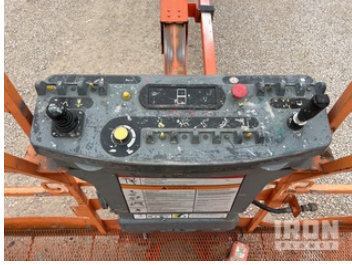
| Item | Assessment | Photo |
|---|---|---|
| Control Console | Material buildup | |

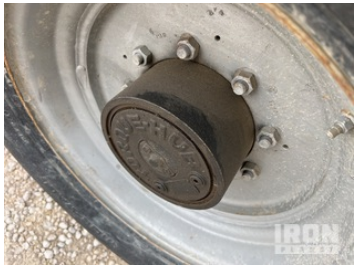
| Right Front Final Drive | ☆☆☆☆<br>Seeping | |

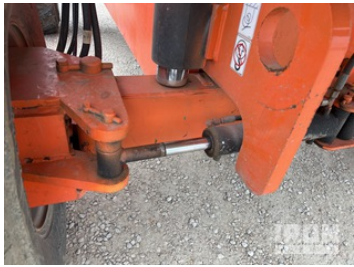
| Hydraulics | | |
|---|---|---|
| Steering Cylinders | ★★★☆☆<br>Left side seep | |

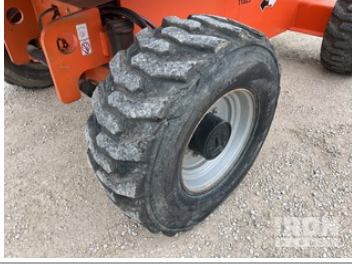
| Chassis | | |
|---|---|---|
| Left Front Tire | Cracks, Chunks missing, Tears | |

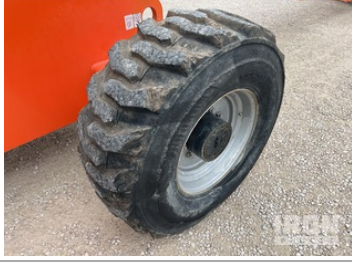
| Chassis | | |
|---|---|---|
| Left Rear Tire | Chunks missing, Tears | |

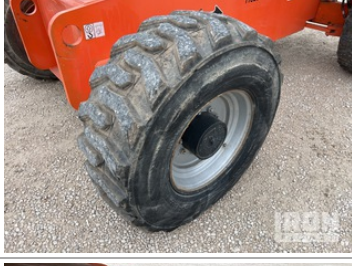
| Chassis | | |
|---|---|---|
| Right Rear Tire | Cracks, Chunks missing, Tears | |

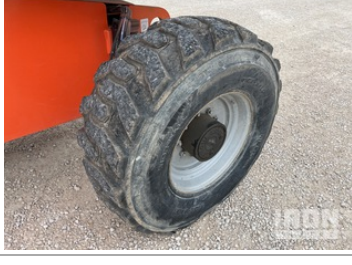
| Chassis | | |
|---|---|---|
| Right Front Tire | Cracks, Chunks missing, Tears | |

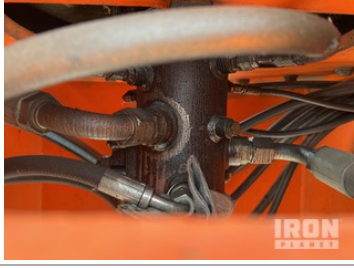
| Hydraulic Center Swivel | ★★★☆☆<br>Dripping leak | |
