## Item #13810610 - 2017 Skyjack SJ45T 4WD Diesel Telescopic Boom Lift

# Inspection Report

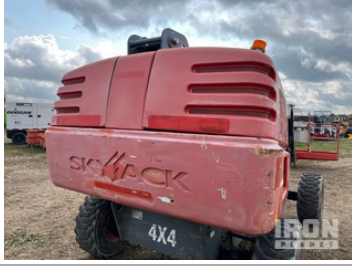
| Paint | damage | |

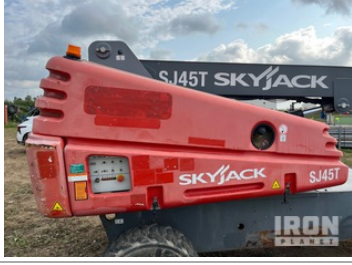
| Body Panels | Engine compartment door damaged | |

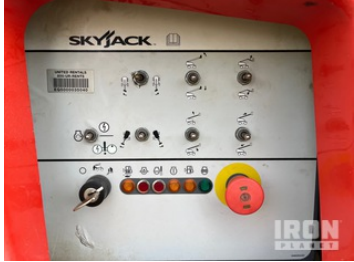
| Control Station Ground | | |
|---|---|---|
| Oil Pressure | No oil pressure indicator | |

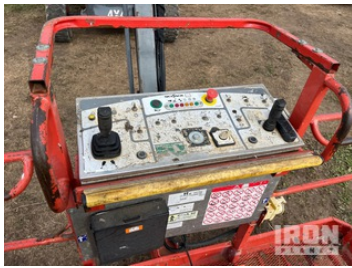
| Item | Assessment | Photo |
|---|---|---|
| Control Console | No visible damage or missing components | |

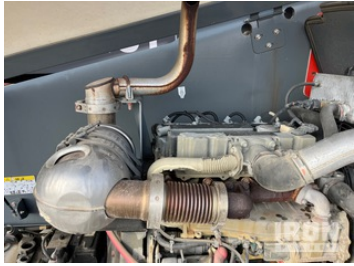
| Engine | | |
|---|---|---|
| Exhaust System | No visible damage or missing components | |

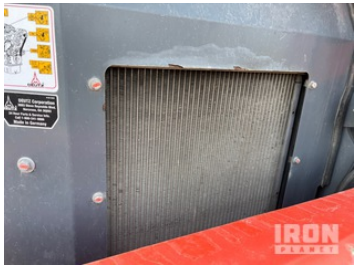
| Engine | | |
|---|---|---|
| Radiator | ★★★★☆ | |

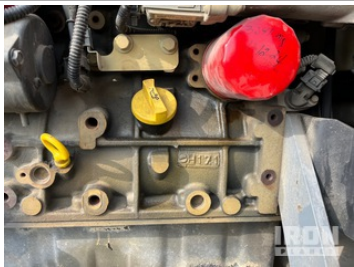
| Engine | | |
|---|---|---|
| Oil Leaks | Seepage | |

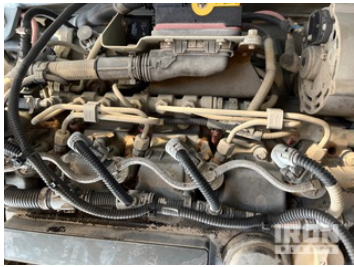
| Fuel Leaks | No dripping leaks | |

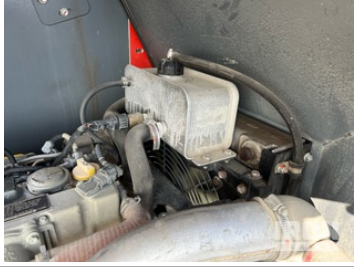
| Cooling System Leaks | No dripping leaks | |

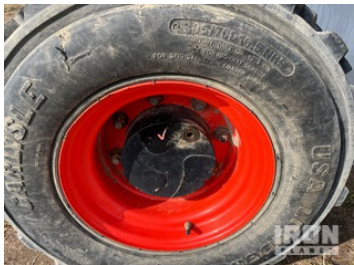
| Item | Assessment | Photo |
|---|---|---|
| Left Front Final Drive | ★★★★☆ | |

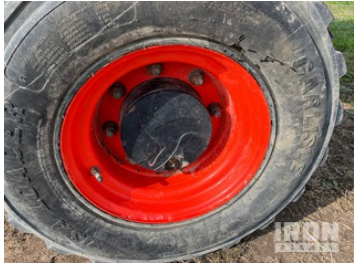
| Item | Assessment | Photo |
|---|---|---|
| Left Rear Final Drive | ★★★★☆ | |

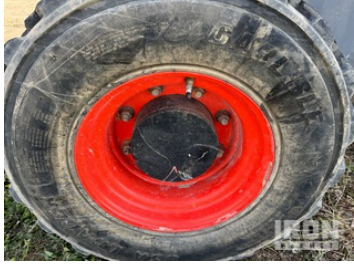
| Item | Assessment | Photo |
|---|---|---|
| Right Rear Final Drive | ★★★★☆ | |

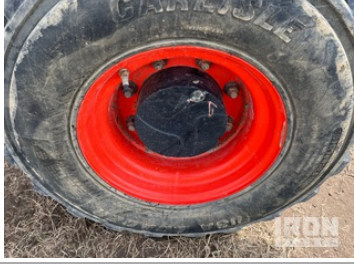
| Item | Assessment | Photo |
|---|---|---|
| Right Front Final Drive | ★★★★☆ | |

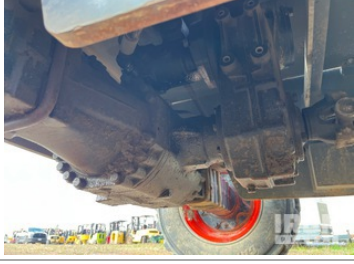
| Item | Assessment | Photo |
|---|---|---|
| Front Center Drive Motor | ★★★★☆ | |

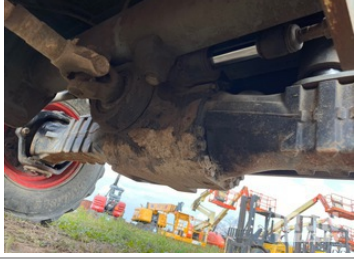
| Item | Assessment | Photo |
|---|---|---|
| Rear Center Drive Motor | ★★★★☆ | |

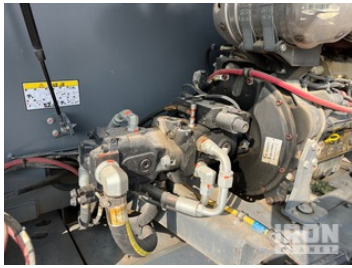
| Hydraulics | | |
|---|---|---|
| Pumps (Hydraulics) | ★★★★☆ | |

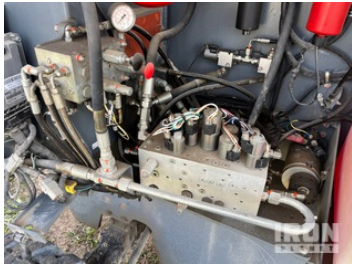
| Hydraulics | | |
|---|---|---|
| Valves | ★★★★☆ | |

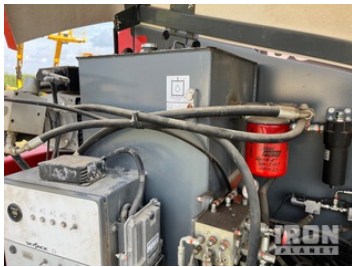
| Hydraulics | | |
|---|---|---|
| Hydraulic Tank | ★★★★☆ | |

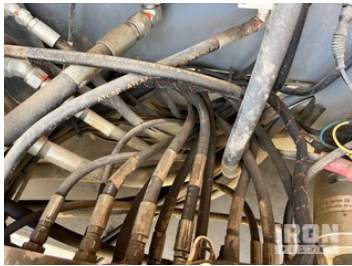
| Hydraulics | | |
|---|---|---|
| Hoses (Hydraulic) | ★★★★☆ | |

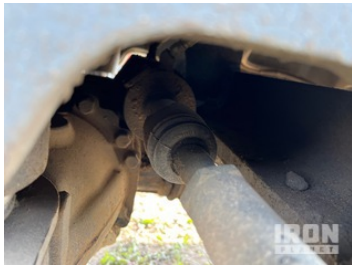
| Hydraulics | | |
|---|---|---|
| Steering Cylinders | ★★★★☆ | |

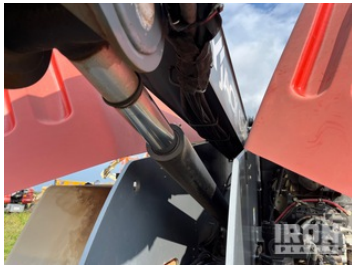
| Hydraulics | | |
|---|---|---|
| Boom Lift Cylinder | ★★★★☆ | |

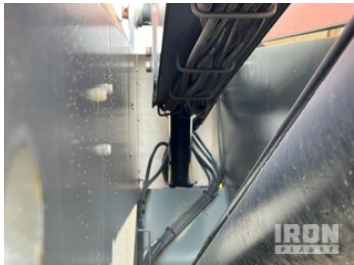
| Secondary Boom Cylinder | ★★★★☆ | |

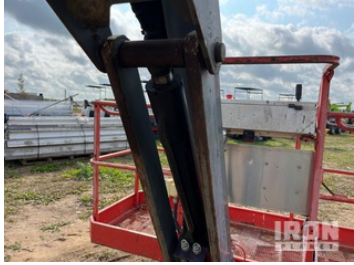
| Jib Cylinder | ★★★★☆ | |

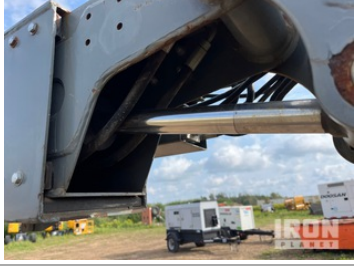
| Basket Tilt Cylinder | ★★★★☆ | |

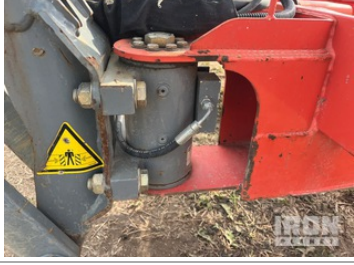
| Basket Rotator Motor | ★★★★☆ | |

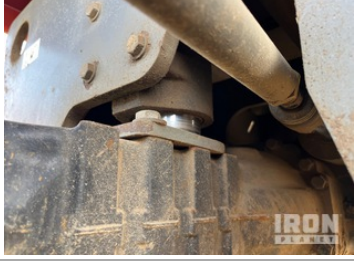
| Frame Leveling Cylinders | ★★★★☆ | |

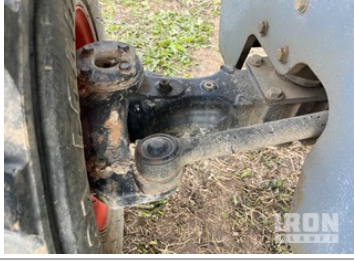
| Chassis | | |
|---|---|---|
| Steering Linkage | ★★★★☆ | |

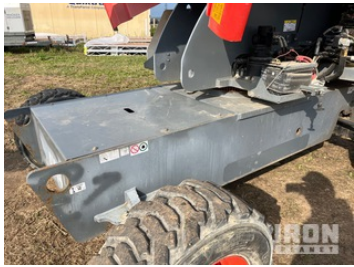
| Frame Condition | ★★★★☆ | |

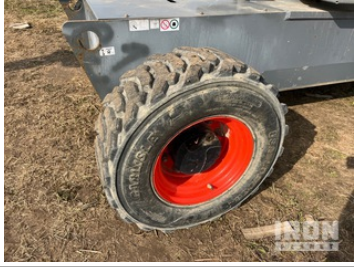
| Left Front Tire | No visible defects | |

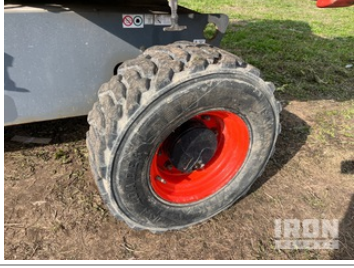
| Left Rear Tire | No visible defects | |

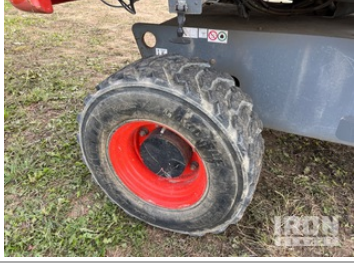
| Right Rear Tire | No visible defects | |

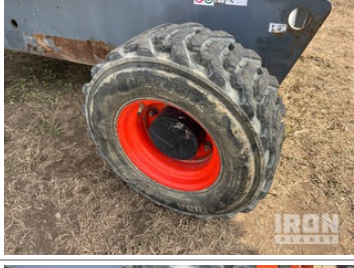
| Right Front Tire | No visible defects | |

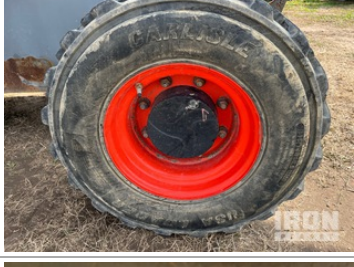
| Wheel Condition | No visible damage or missing components | |

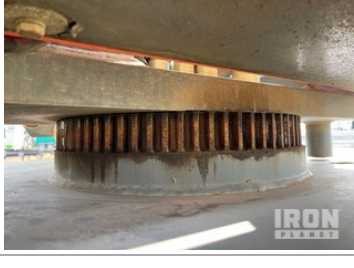
| Turntable Bearing | ★★★★☆ | |

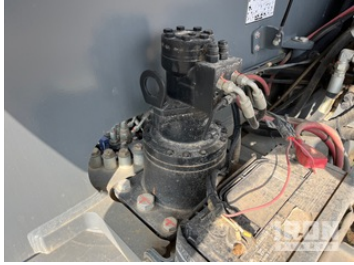
| Swing Motor | ★★★★☆ | |

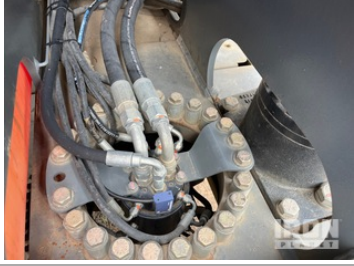
| Hydraulic Center Swivel | ★★★★☆ | |

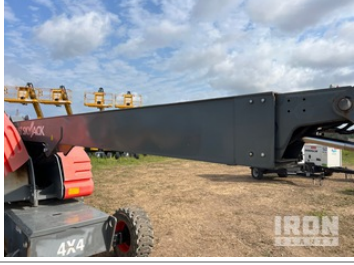
| Boom Condition | ★★★★☆ | |

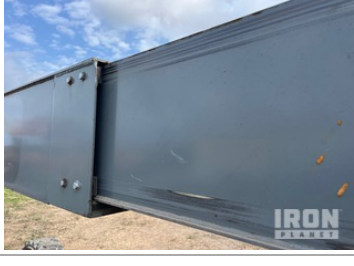
| Boom Wear Guides | ★★★★☆ | |
