## Item #13811326 - 2017 Skyjack SJ45T 4WD Diesel Telescopic Boom Lift

# Inspection Report

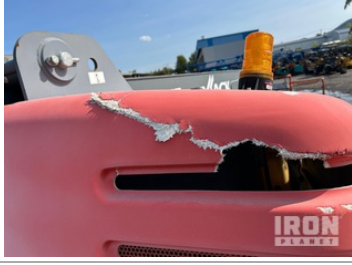
| Body Panels | Hydraulic compartment door damaged | |

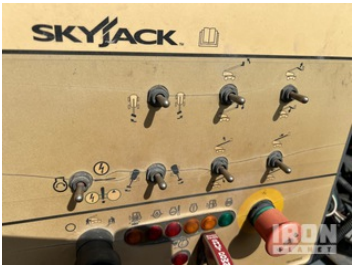
| Control Station Ground | | |
|---|---|---|
| Function Controls | ★★★★☆ | |

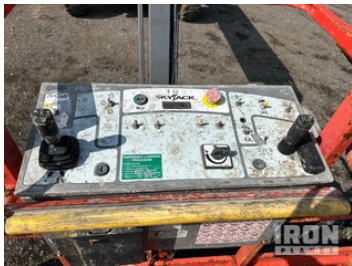
| Control Station | | |
|---|---|---|
| Control Console | Control area (top) damaged Material buildup | |

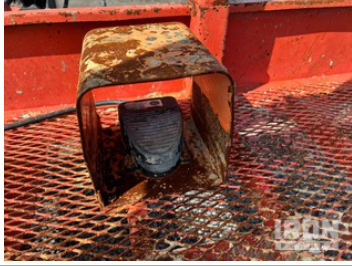
| Control Station | | |
|---|---|---|
| Safety Control Foot Switch | ★★★★☆<br>Operational | |

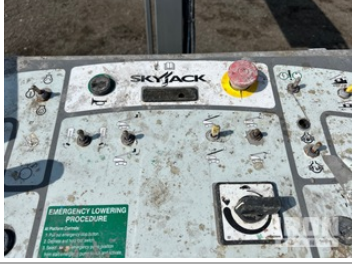
| Control Station | | |
|---|---|---|
| Function Controls | ★★★★☆ | |

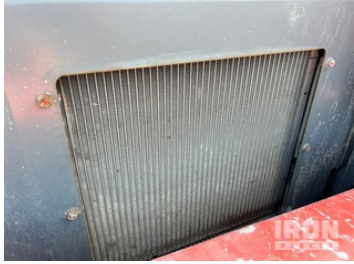
| Engine | | |
|---|---|---|
| Radiator | ★★★★☆ | |

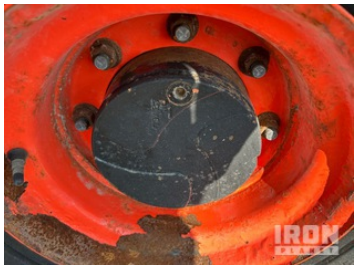
| Item | Assessment | Photo |
|---|---|---|
| Left Front Final Drive | ★★★★☆ | |

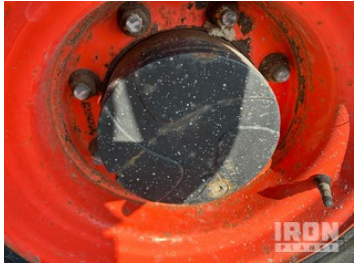
| Item | Assessment | Photo |
|---|---|---|
| Left Rear Final Drive | ★★★★☆ | |

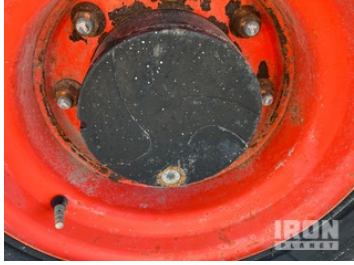
| Item | Assessment | Photo |
|---|---|---|
| Right Rear Final Drive | ★★★★☆ | |

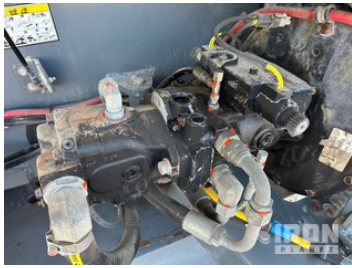
| Hydraulics | | |
|---|---|---|
| Pumps (Hydraulics) | ★★★★☆ | |

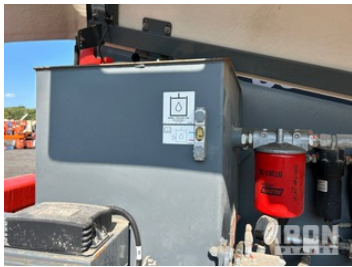
| Hydraulics | | |
|---|---|---|
| Hydraulic Tank | ★★★★☆ | |

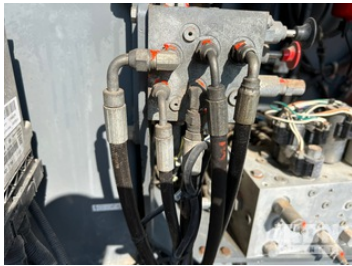
| Hydraulics | | |
|---|---|---|
| Hoses (Hydraulic) | ★★★★☆ | |

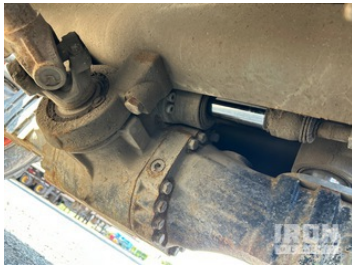
| Hydraulics | | |
|---|---|---|
| Steering Cylinders | ★★★★☆ | |

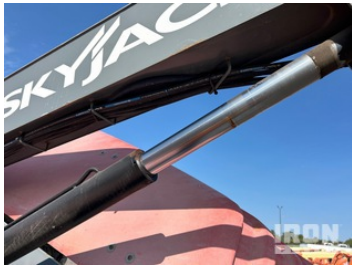
| Hydraulics | | |
|---|---|---|
| Boom Lift Cylinder | ★★★★☆ | |

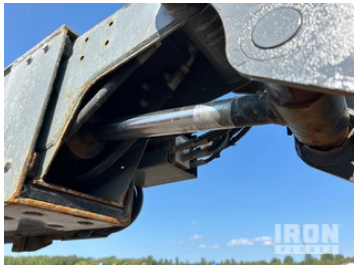
| Jib Cylinder | ★★★★☆ | |

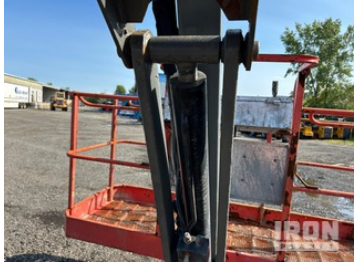
| Basket Tilt Cylinder | ★★★★☆ | |

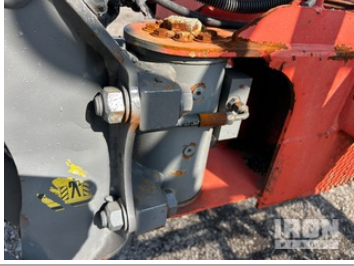
| Basket Rotator Motor | ★★★★☆ | |

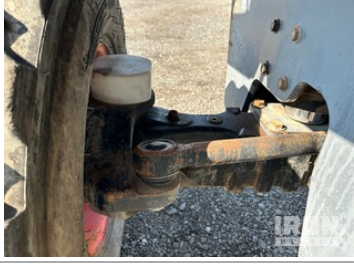
| Steering Linkage | ★★★★☆ | |

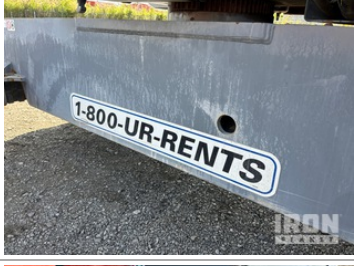
| Frame Condition | ★★★★☆ | |

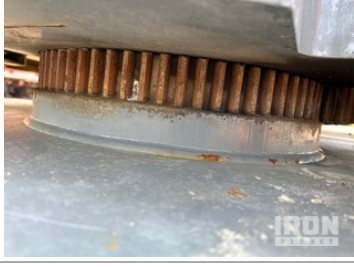
| Turntable Bearing | ★★★★☆ | |

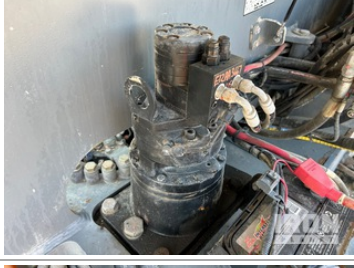
| Swing Motor | ★★★★☆ | |

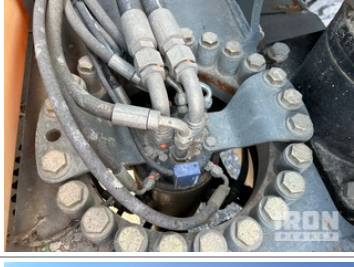
| Hydraulic Center Swivel | ★★★★☆ | |

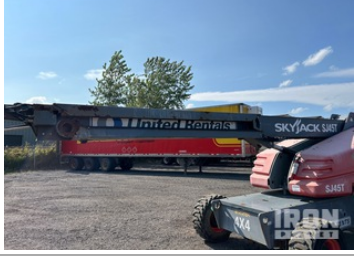
| Boom Condition | ★★★★☆ | |

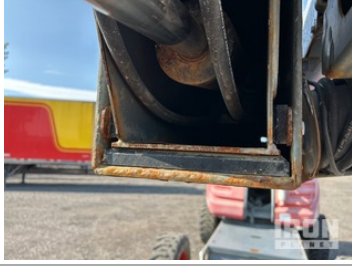
| Boom Wear Guides | ★★★★☆ | |

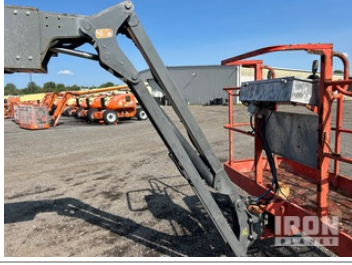
| Jib Condition | ★★★★☆<br>Repainted | |
