## Item #13890476 - 2016 Skyjack SJ61T 4WD Diesel Telescopic Boom Lift

- Features: 61 ft Max Platform Height, 500 lb Max Weight Capacity, Power to Platform, Onboard Generator, 2016 US EPA Label, Deutz TD 2.9 L4 4 Cylinder 74 hp 2.92 L Diesel Engine, 385/65D19.5 Foam-Filled Tires
- Meter Reading: 2,409 Hours
- Serial # : 97001957
- Inspection Completed: 9/4/25

# Inspection Report

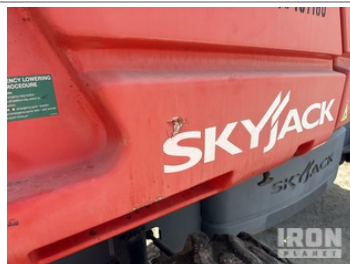
| Body Panels | Engine compartment door damaged, Hydraulic compartment door damaged | |

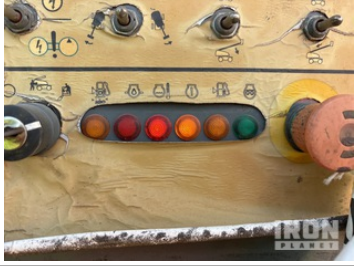
| Control Station Ground | | |
|---|---|---|
| Oil Pressure | Warning light inoperable | |

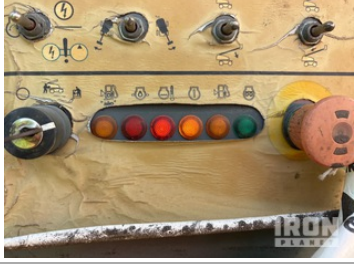
| Control Station Ground | | |
|---|---|---|
| Warning Lights | Operational, Check engine light stays on, coolant temperature warning light stays on, Some warning lights are inoperable | |

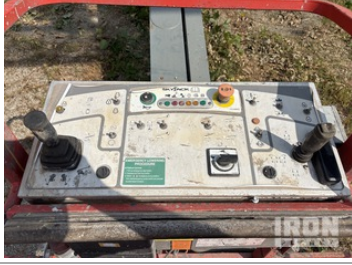
| Item | Assessment | Photo |
|---|---|---|
| Function Controls | ☆☆☆☆<br>Damaged boots | |

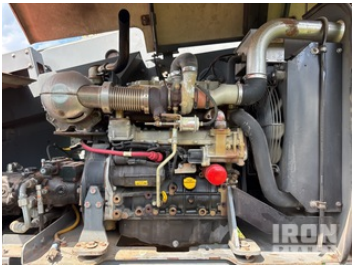
| Limited Function Check | After jump starting, the engine ran. The engine would not re-start after shutting down without jump starting. | |

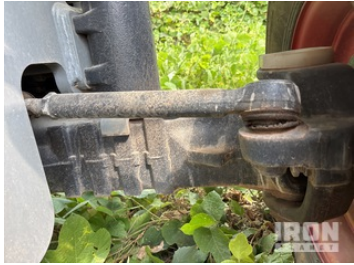
| Chassis | | |
|---|---|---|
| Steering Linkage | ★★☆☆☆<br>Damaged boots | |

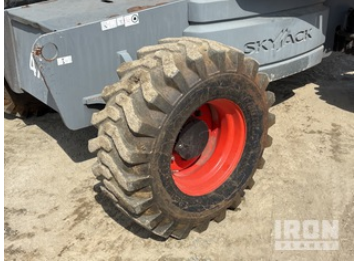
| Chassis | | |
|---|---|---|
| Left Front Tire | Tears | |

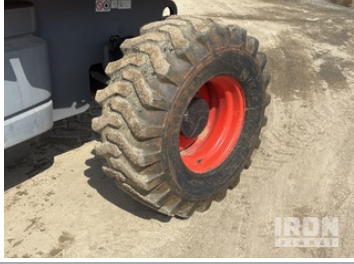
| Chassis | | |
|---|---|---|
| Left Rear Tire | Chunks missing, Tears | |

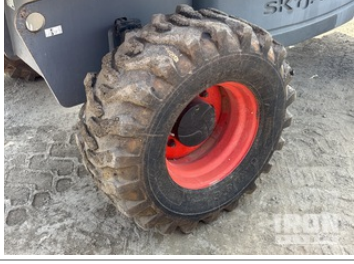
| Chassis | | |
|---|---|---|
| Right Rear Tire | Cracks, Chunks missing, Tears | |

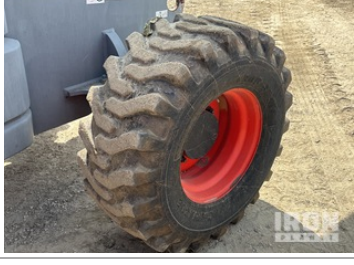
| Chassis | | |
|---|---|---|
| Right Front Tire | Cracks, Chunks missing, Tears | |
